## Buffer Breaches

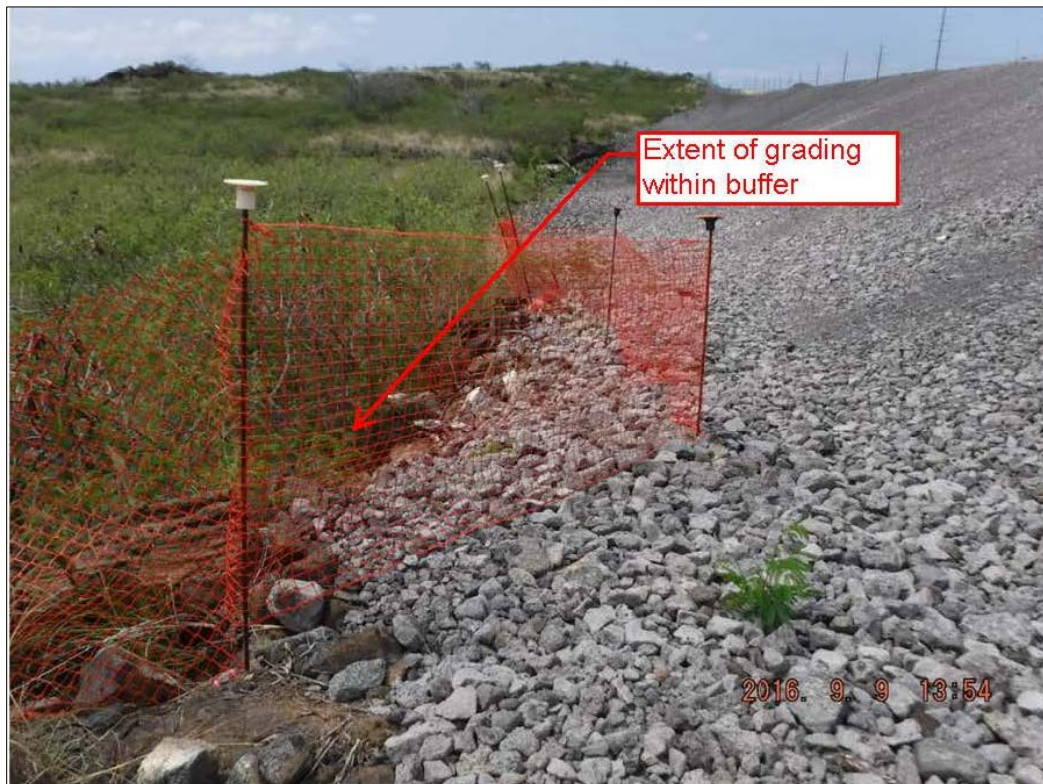
September 9, 2016 photograph of Site 19447 looking north.

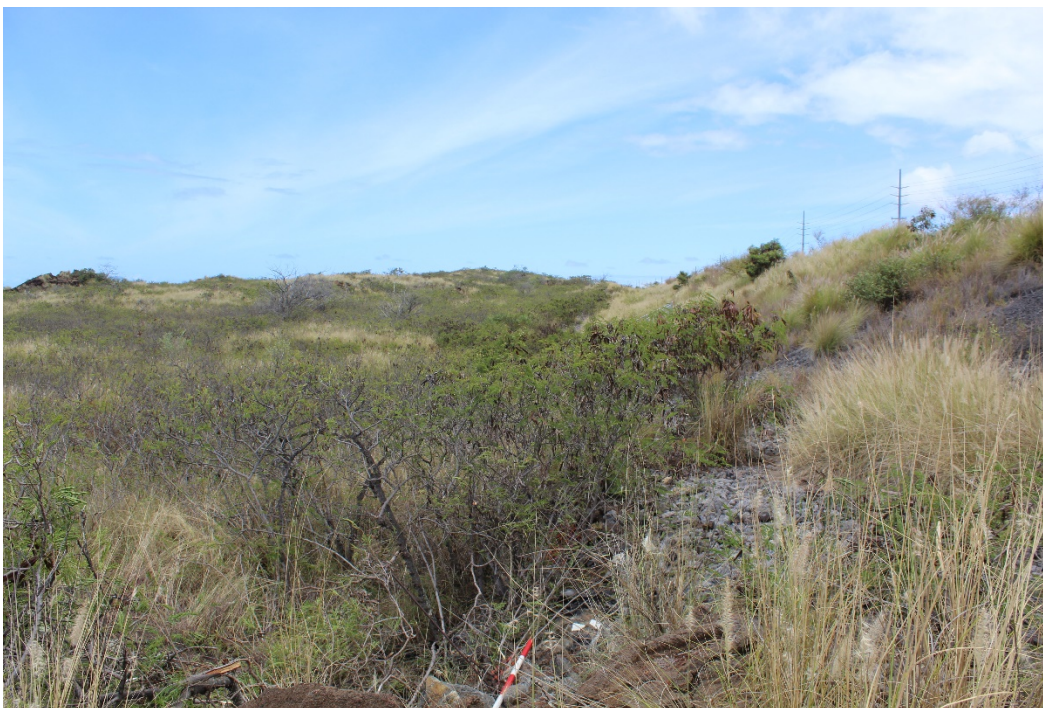
**Site 19947** is located within Kohanaiki Ahupua'a and consists of three collections of stacked rocks. It is interpreted as an ahupua'a boundary marker. It has an accepted preservation buffer of 5 m (approximately 15 feet) on all sides. Grading activities encroached within 2.4 meters of the eastern edge, as measured from feature B (the eastern most rock pile). The site itself was not damaged.

Same photograph of Site 19447 looking north taken on May 12, 2020 (with meter stick along limits of grading).

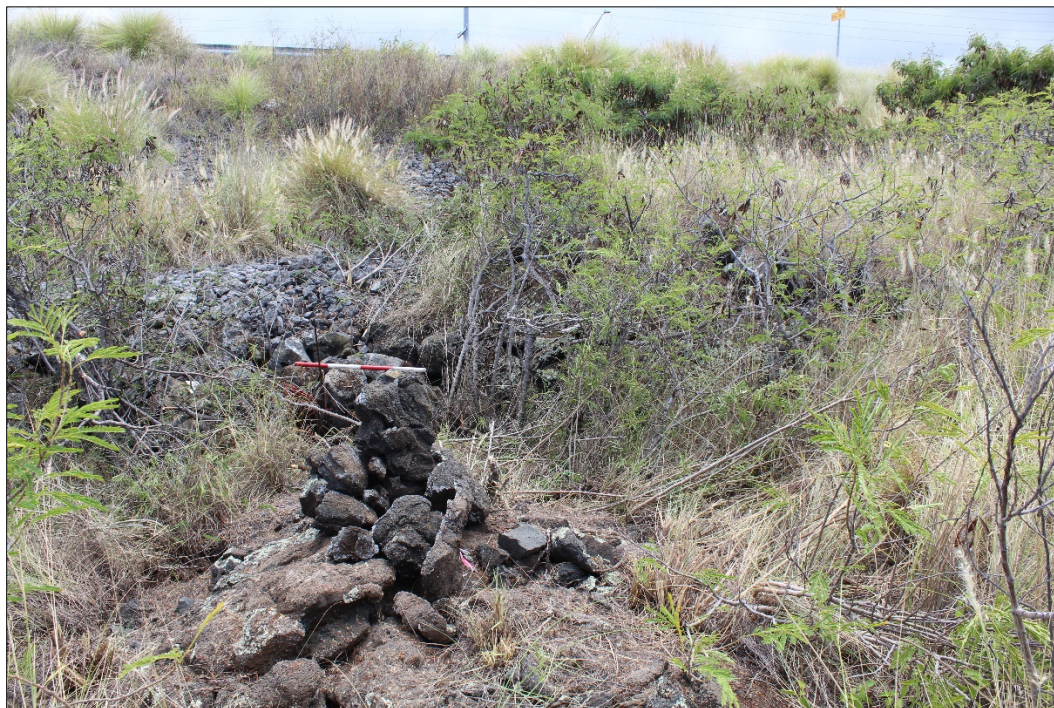
May 12, 2020 photograph of Site 19447 taken from Feature B looking east (with meter stick along limits of grading).

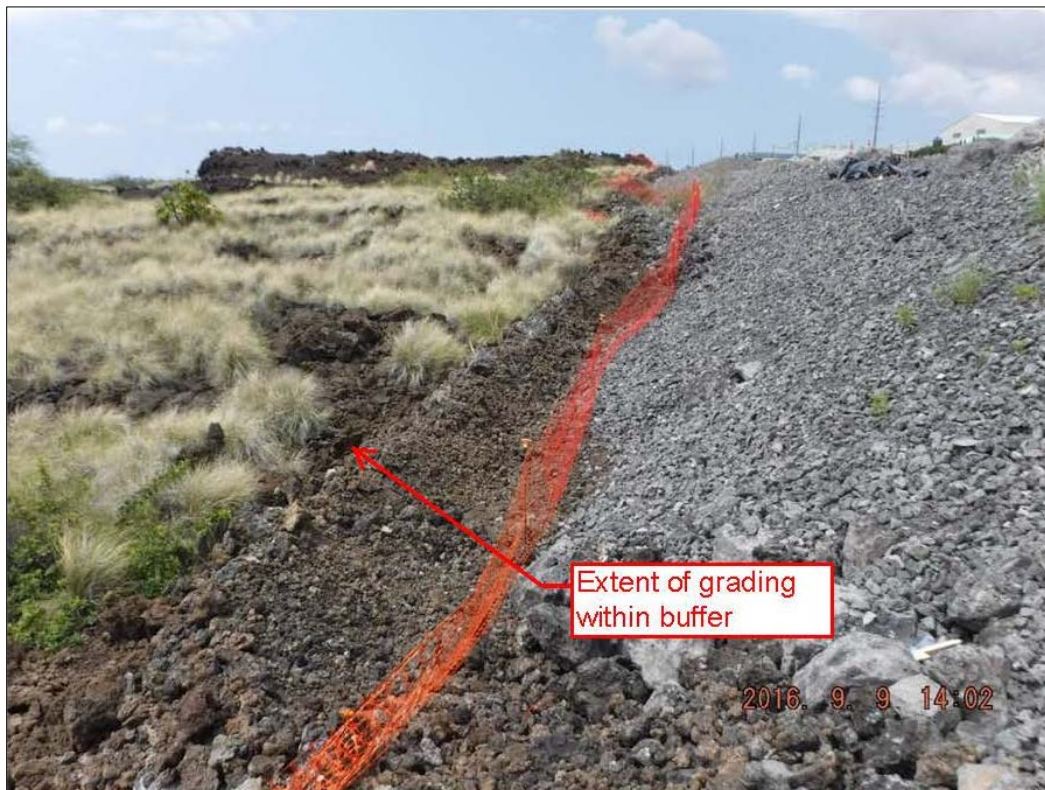
September 9, 2016 photograph of Site 28783 looking north.

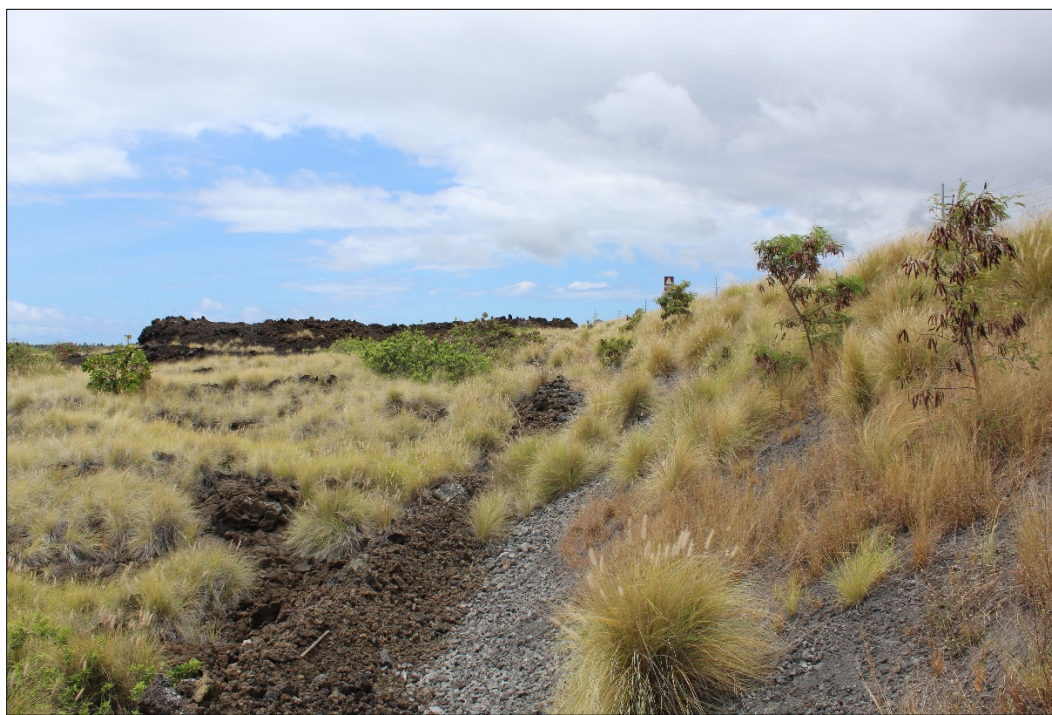
**Site 28783**, located within Kaloko Ahupua'a consists of a complex of six agricultural planting areas and has an accepted preservation buffer of 5 m on all sides except the east (highway) side where the buffer is 3.6 m (approx. 11.8 ft). Grading activities associated with the Queen Kaahumanu Highway Widening Phase 2 project encroached upon Feature B, which is located directly in front of a large culvert. Grading encroached to within 2.6 meters of the two Christmas berry trees which are presumed to denote 2 features of this site (unclear which letter corresponds to which site for Features C-F).

Same photograph of Site 28783 looking north taken on May 12, 2020.

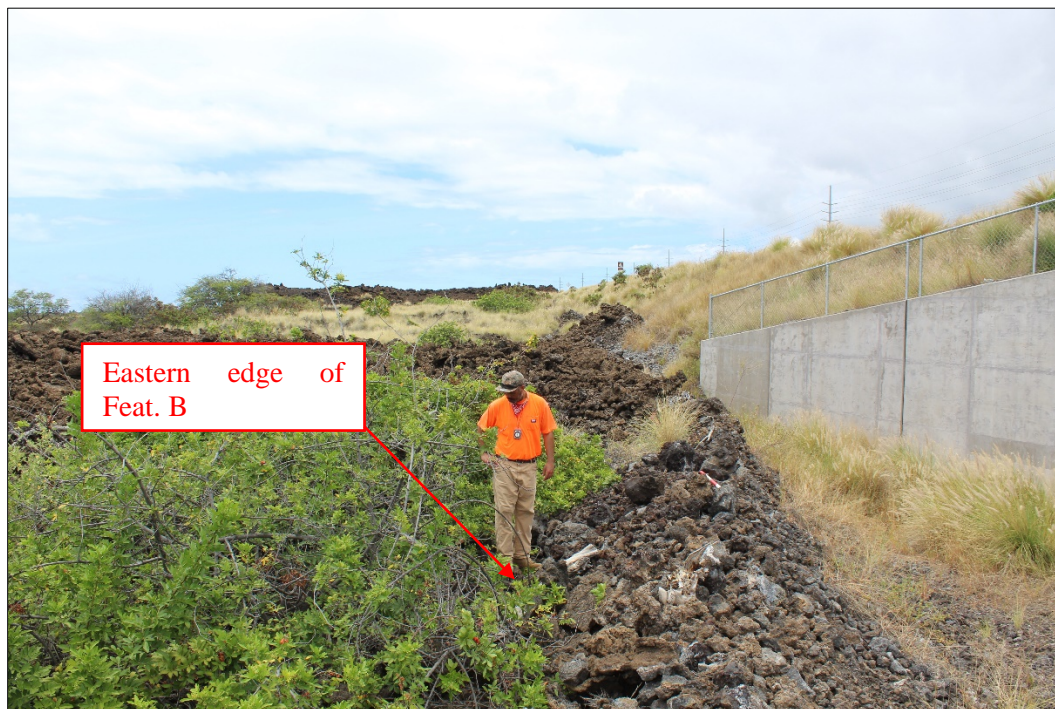
May 12, 2020 photograph of Site 28783 Feature B looking north (with meter stick along limits of grading).

Recommendation is no further action upon concurrence from SHPD. Section 5.7 of the APMP notes that SHPD has requested permanent buffer zones be demarcated with plants or some type permanent barrier if a site is threatened by on-going activities. Because of its location, Feature B of Site 28783 may be threatened by on-going activities. However, the recommendation for this site is data recovery rather than preservation. Possibly because of its location in front of the culvert.

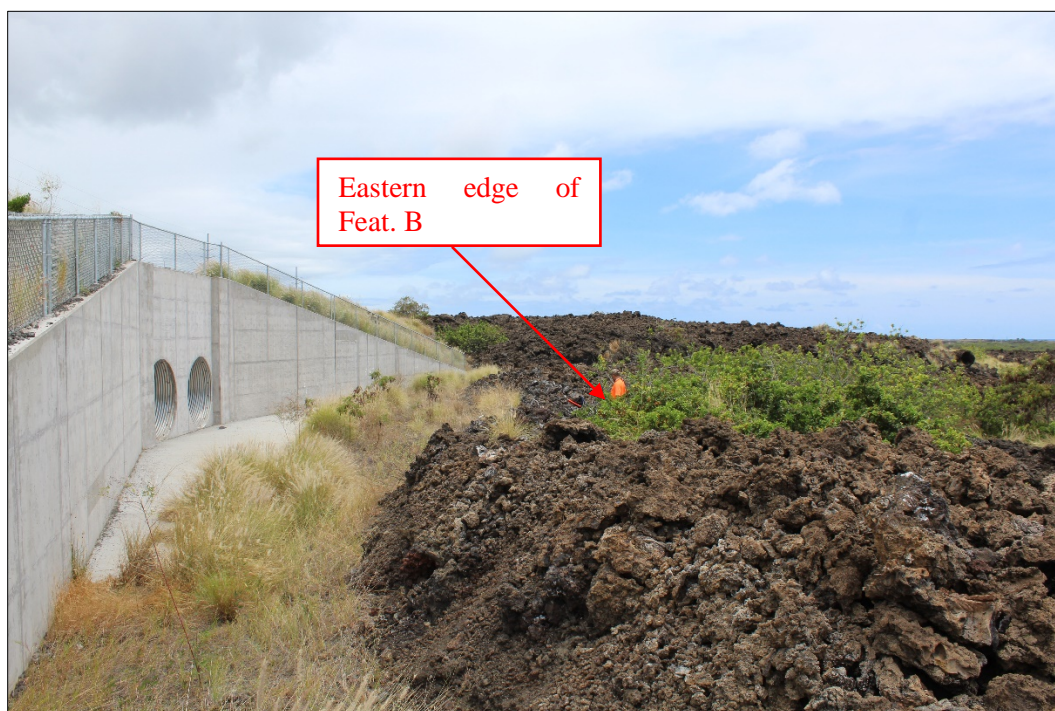
May 12, 2020 photograph of Site 28783 Feature B looking south.

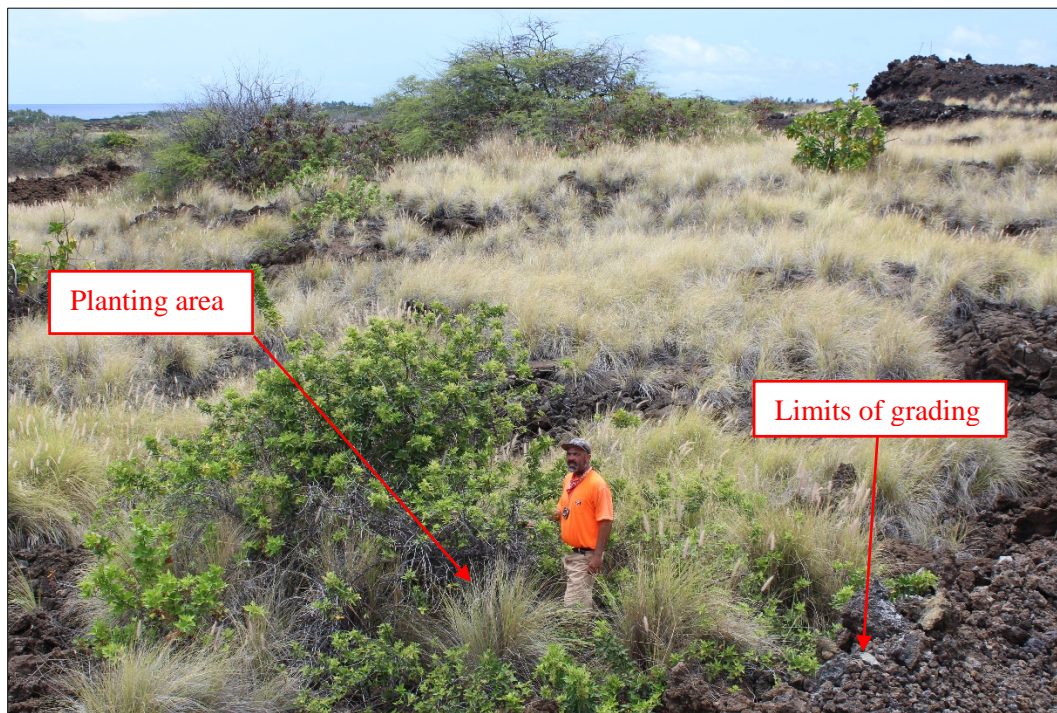
May 12, 2020 photograph of an undesignated planting area at Site 28783 looking northwest with the limits of grading indicated.

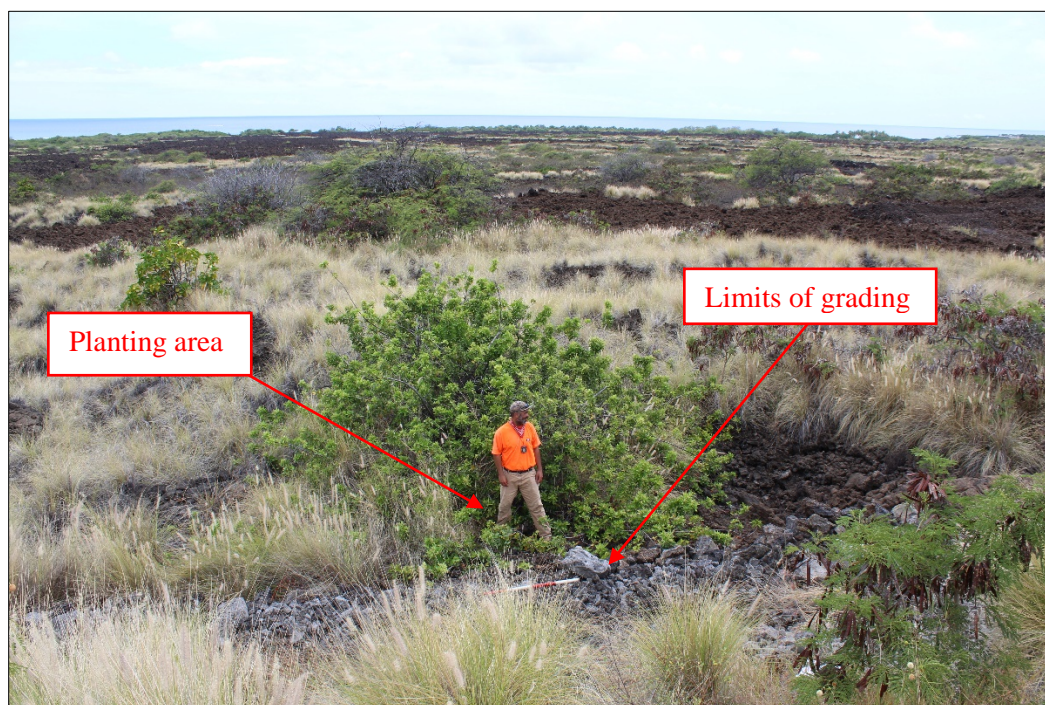
May 12, 2020 photograph of an undesignated planting area at Site 28783 looking northwest with the limits of grading indicated.

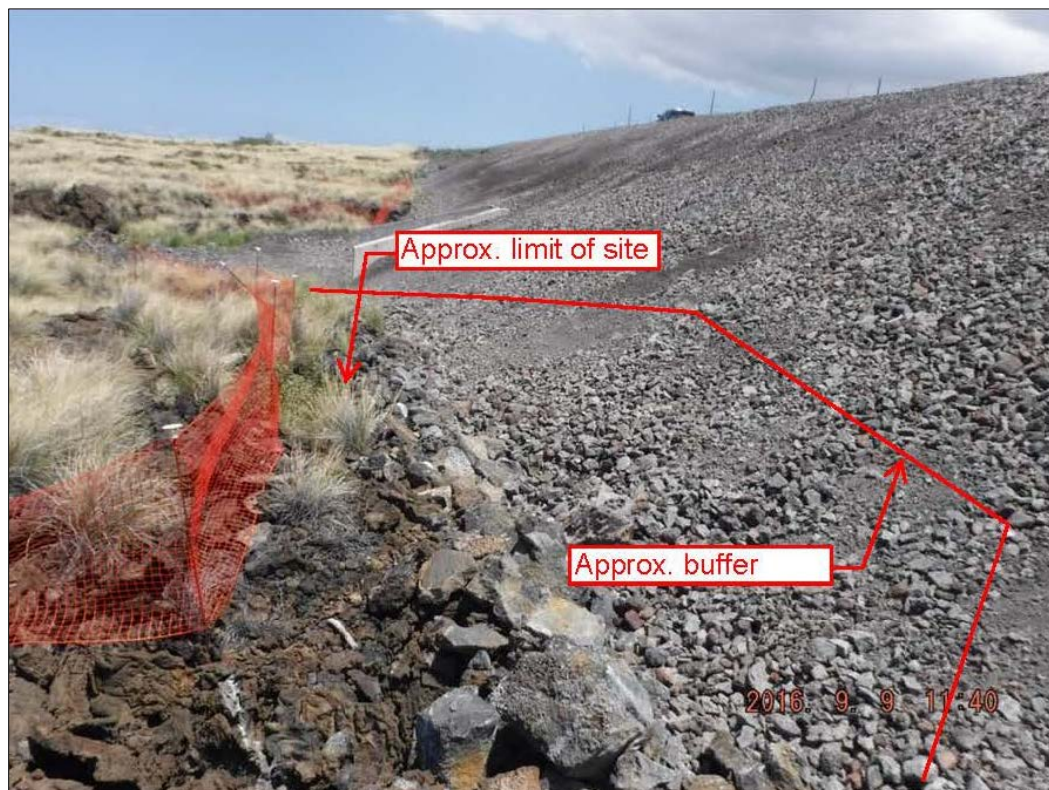
September 9, 2016 photograph of Site 28811 looking north.

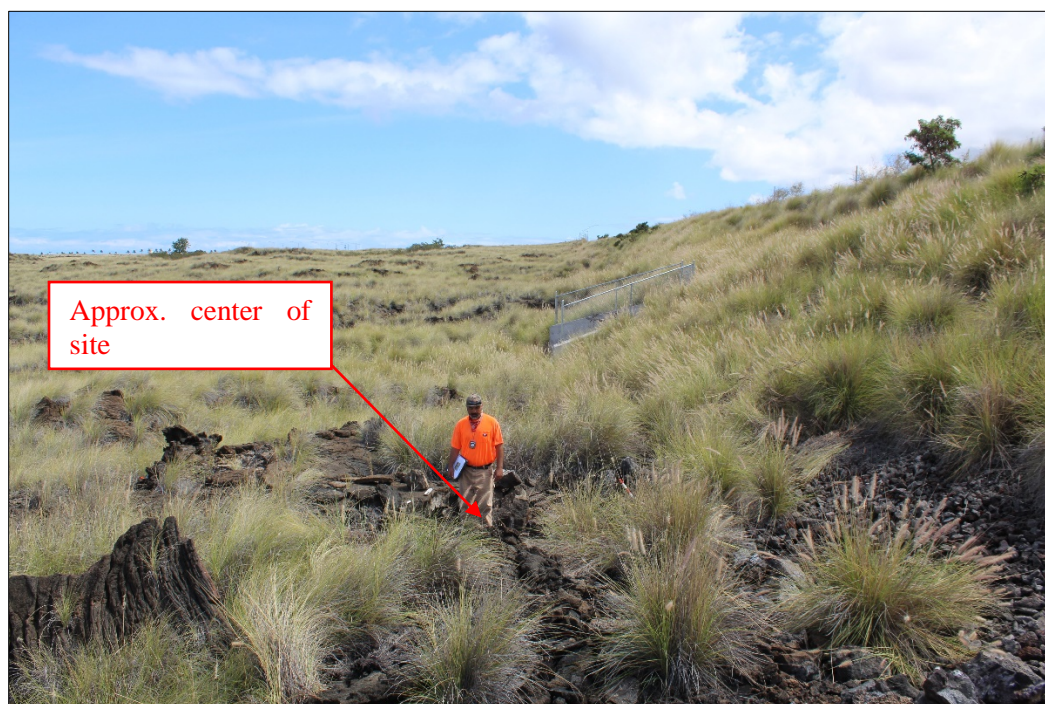
**Site 28811** is located within 'O'oma 1<sup>st</sup> Ahupua'a and consists of a pahoehoe excavation interpreted as a quarry site. It has a preservation buffer of 5 m on all sides except the highway sides (east), where the buffer is 2.2 m. Grading activities associated with the Queen Kaahumanu Highway Widening Phase 2 project encroached to within 1.2 m of the eastern edge of the site. The site itself was not damaged

May 12, 2020 photograph of Site 28811 looking north.

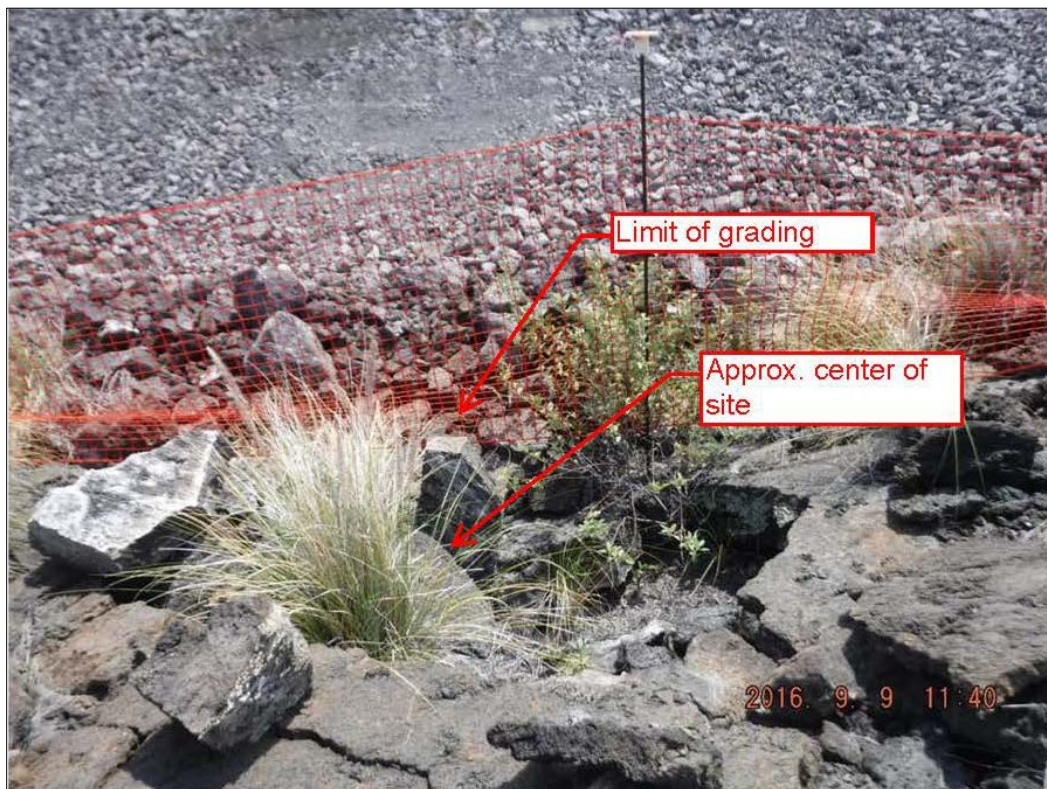
September 9, 2016 photograph of Site 28811 looking east.

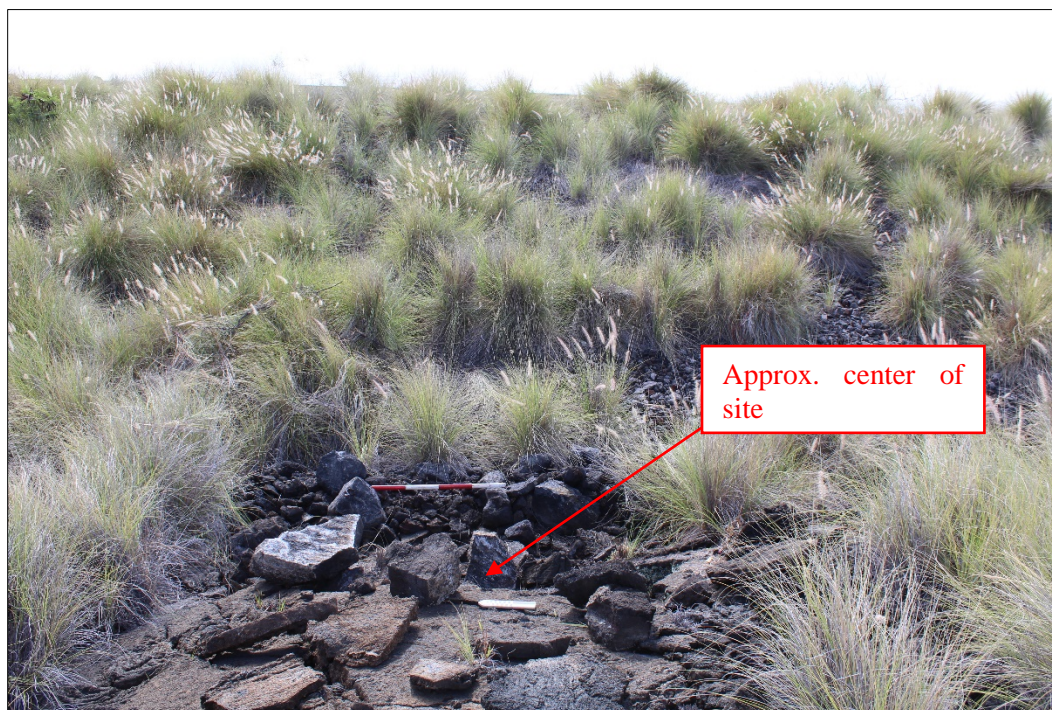
May 12, 2020 photograph of Site 28811 looking east (with meter stick along limits of grading).

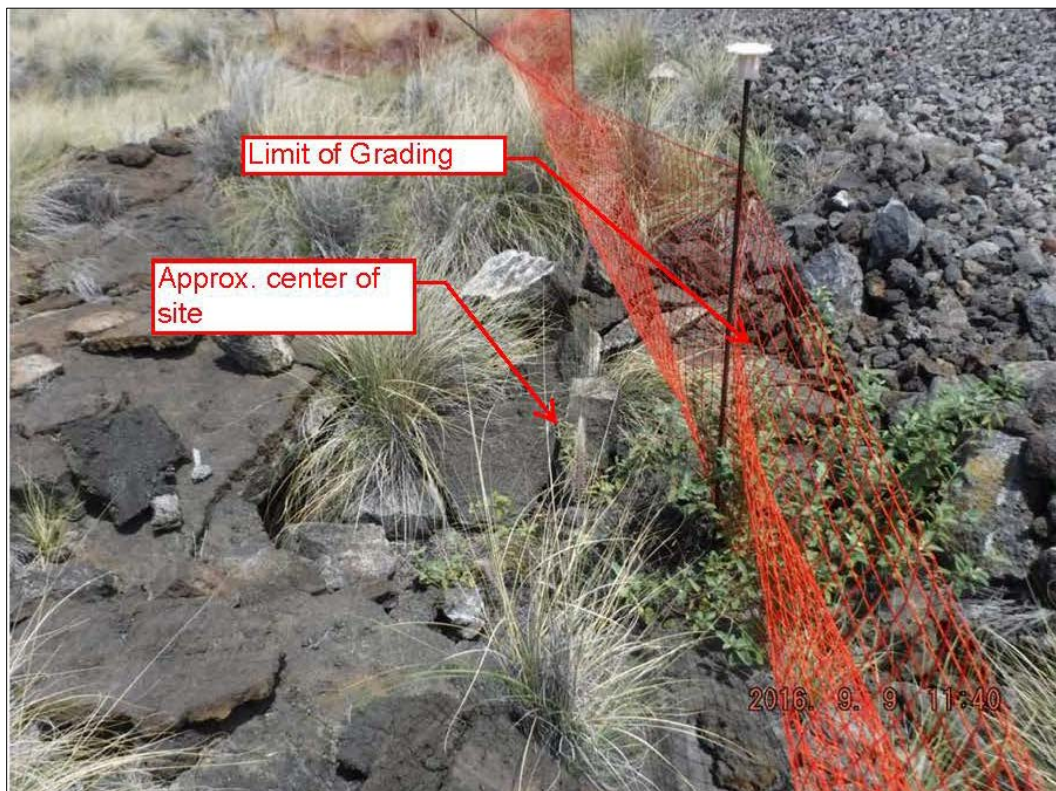
September 9, 2016 photograph of Site 28811 looking north.

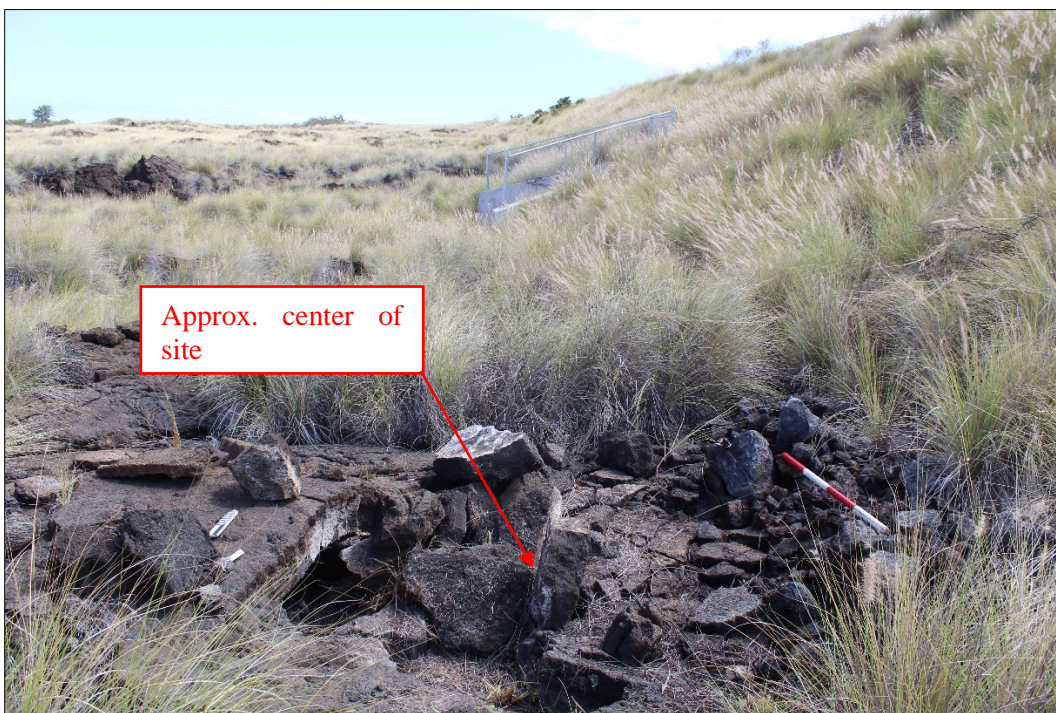
May 12, 2020 photograph of Site 28811 looking north (with meter stick along limits of grading).
