# **SECTION C**

CULVERTS

## HAER CULVERTS OVERVIEW

## Hana Highway, Route 360

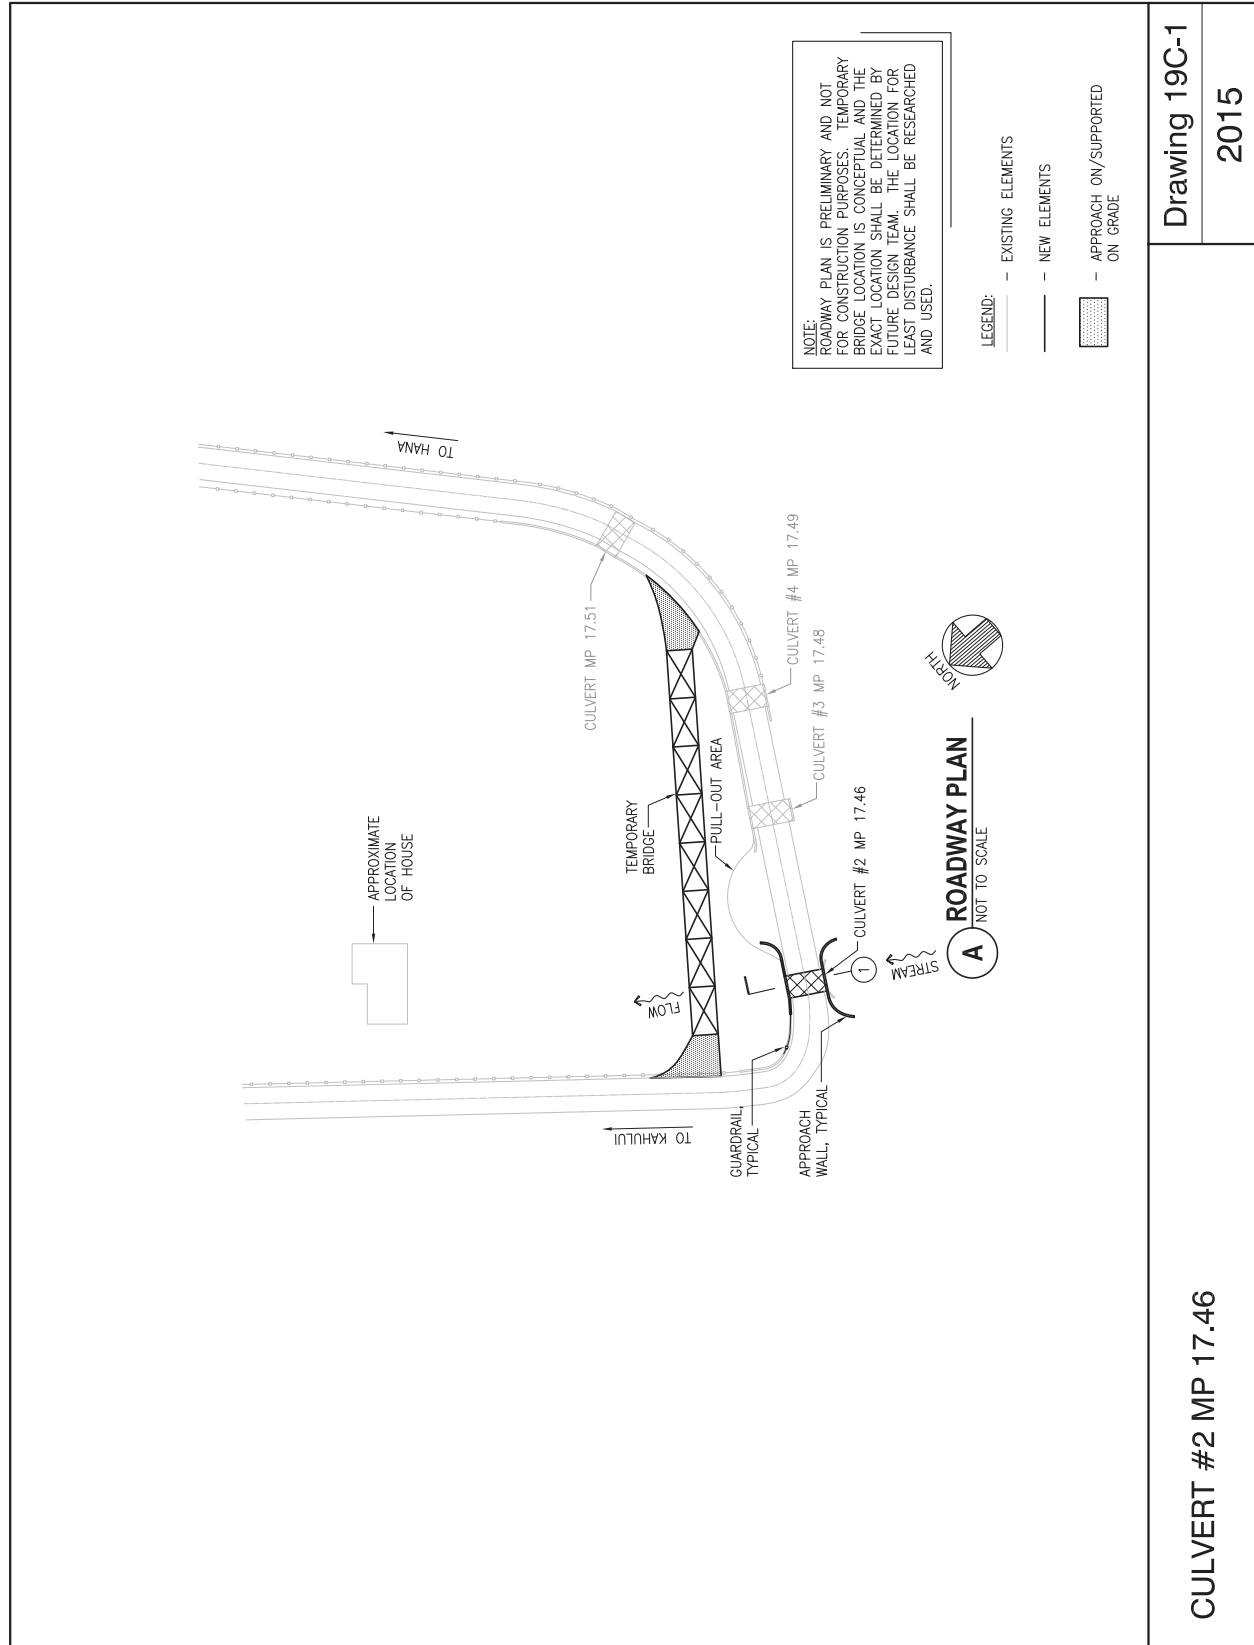
CULVERT #2 MP 17.46

Culvert #2 receives storm water runoff from a 51-acre drainage area (approximate) and consists of mostly forest type terrain. The downstream end of the culvert consists of an unnamed shallow stream that travels towards the ocean and has a constant flow caused by a continuous flowing natural spring. The absolute outlet of the stream is unidentifiable from the highway travel way.

It is recommended that the existing culvert structure of Culvert #2 be rehabilitated. Any rehabilitation work to this culvert will need to consider the historical and cultural areas in its surroundings during design and construction. Recommendations are based on site visits conducted during the months of May, June, and July of 2014. Refer to Section A, Chapter 5. *Application of Design Standards & Guidelines* for more information.

A localized topographic study is recommended in order to give further analysis of the drainage patterns and runoff capacity of the culvert in question. Near the base of Culvert #2, Ohia Stream provides irrigation for agricultural fields located downstream of Hana Highway, Route 360. If Culvert #2 is to be rehabilitated, care shall be taken to ensure that construction activities do not interfere or contaminate the stream.

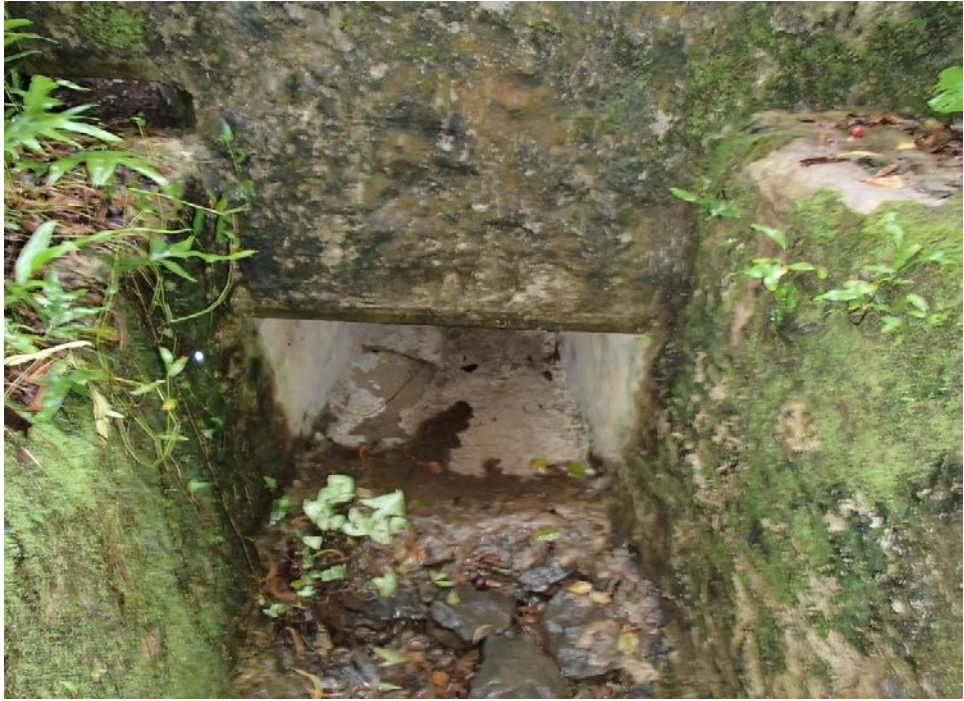
Close-up view of upstream culvert opening.

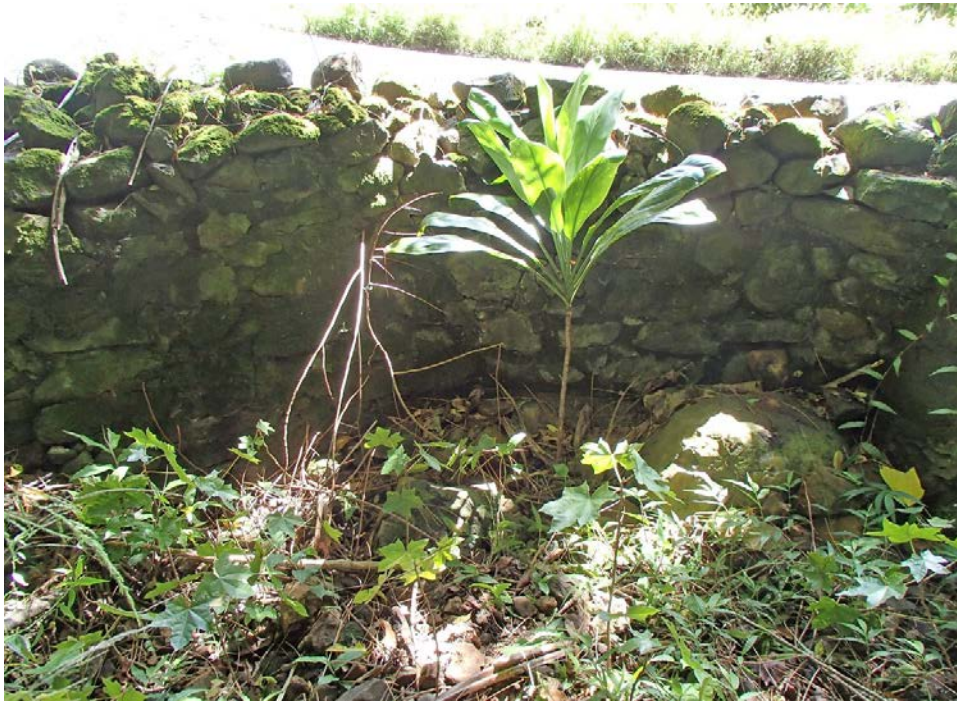
Upstream elevation of CRM parapet. Note: Nothing could be seen per description on as-builts.

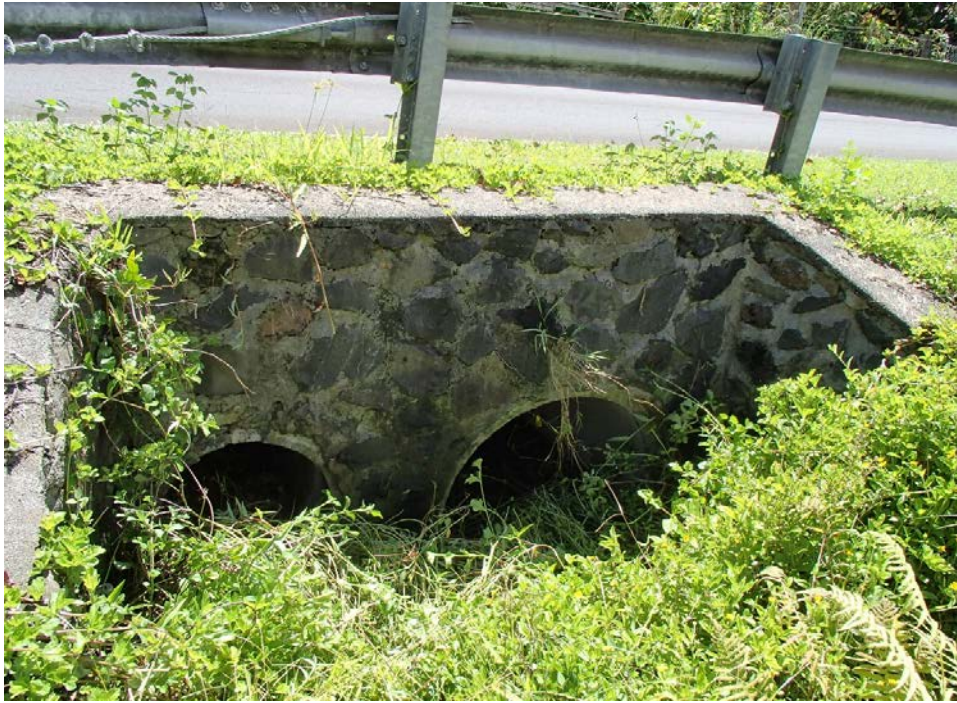
1 - 24" diameter and 1- 36" diameter RCP inlets in upstream CRM headwall.

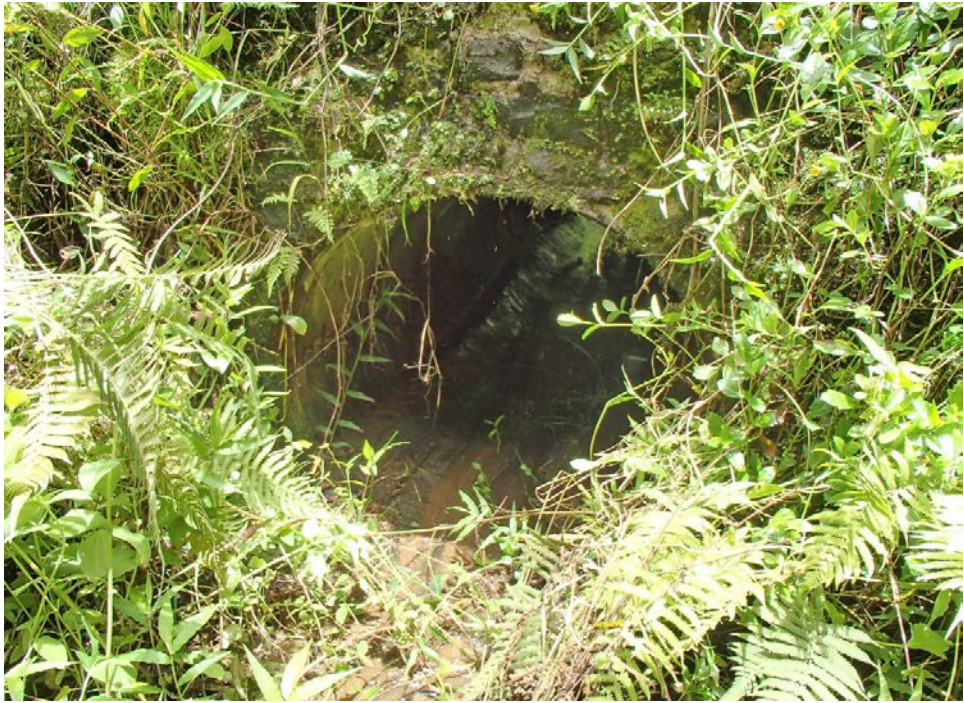
48" diameter CMP inlet at upstream side.

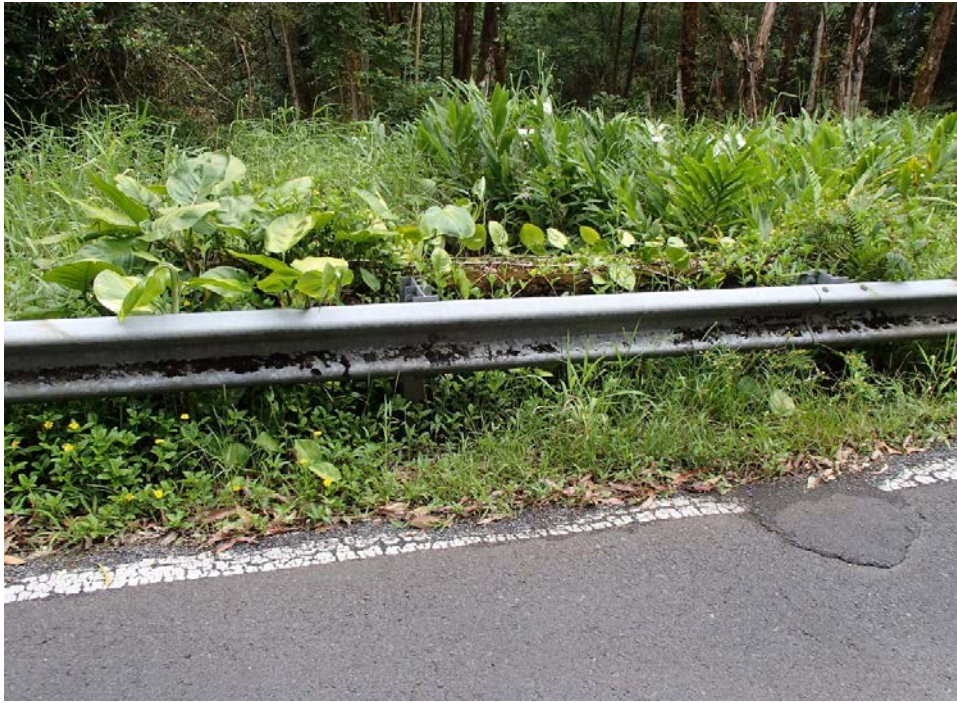
View of downstream CRM parapet with continuous metal guardrail in-front.
