Preliminary Baseline Assessment of Reef Coral Community Structure in the Vicinity of the Wharf in Hāna Bay

**PRELIMINARY BASELINE ASSESSMENT OF REEF CORAL COMMUNITY STRUCTURE
IN THE VICINITY OF THE WHARF IN HANA BAY
HANA, ISLAND OF MAUI**

June 15, 2010

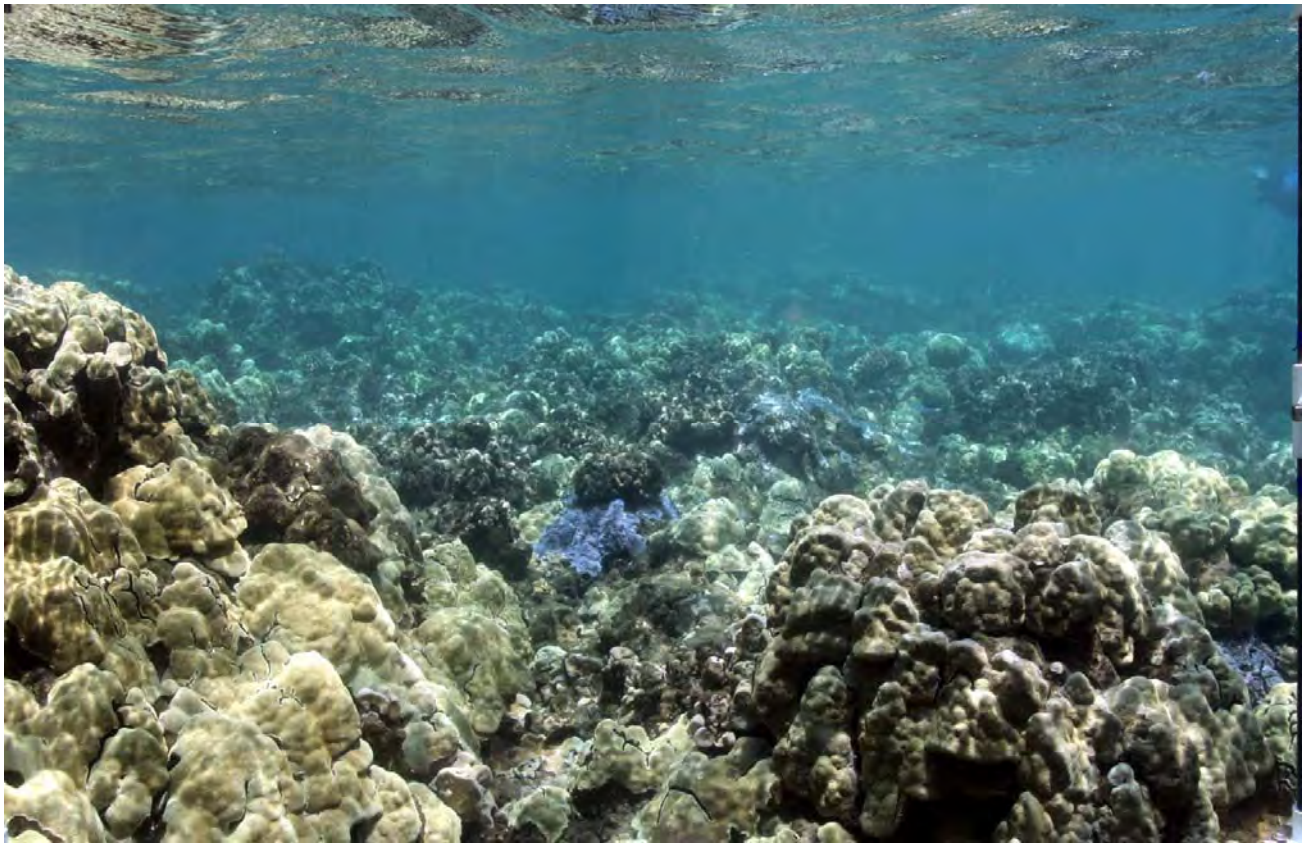
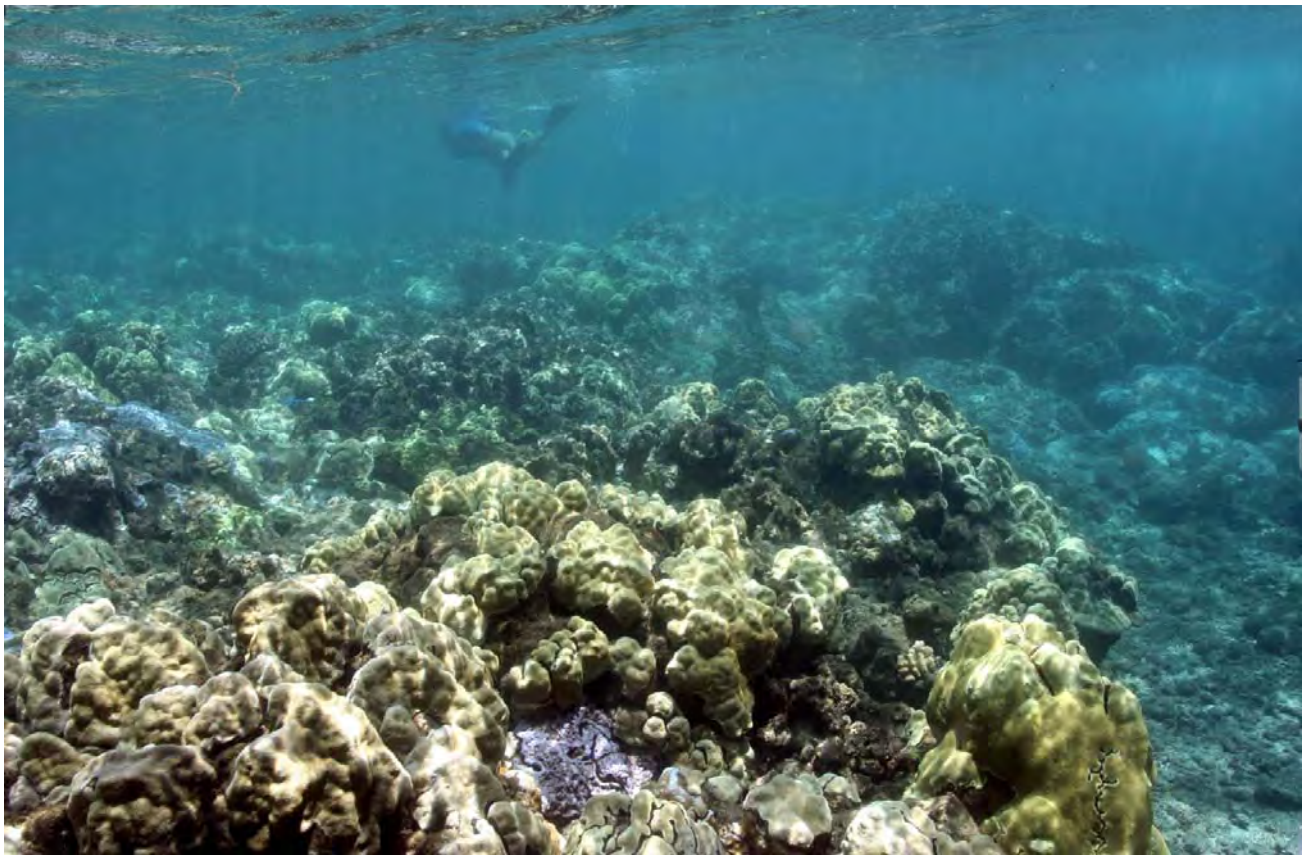
At the northeastern most end of the study area (Region A in Figure 5), community structure consists of a shallow calcium carbonate reef platform dominated by high coral cover, mainly consisting of large mound-shaped colonies of *Porites lobata* and encrustations of *Montipora capitata* and *M. flabellata* (Figures 6-8). Coral abundance in this area is high, with little signs of “stress” likely as a result of shelter from waves approaching from the northeast provided by the headland peninsula that defines the southern boundary of the bay (Figures 1-3). Percent cover of live coral in this area as determined by calibration/validation assessments ranged from about 35-50% (Table 3).

FIGURE 6. Two views of reef flat northeast of wharf in Hana Bay, Maui (Region A in Figure 5). Water depth is approximately 2-3 feet.

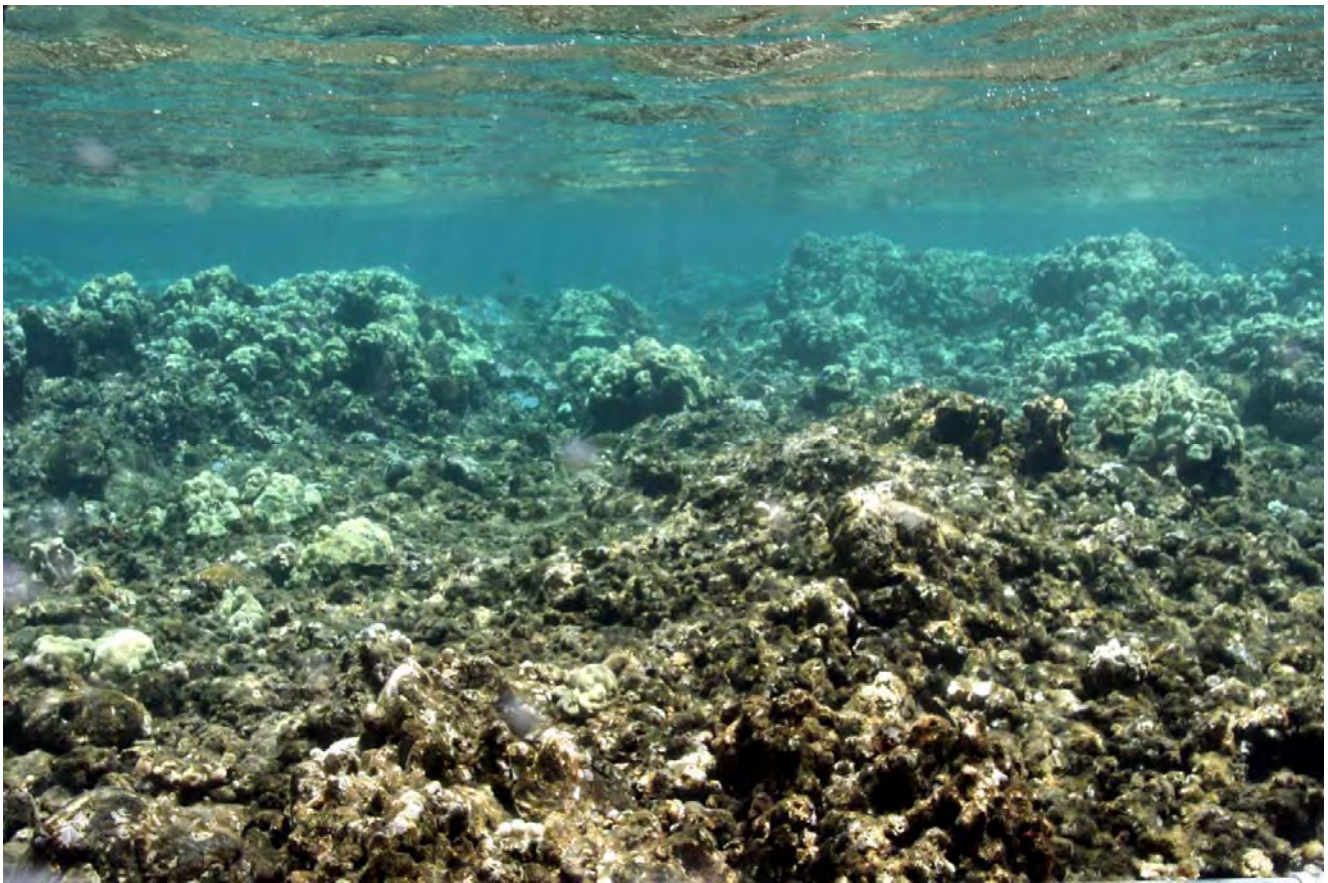
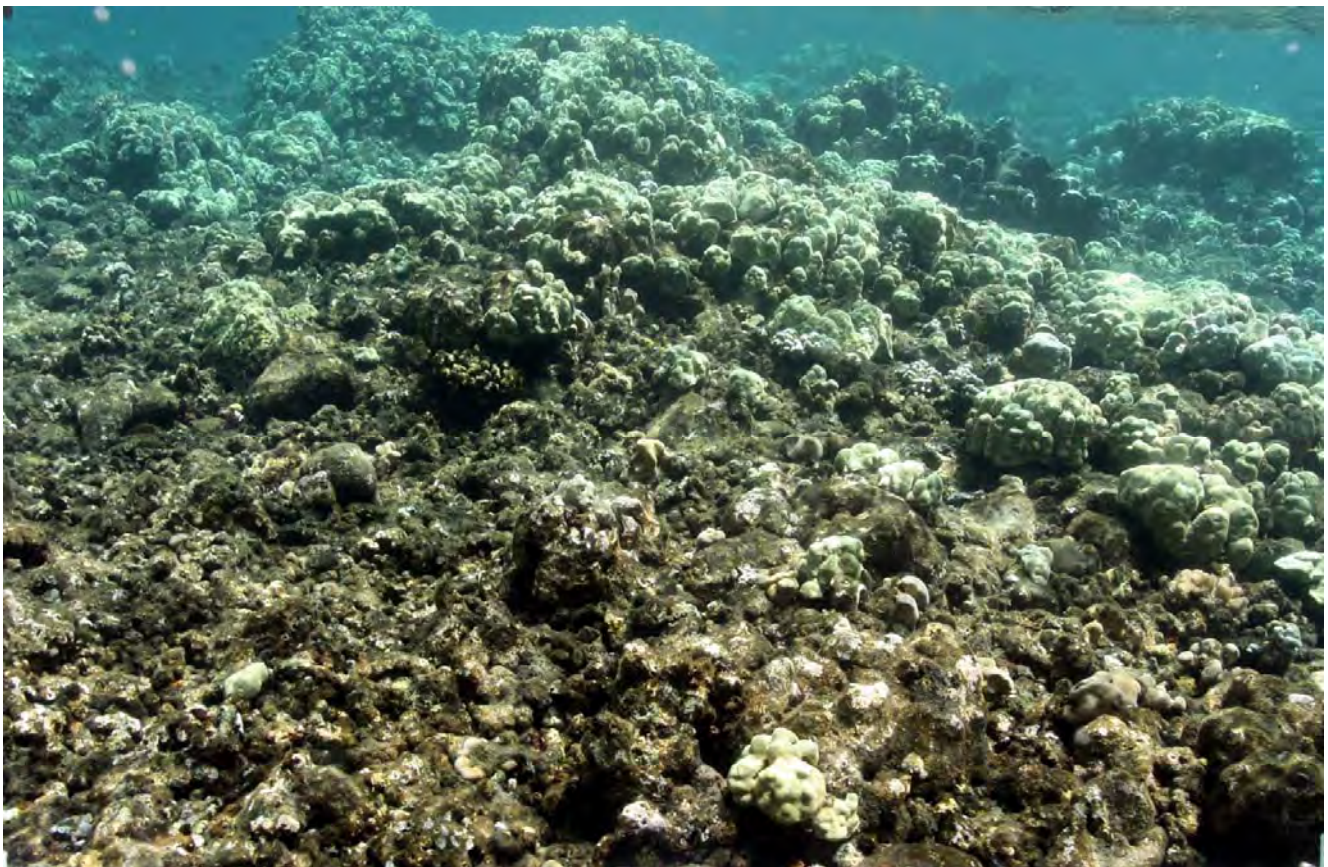
FIGURE 7. Shallow reef flat northeast of wharf in Hana Bay, Maui (Region A in Figure 5). Water depth is approximately 2-3 feet.

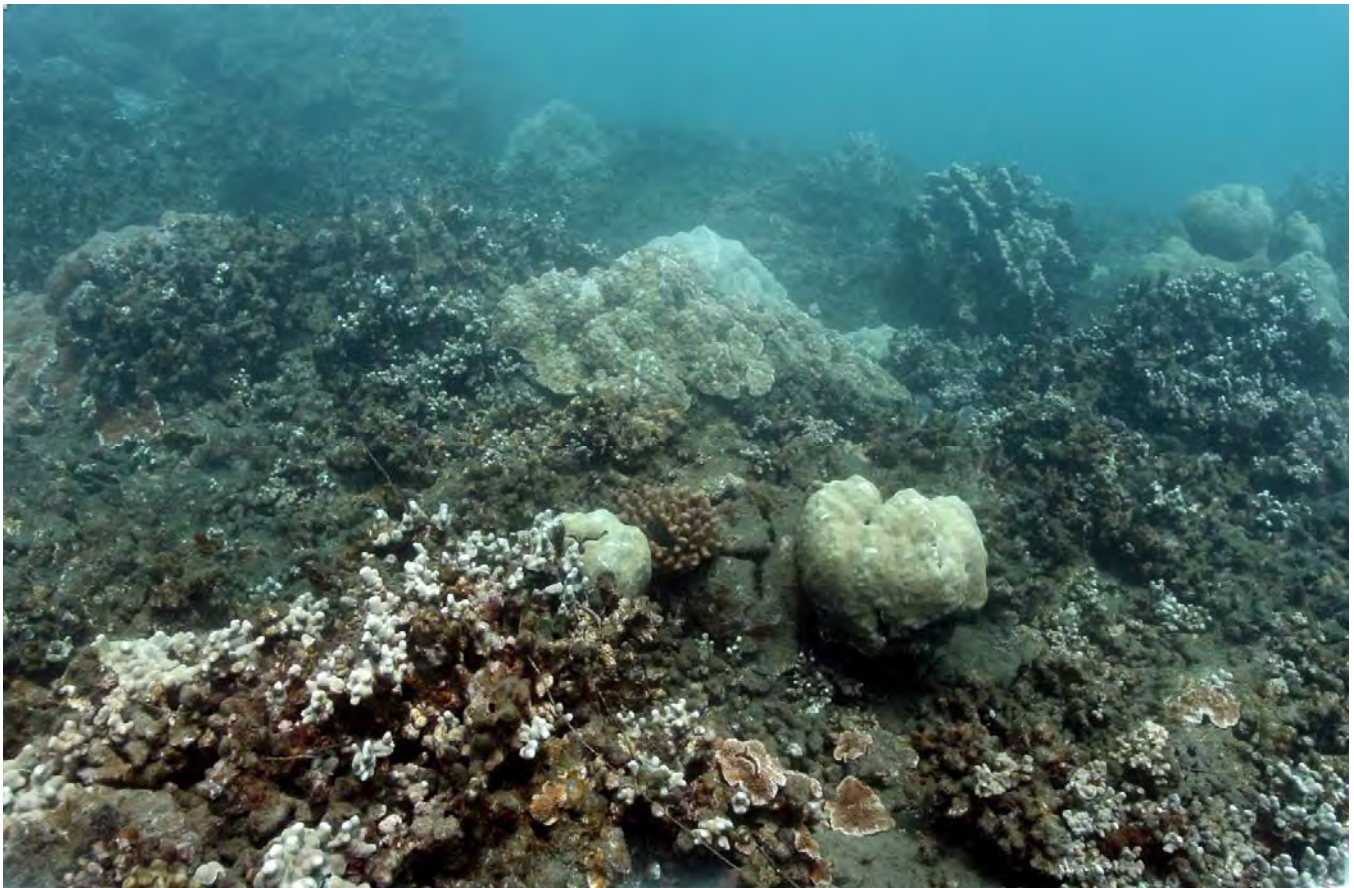
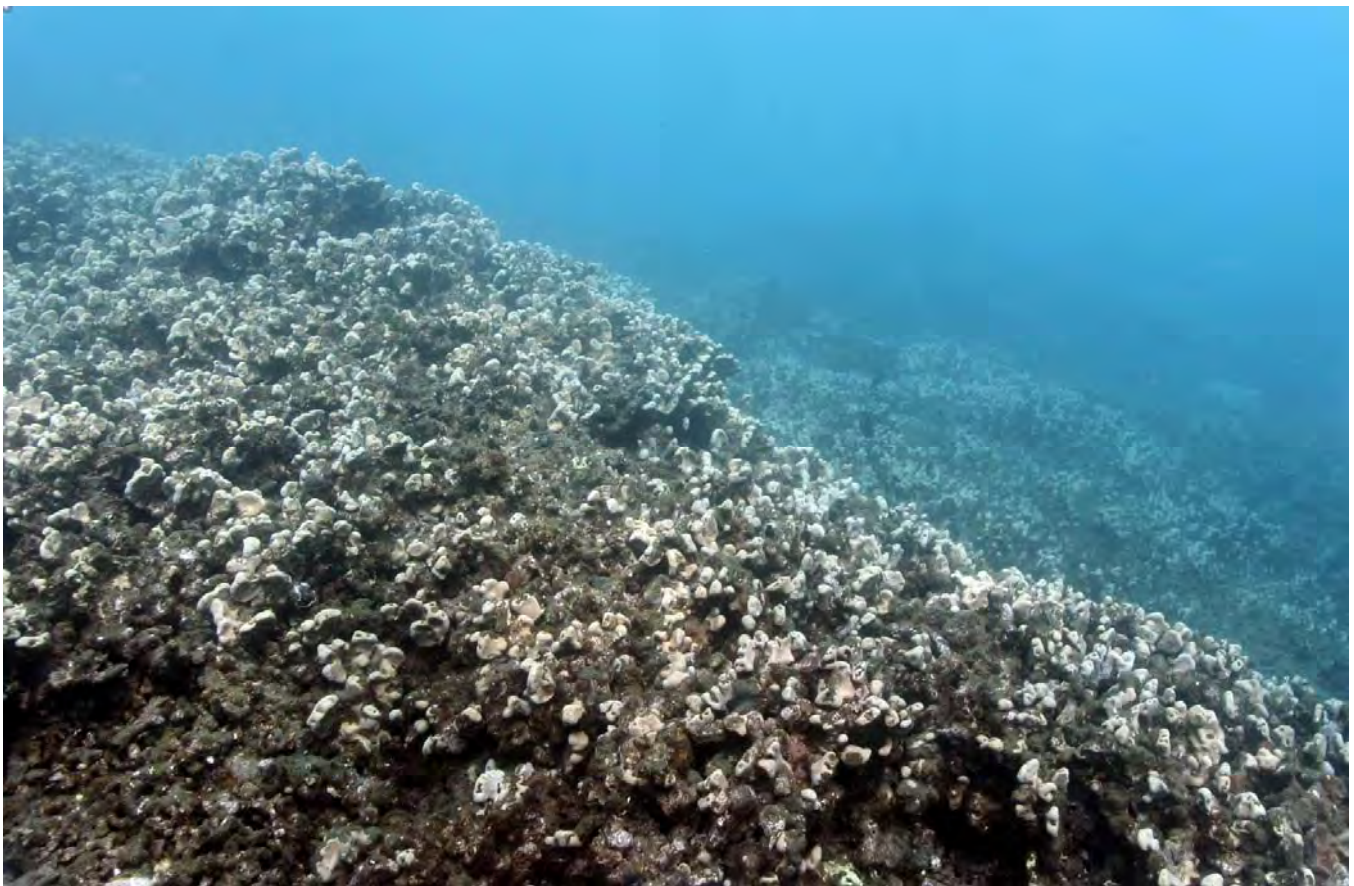
Moving toward the wharf on the outer edge of the reef platform, bottom angle slopes sharply to the sand channel floor (Region B in Figure 5). The reef slope is colonized by a variety of coral species, particularly “mats” of the short branched coral *Pavona duerdeni* (Figure 9). In addition, dominant coral species on the outer reef edge and slope are large dome-shaped colonies of *Porites lobata*, hemispherical branching colonies of *Pocillopora meandrina*, and extensive encrustations of *Montipora flabellata* (Figures 9 and 10). Percentage coral cover in this zone ranged from approximately 20-60% (Table 3).

FIGURE 9. Two views of outer reef slope northeast of wharf in Hana Bay (Region B in Figure 5). Large green mound-shaped coral colonies in upper photo are *Porites lobata*; short-branched mats of coral in lower photo are *Pavona duerdeni*. Water depth is approximately 25 ft.

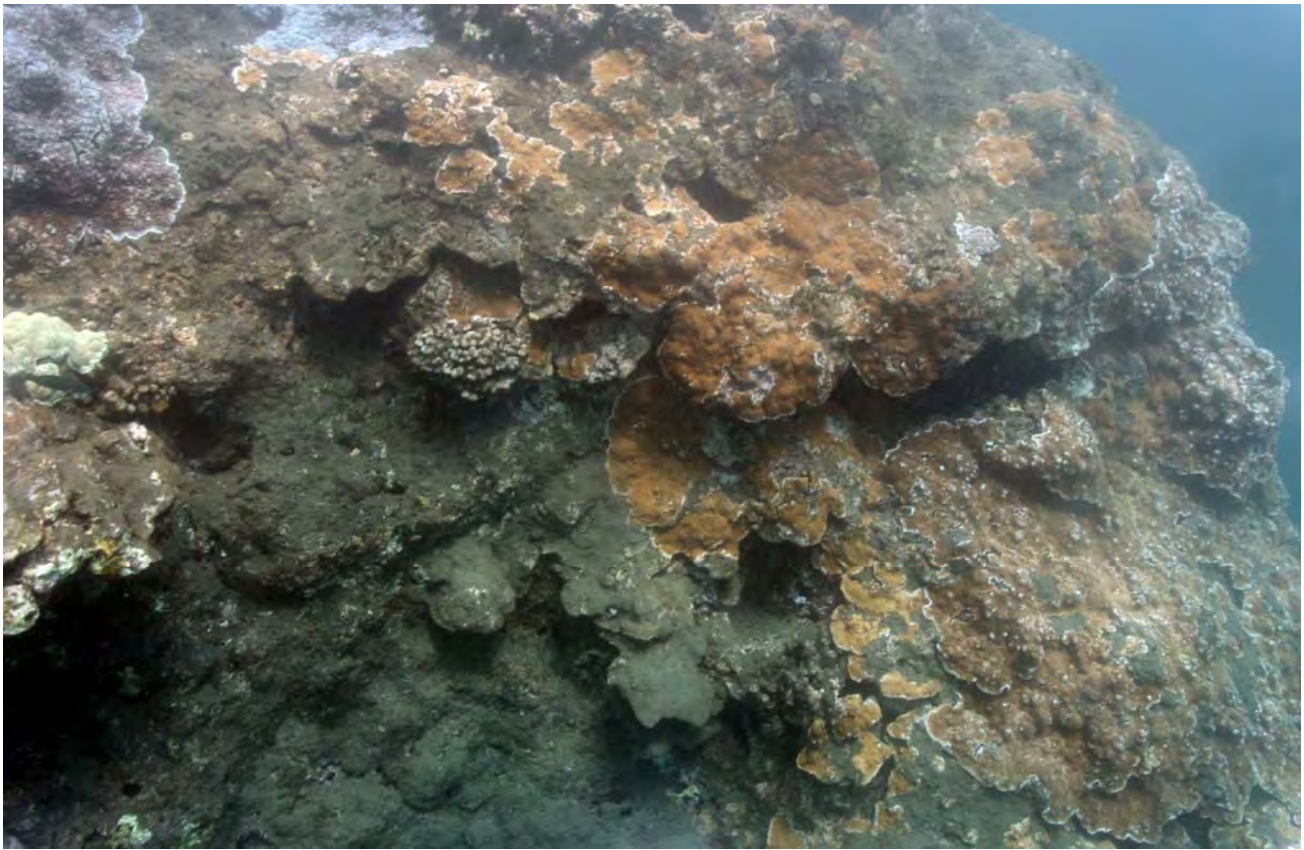
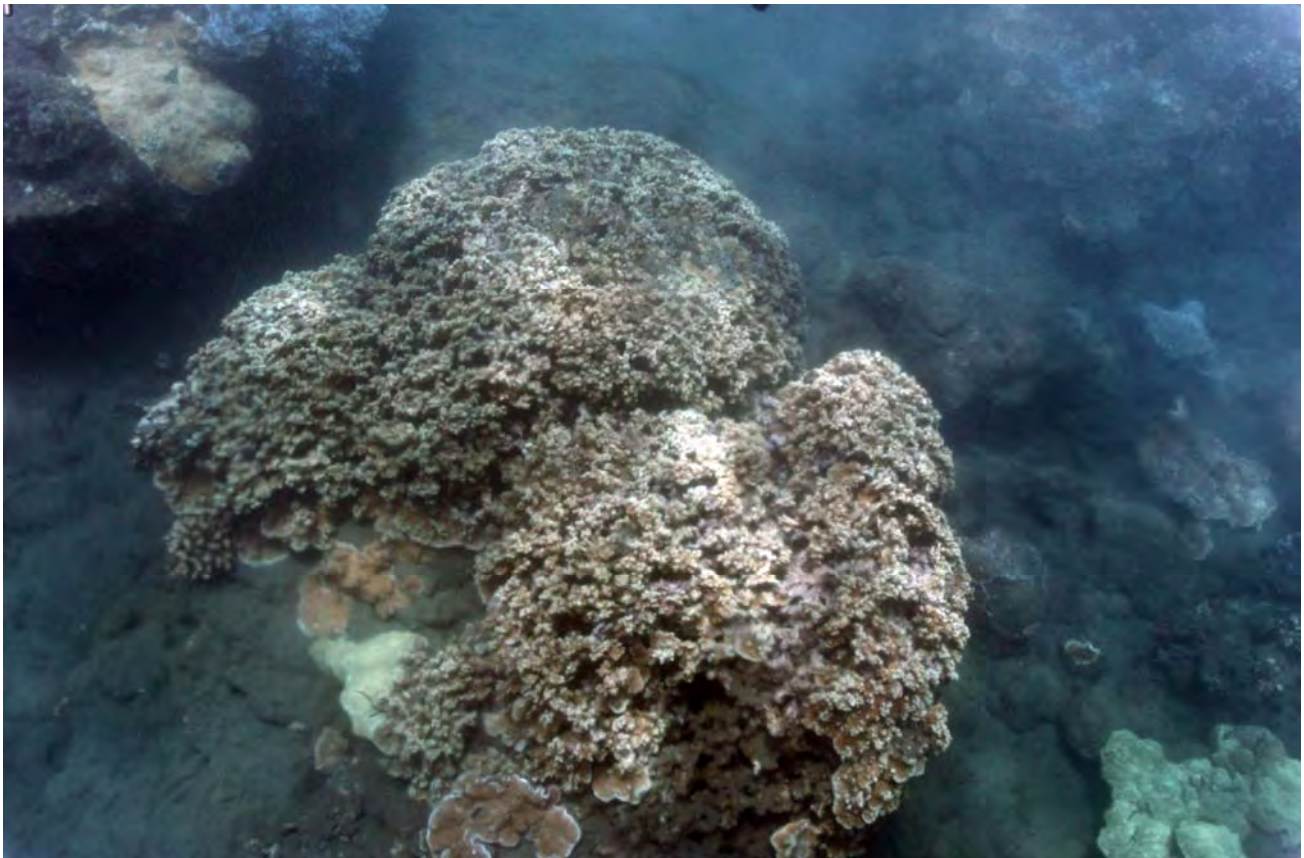
FIGURE 11. Two views of coral mounds located between Hana Wharf and shoreline (Region C in Figure 5). Dominant brown coral in both photos is *Montipora capitata*, occurring in two different growth forms.

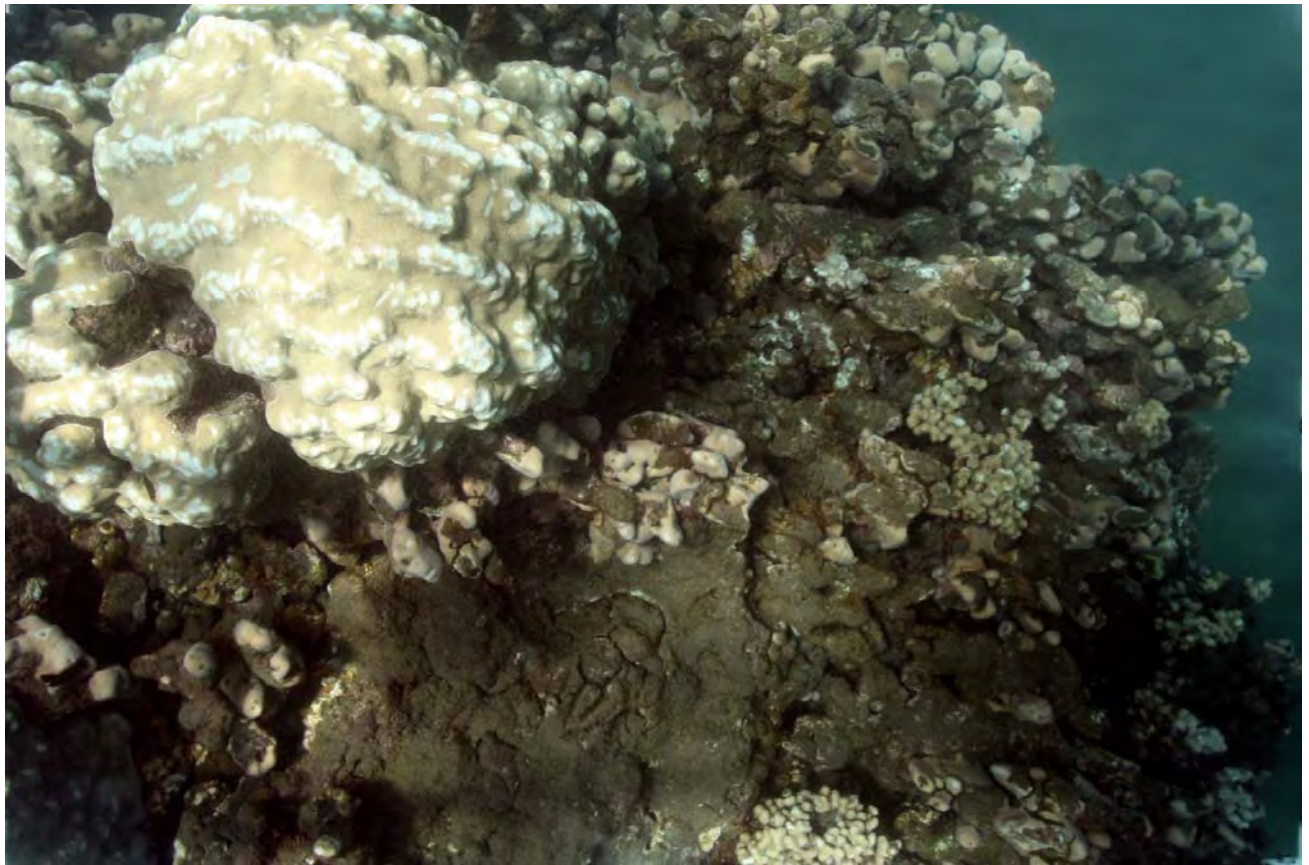
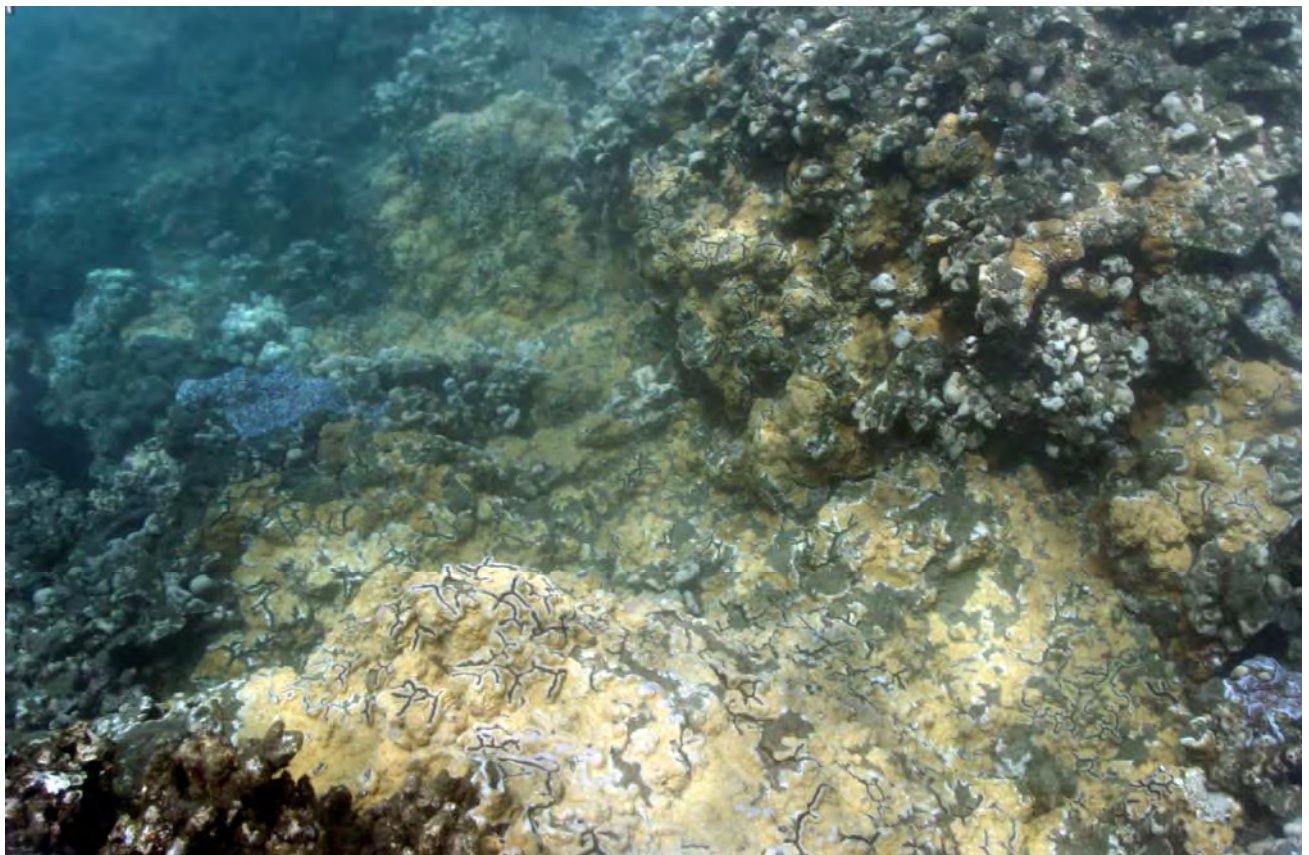
To the southwest of the wharf, a crescent-shaped shallow reef occurs between the beach and the outer sand channel (Region F in Figure 5). At low tide the upper surface of the reef is barely below the surface. While portions of the shallow reef are colonized by abundant coral, there are also areas of the reef that appear to be affected by sediment deposition (Figure 13).

FIGURE 13. Two views of shallow reef between southwest end of Hana Wharf and shoreline (Region F in Figure 5). This region consists of a crescent-shaped reef surrounded by sand flats.

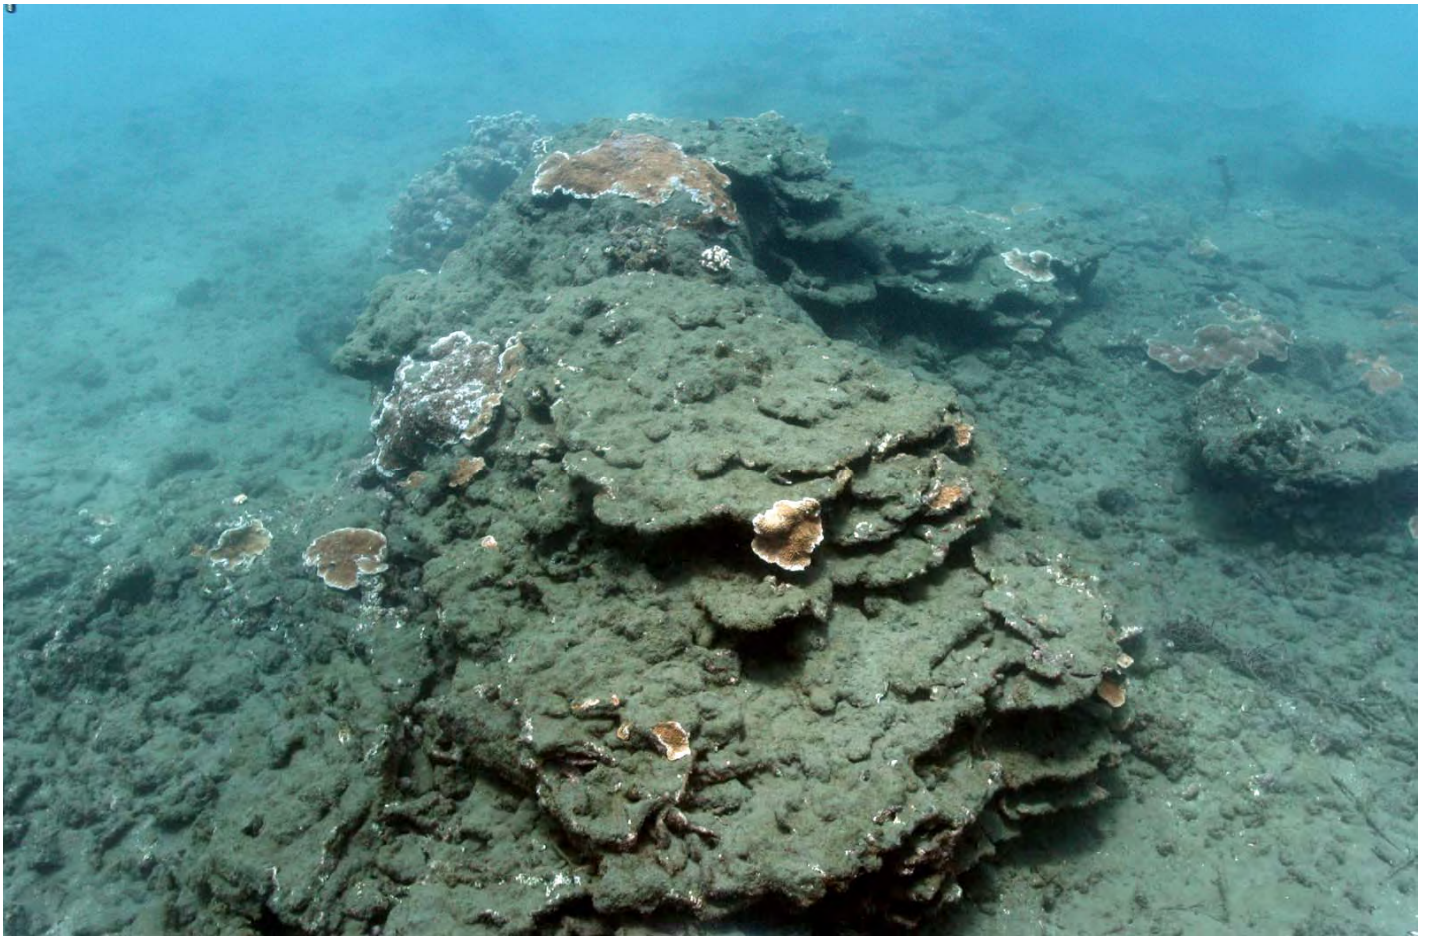
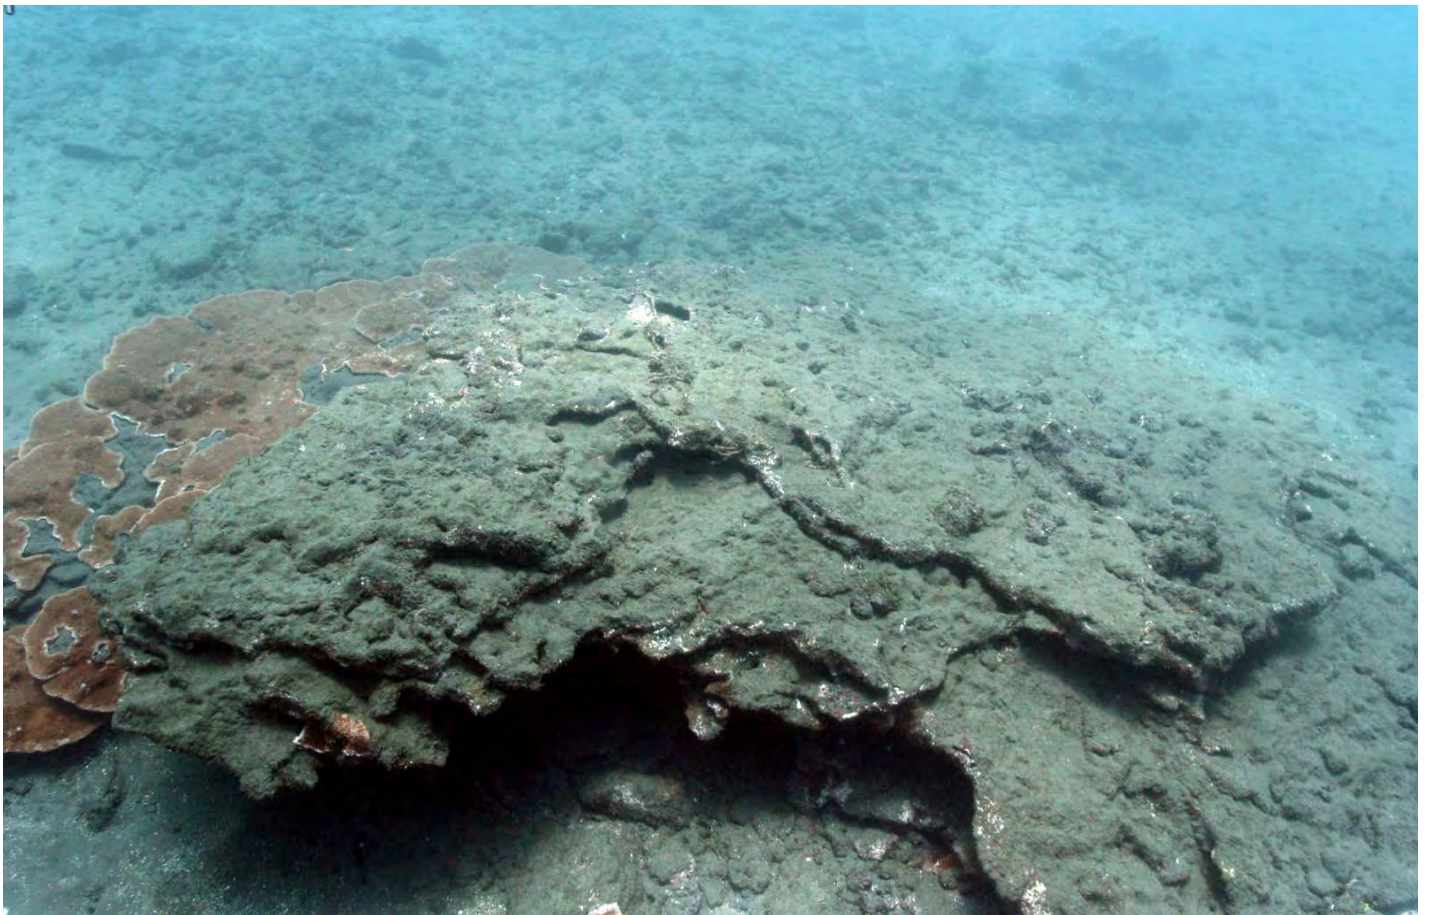
FIGURE 17. Two views of dead and sediment covered plates of *Montipora capitata* adjacent to northwest side of wharf in Hana Bay, Maui (Region G in Figure 5). Water depth is approximately 25 feet.

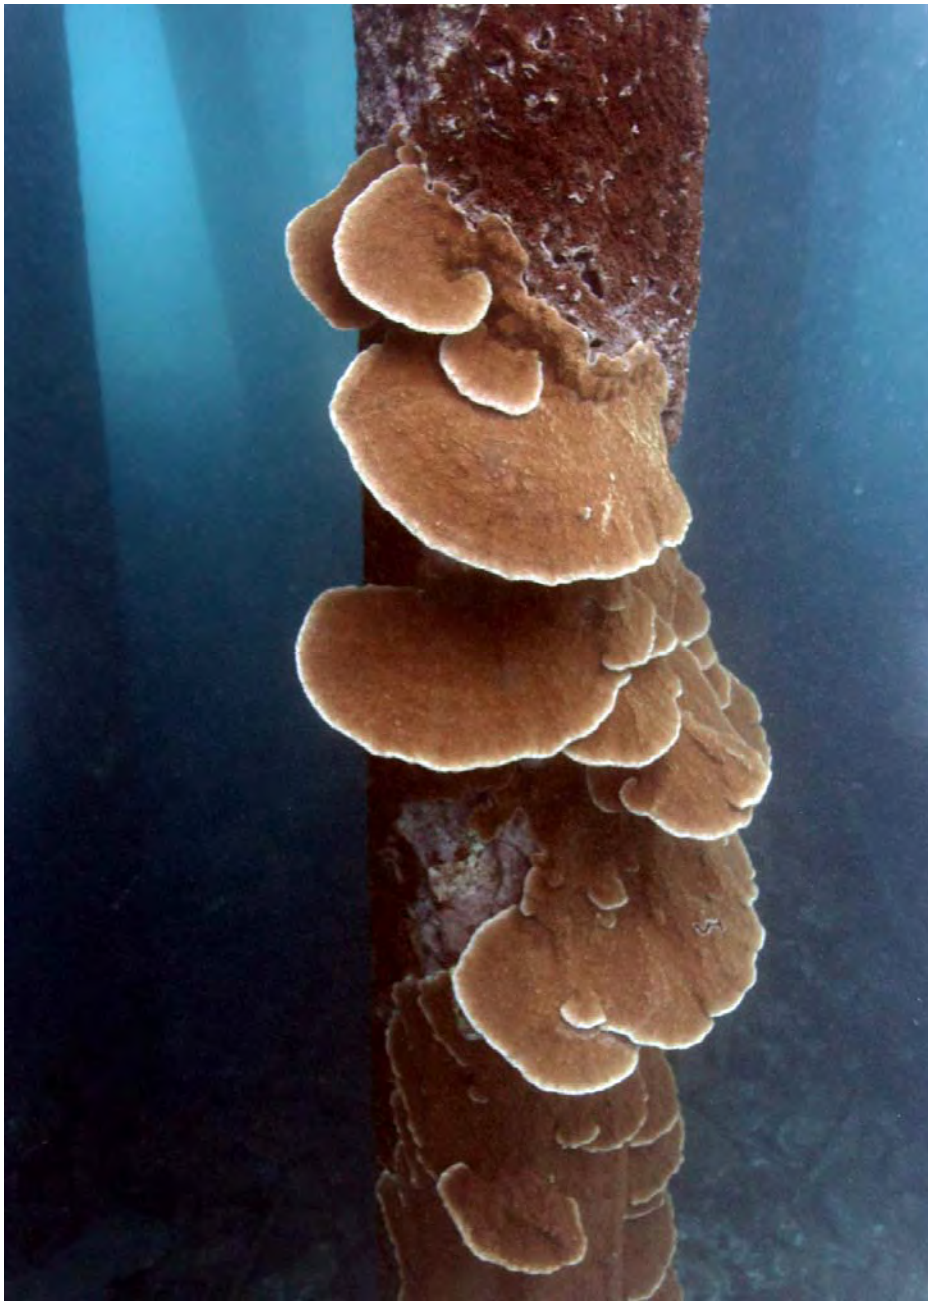
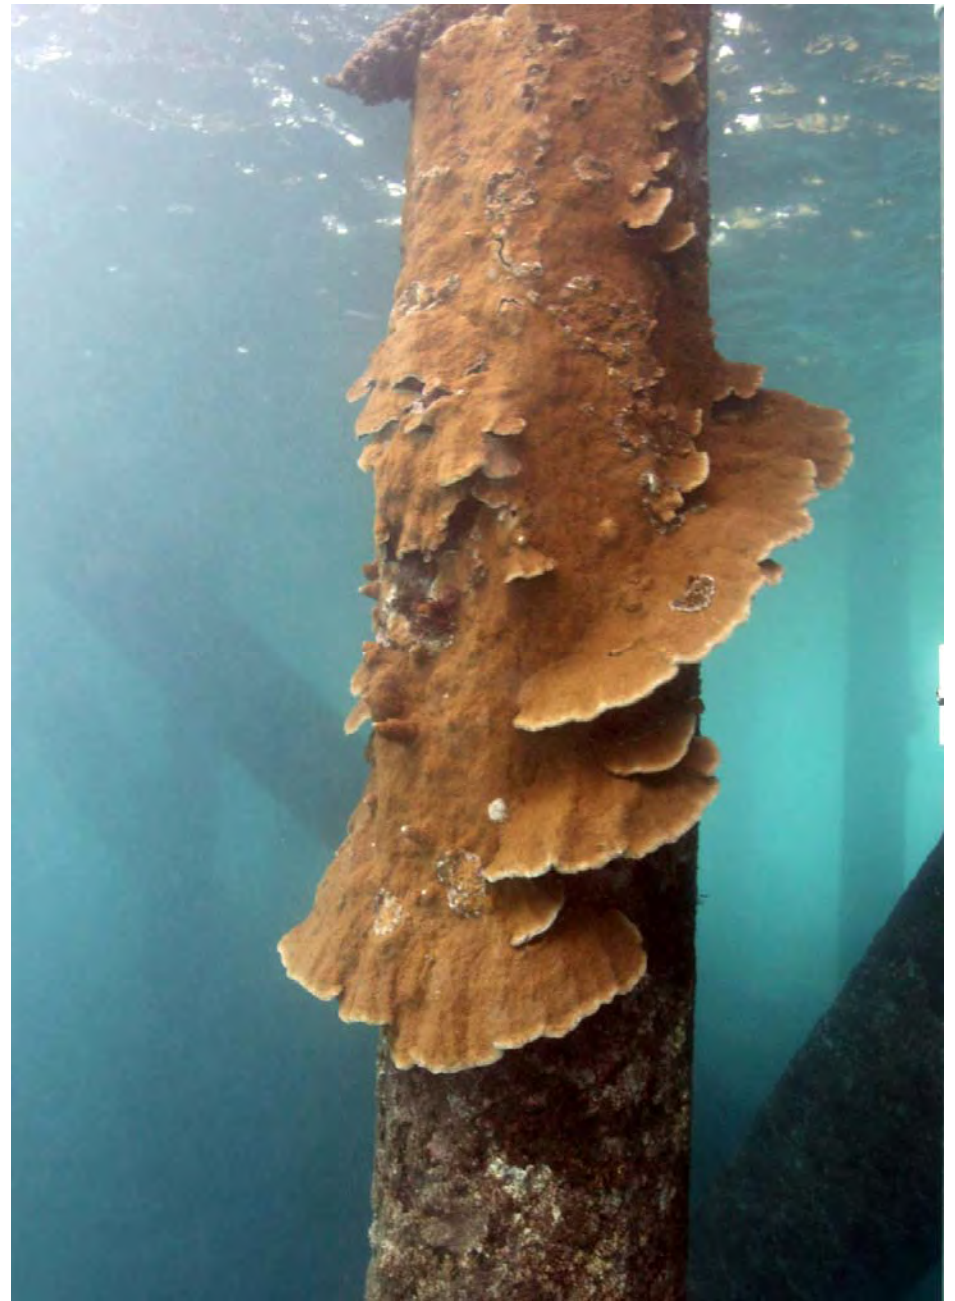
Many of the concrete piles on the outer northern side of the wharf are colonized by overlapping plates and flat encrustations of *Montipora capitata* that extend from near the surface to a depth of approximately 20 feet. Figures 18-21 show a variety of growth forms of this coral species on numerous pilings on the outer edge of the north side of the wharf. Pilings in the interior of the wharf are essentially barren of coral colonization owing to complete shading (Figure 22).

FIGURE 18. Two pilings on northwest side of wharf in Hana Bay, Maui showing overlapping plating coral *Montipora capitata*.

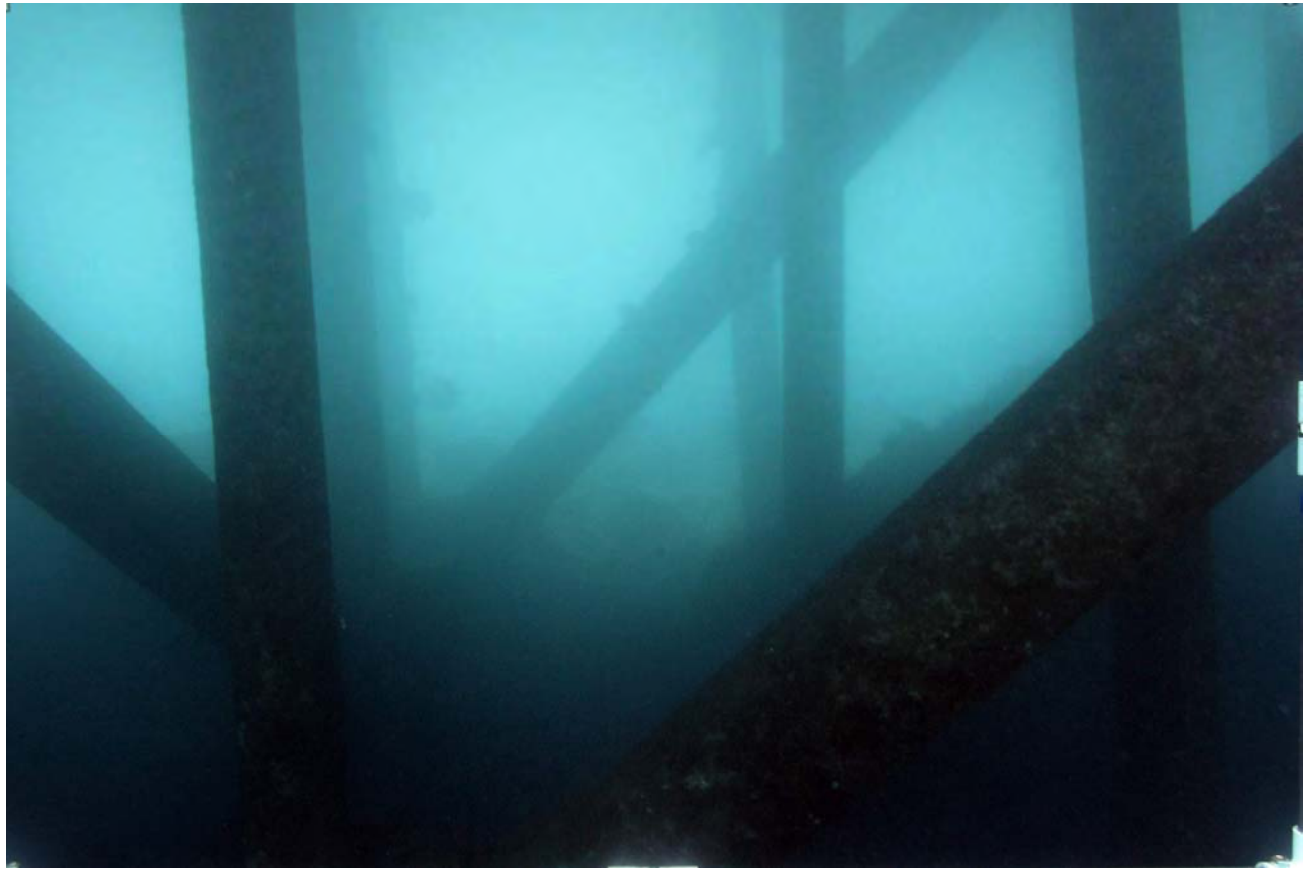
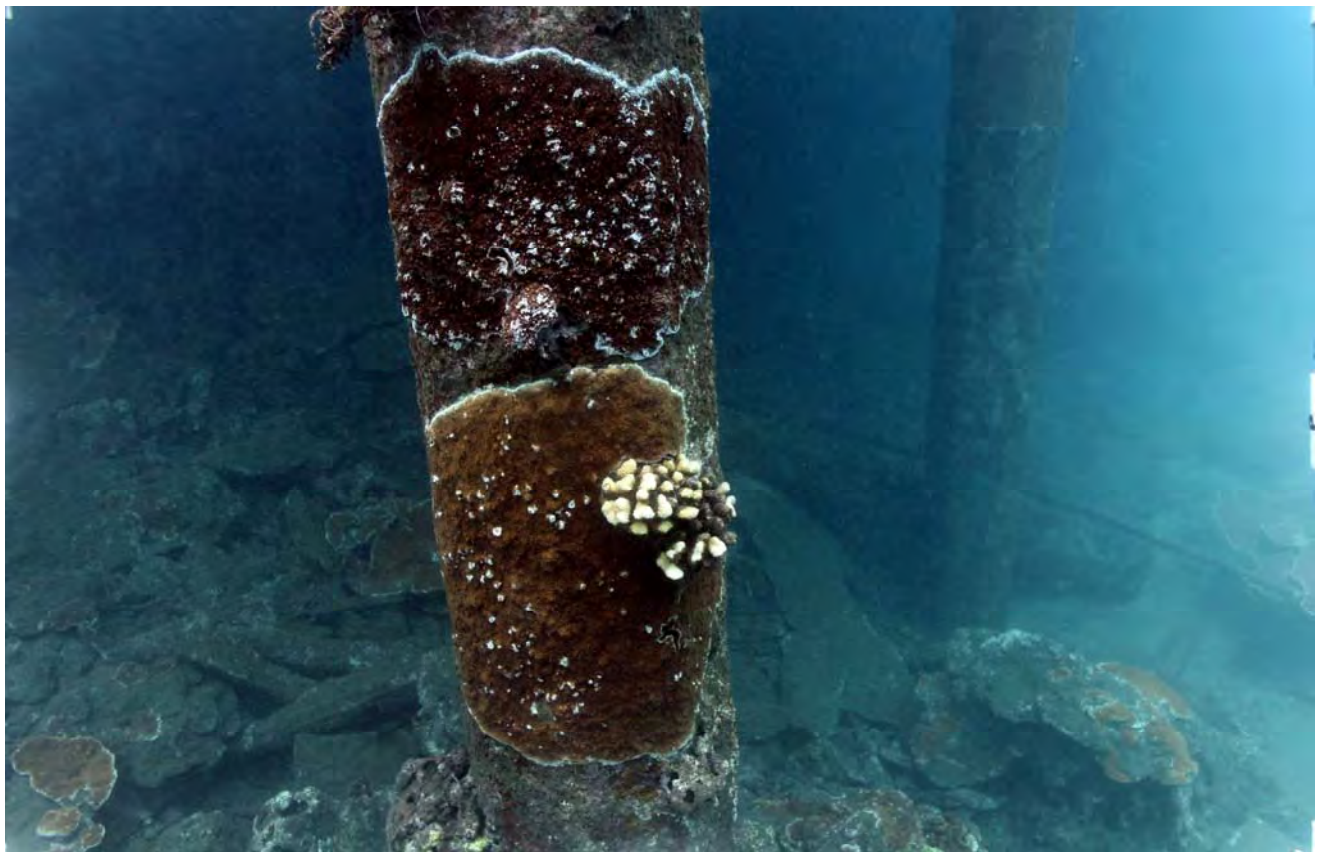
on the southern inner face. Rather, coral occurred primarily as circular flat encrustations (Figures 22 and 23). However, non-living remnants of plates did occur on pilings located on the inner side of the wharf, particularly near the end of the wharf (Figures 25 and 26). The occurrence of numerous living plating corals on the outer face of the wharf, and only dead plates on the inner face suggest substantially different environmental stresses on each side of the wharf.

FIGURE 22. View of bare pilings underneath wharf in Hana Harbor (top). Outer face of pilings at edge of south side of wharf are colonized with encrusting colonies of *Montipora capitata* and branching *Pocillopora meandrina* (bottom).

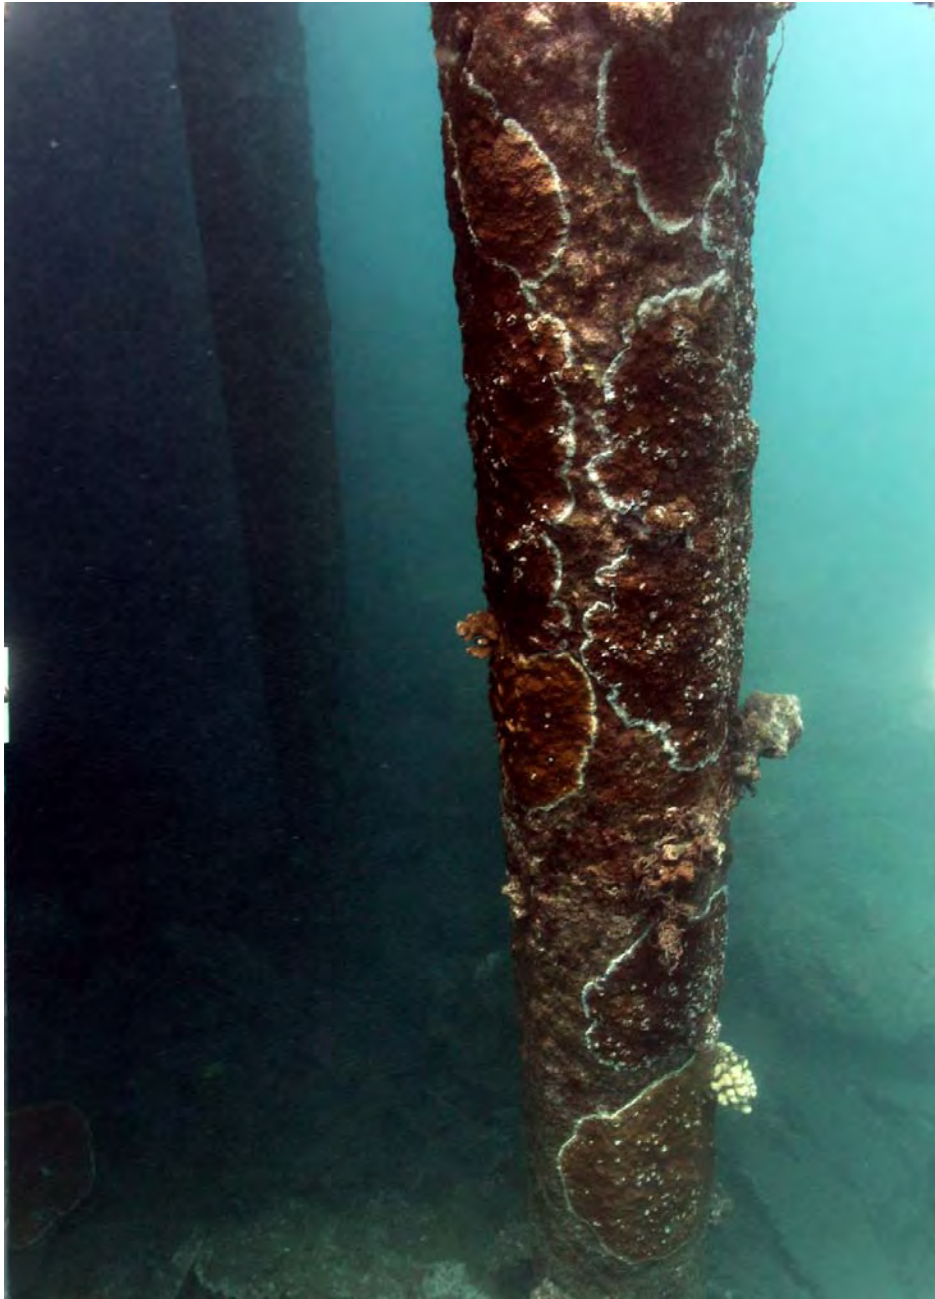
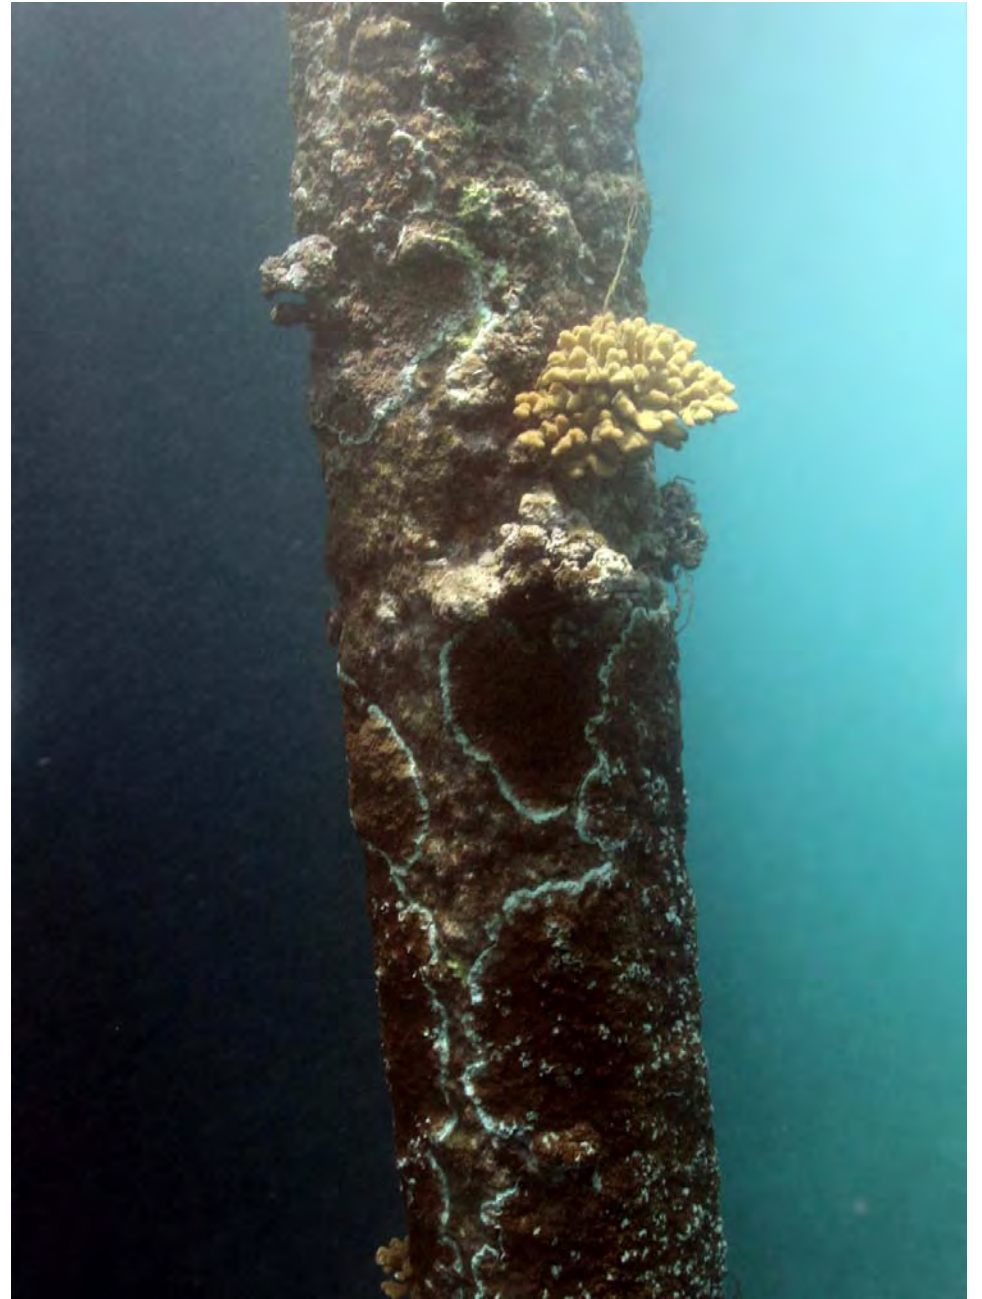
FIGURE 23. Two pilings located near the northwest end of the wharf in Hana Harbor, Maui. Circular brown encrusting corals in both photos is *Montipora capitata*. Yellow hemispherical branching coral in photo on right is *Pocillopora meandrina*.
