Preliminary Baseline Assessment of Reef Coral Community Structure in the Vicinity of the Wharf in Hāna Bay

**PRELIMINARY BASELINE ASSESSMENT OF REEF CORAL COMMUNITY STRUCTURE
IN THE VICINITY OF THE WHARF IN HANA BAY
HANA, ISLAND OF MAUI**

June 15, 2010

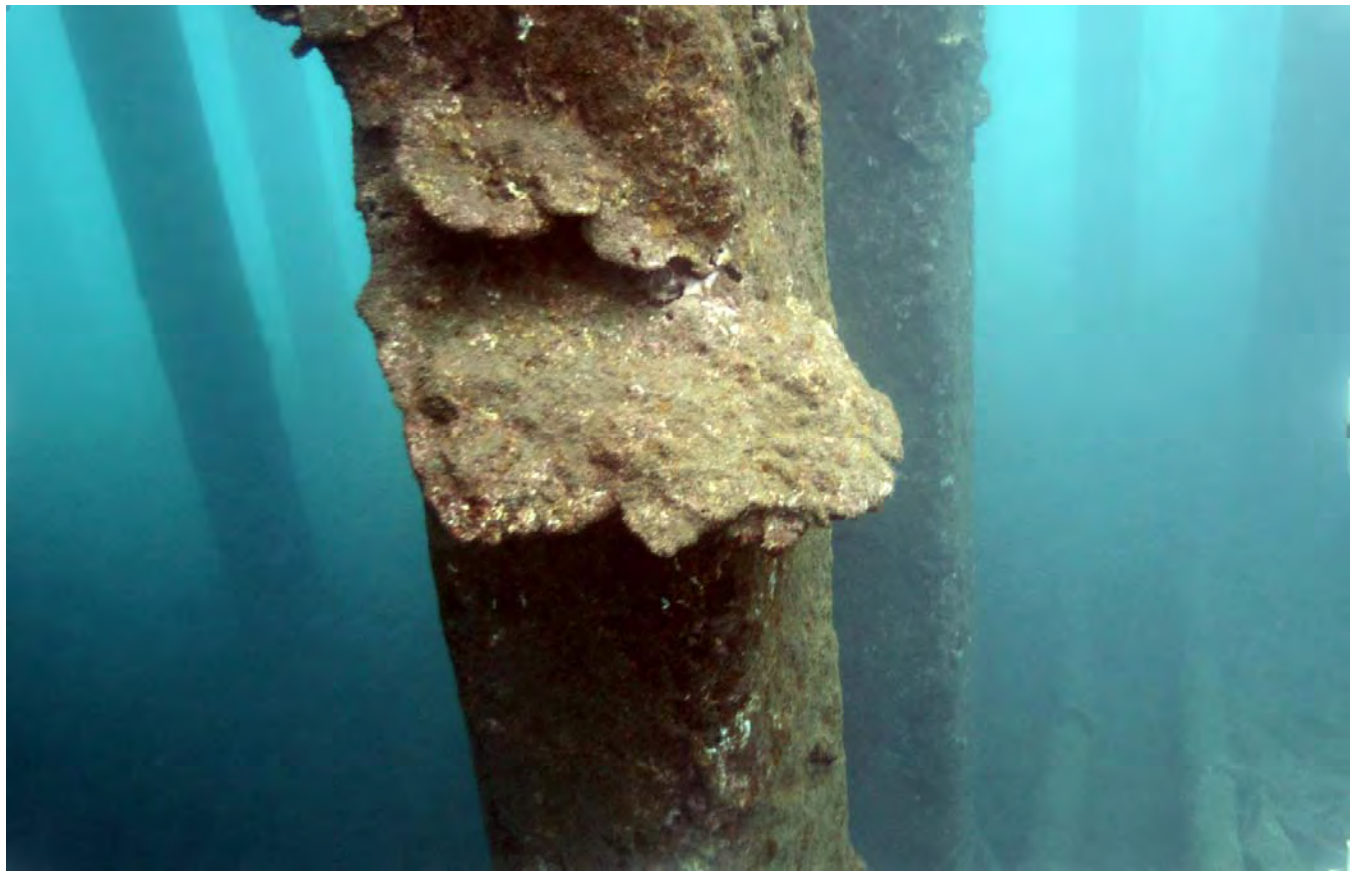
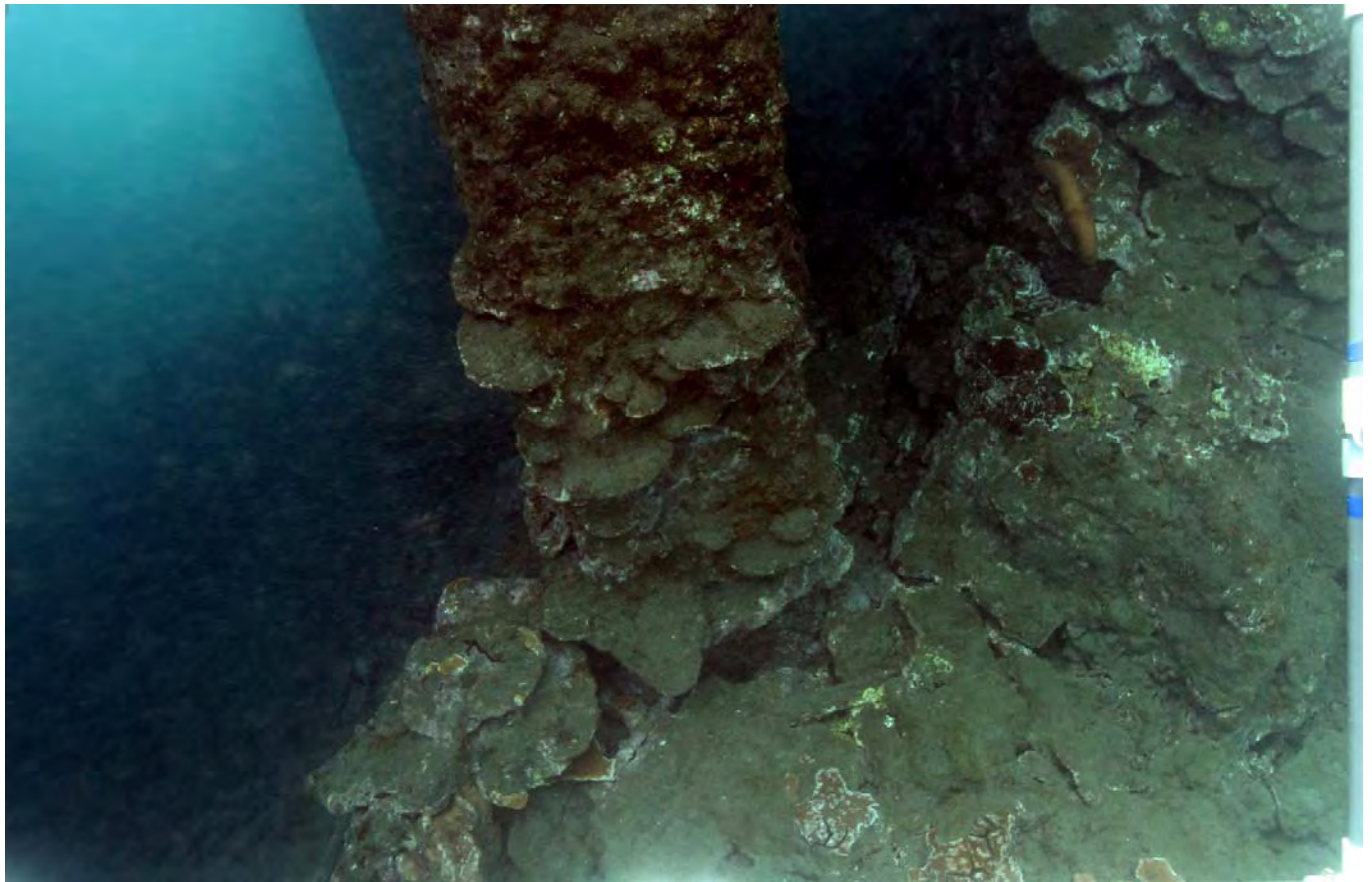
A substantial portion of the vertical surfaces of the pilings on the outer edge of the wharf (visually estimated at ~20%) are colonized with extensive overlapping plates of *Montipora capitata*. Similar growth of the same species has been observed on submerged piling within Kahului Harbor. Pilings interior to the edge of the wharf are essentially barren of coral colonization, likely as a result of lack of exposure to light. Surprisingly, virtually no other macro-organisms were observed on any of the pilings. Pilings on the outer edge of the south side of the wharf were not colonized by overlapping plates of *Montipora*; rather this coral occurred in circular encrustations. Toward the end of the wharf, remnant dead and eroding plates were observed.

FIGURE 25. Dead and eroding plates of *Montipora capitata* on south side of wharf in Hana Harbor, Maui.

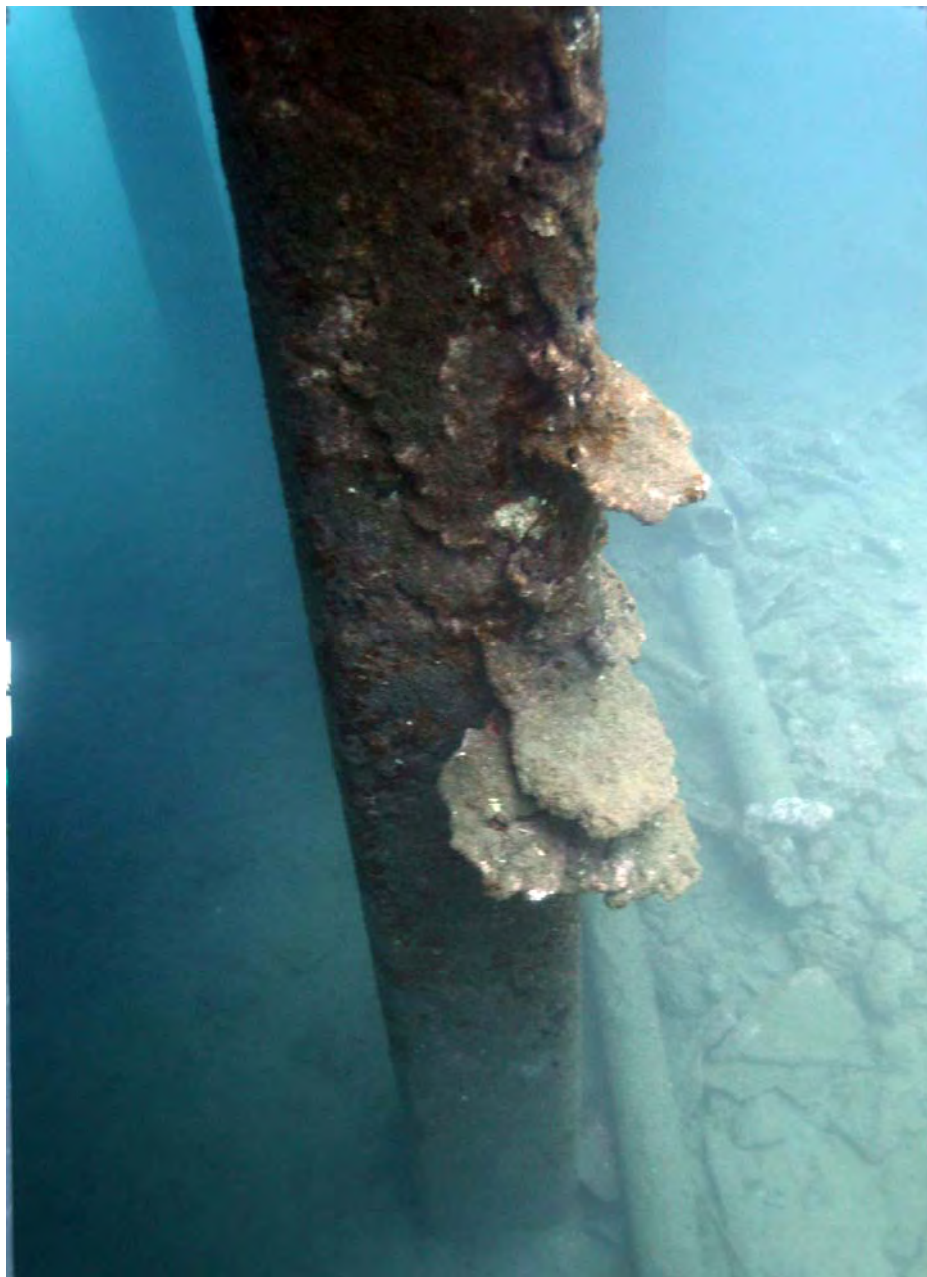
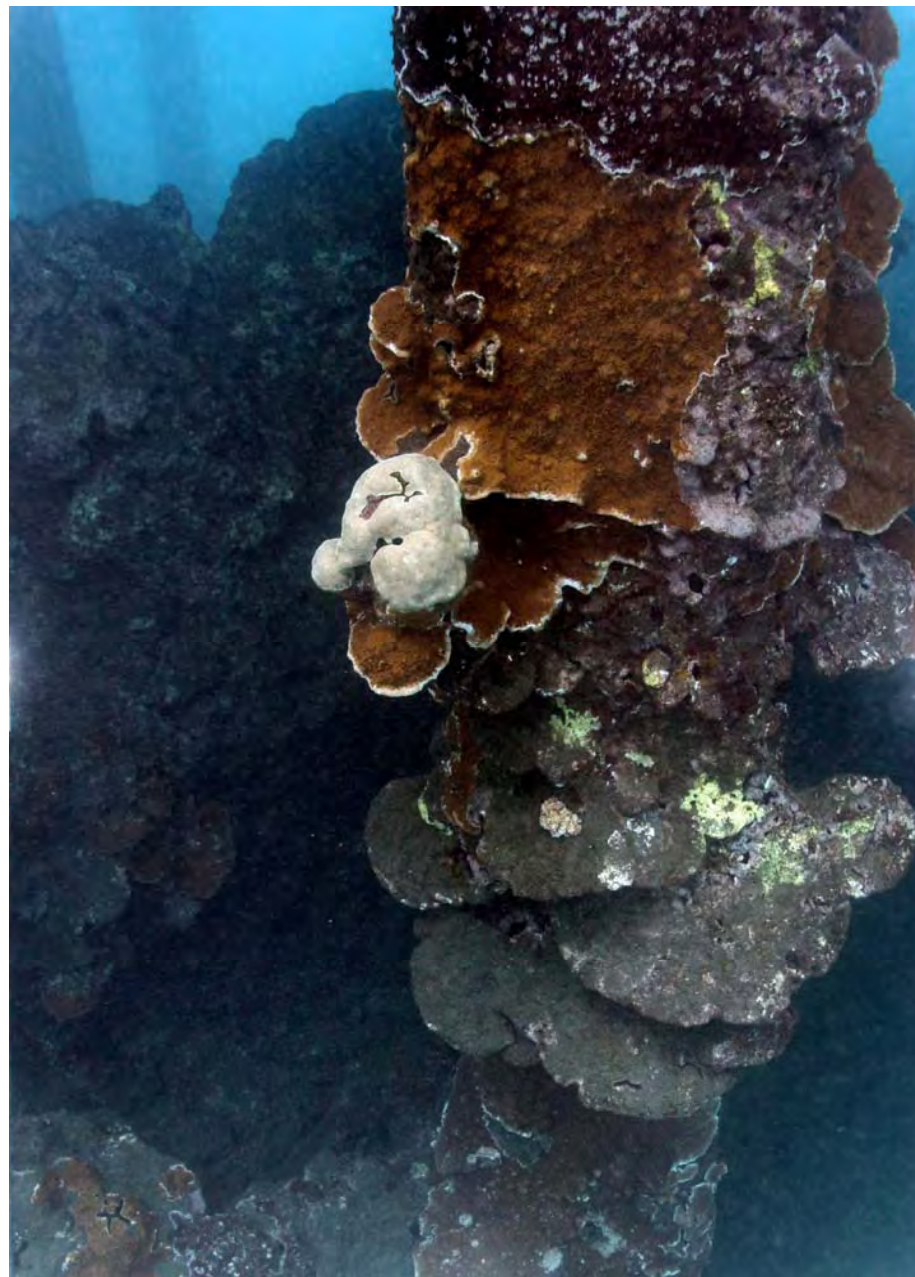
FIGURE 26. Pilings on south side of wharf in Hana Bay showing dead plates of *Montipora capitata*.

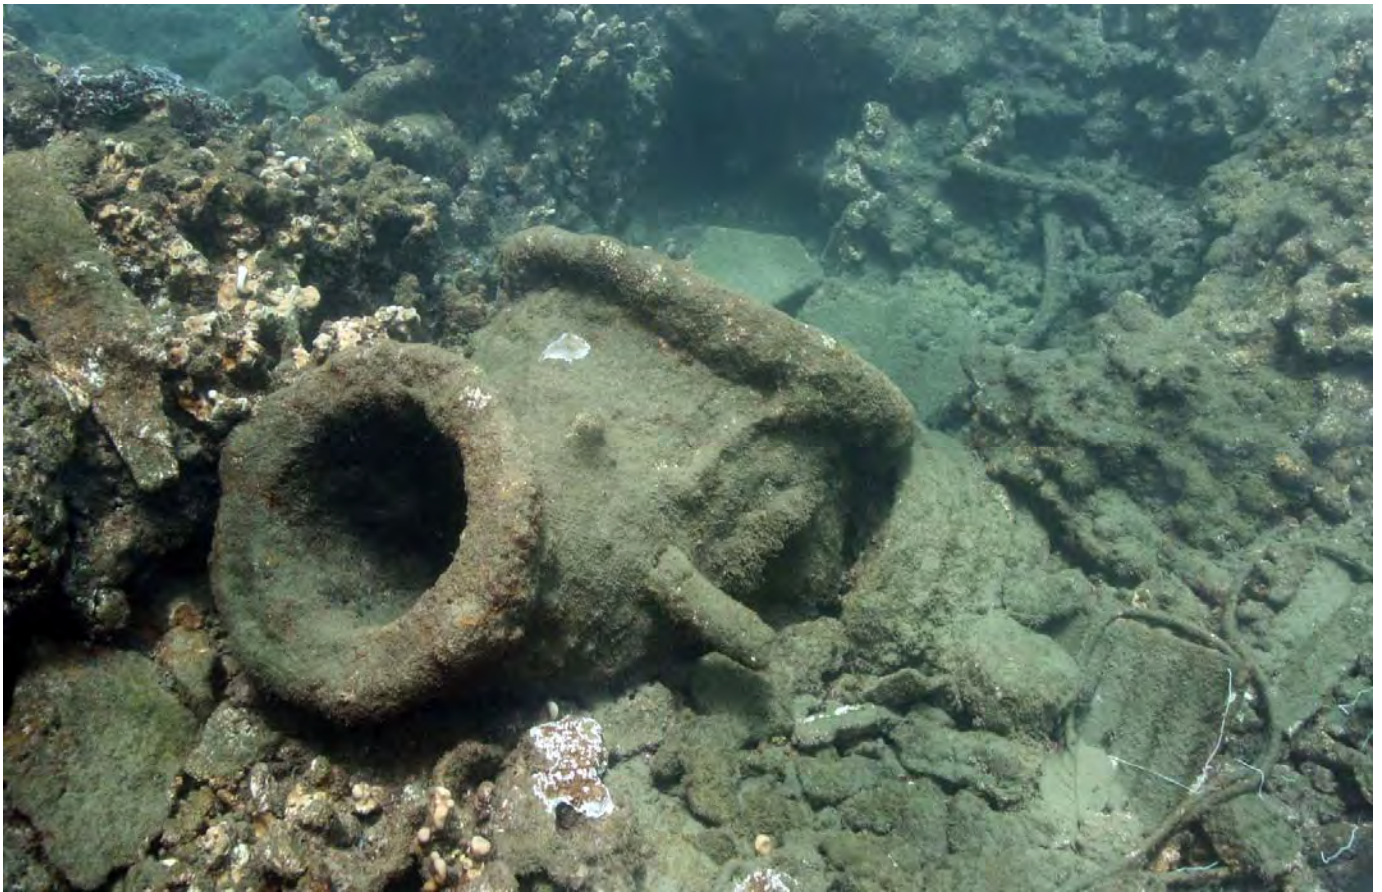
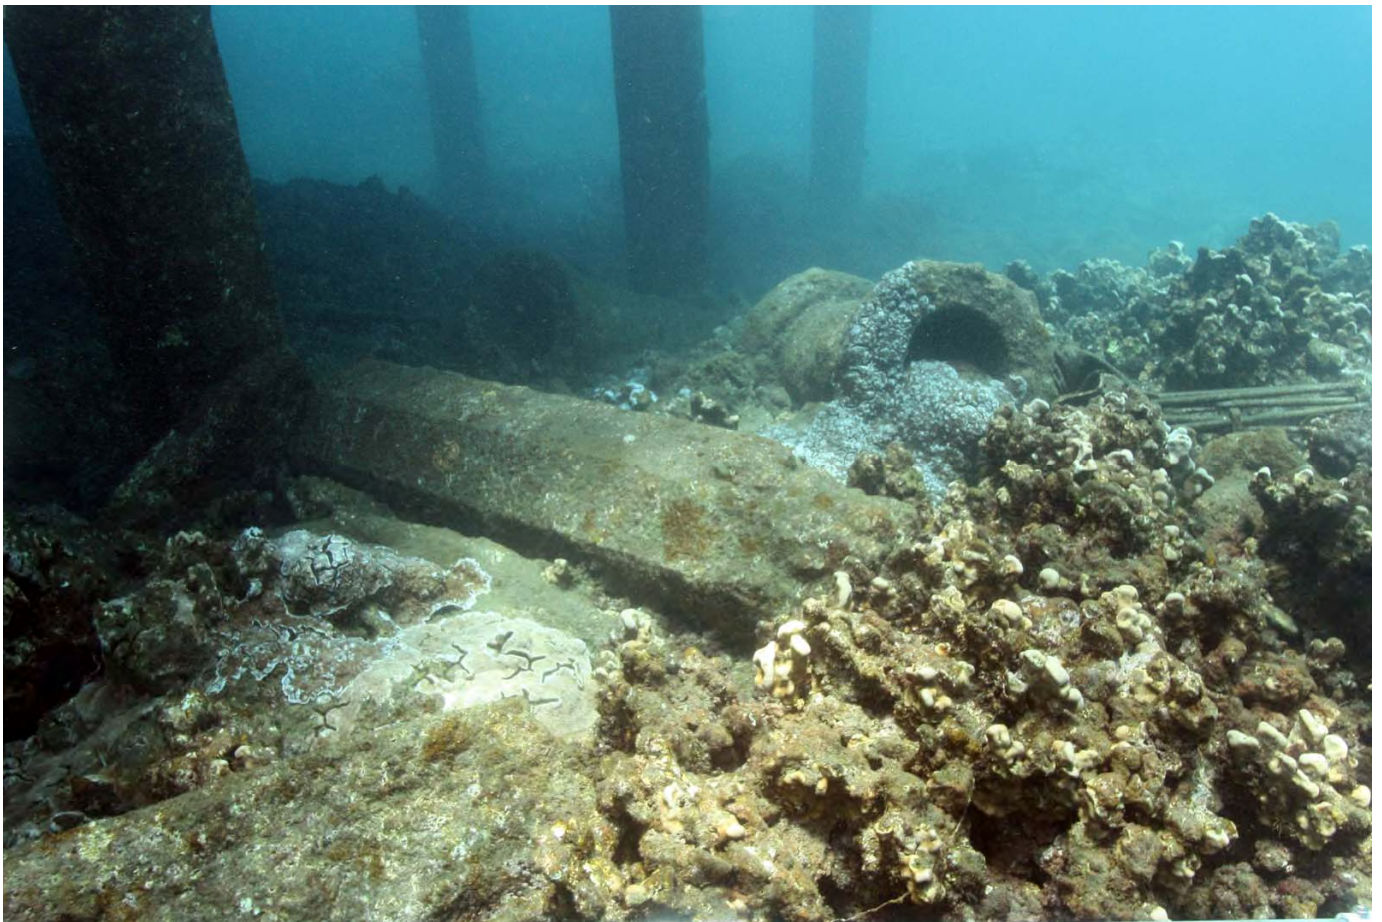
Off the end of the wharf there are large accumulations of various pieces of discarded materials, including pipes, piles, cables and various other forms of metal debris (Figure 27). Off the north side of the wharf, a series of large rubber tires are embedded in the sand.

FIGURE 27. Assorted metal objects and debris, including broken pilings off end of wharf in Hana Bay, Maui.
