PRESERVATION PLAN PROJECT
FOR STATE BRIDGES WITHIN THE

**HANA BELT ROAD
HISTORIC DISTRICT**

BRIDGE PRESERVATION PLAN

FINAL

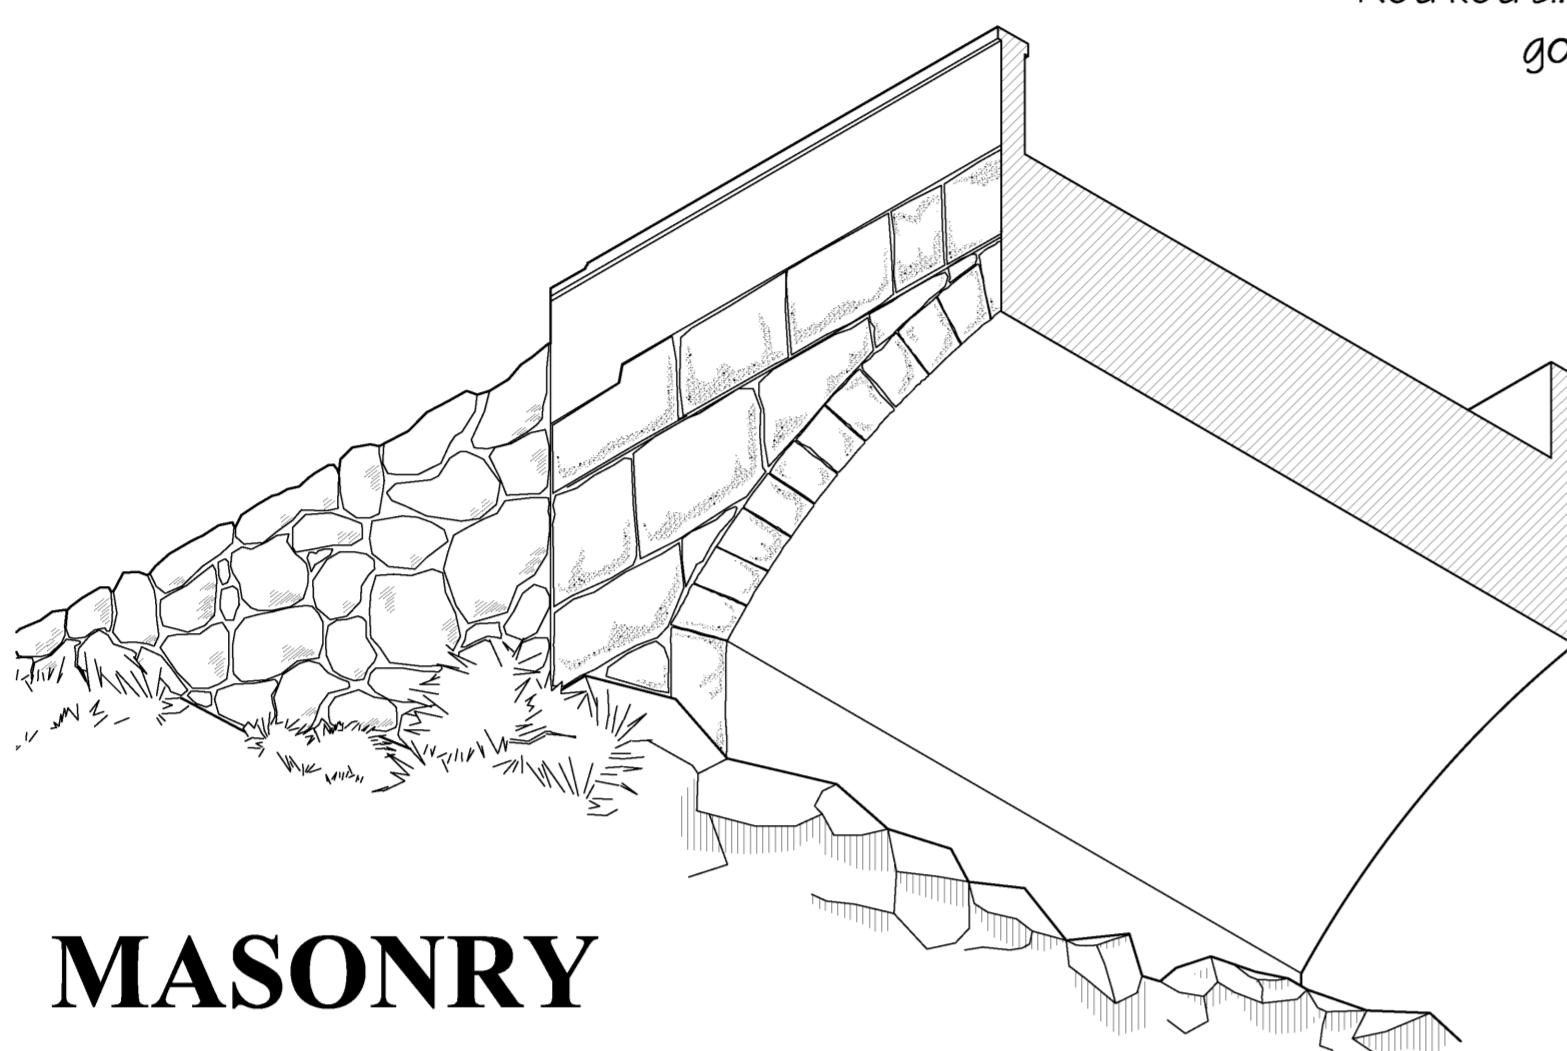
WAIELE BRIDGE (1910)

**MASONRY
ARCH**

The majority of the Hana Coast bridges were built with reinforced-concrete flat slabs or girders. Flat-slab bridges (and culverts) were constructed when short spans were required. For longer spans, Tee-beam girder bridges were utilized. Some structures, particularly those with very thick parapets such as Pa'ihi Bridge, used Tee-beam girders with cross members, which were poured with the parapets so that all members worked together to support the roadway. Three barrel-arch bridges, built in 1916 and 1926, utilized a solid concrete arch with fill material above the arch to carry the roadway. Two open-spandrel rib-arch bridges, Kou'kou'ai (1911) and Wailuanui (1926), were built to span high, rocky gorges. These structures carried the load on the rib arches, which were further strengthened with cross-struts and spandrel columns.

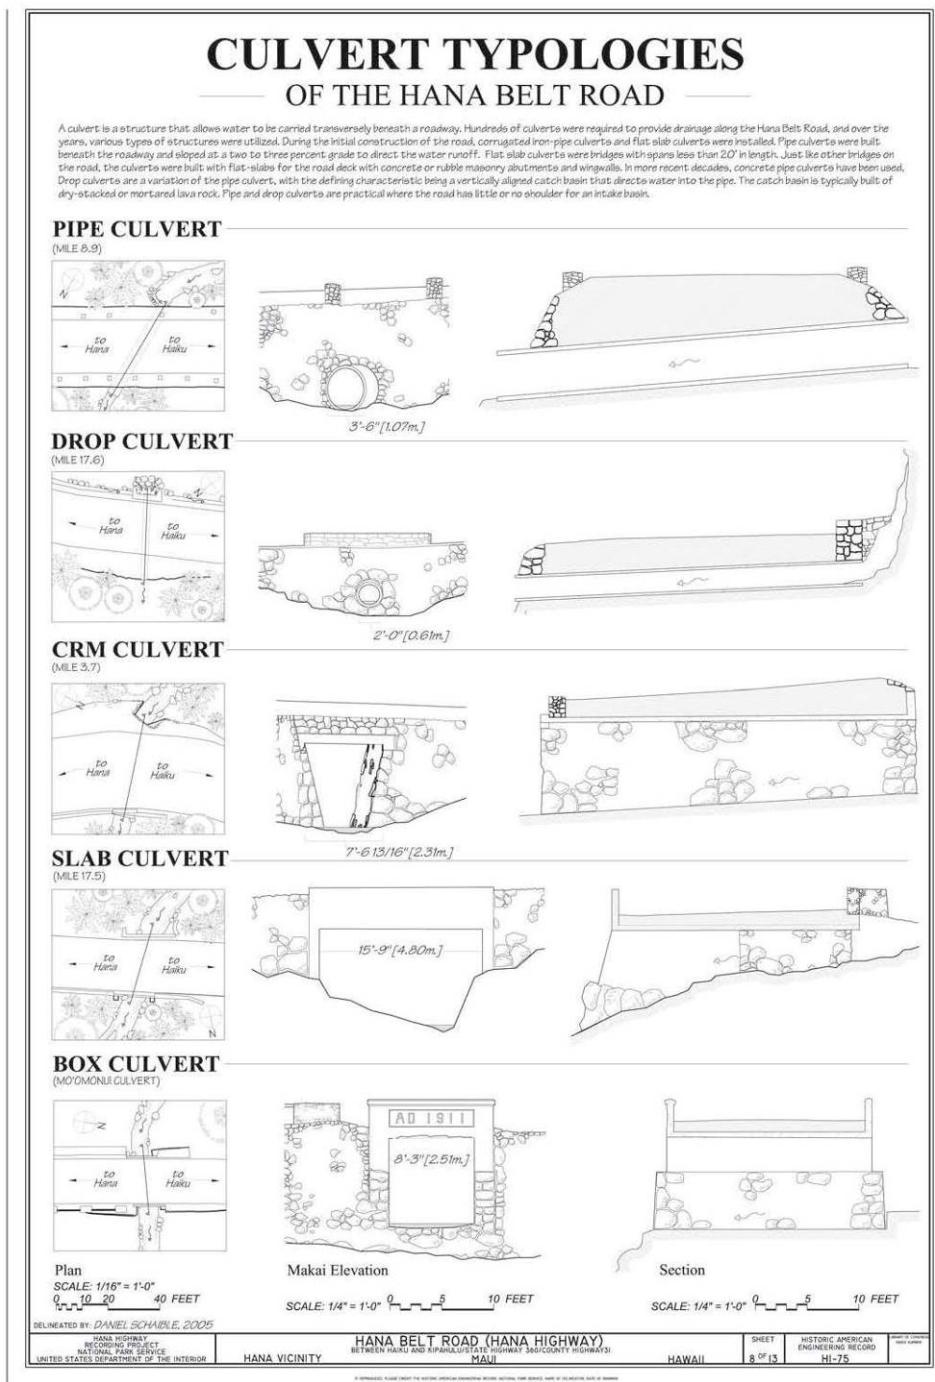
Figure D – 2: Culvert typologies of the Hana Belt Road
Courtesy of HAER HI-75

Record drawings do not exist for these found culverts and it is unknown as to when they were constructed. The HAER report mentions and describes culvert types found along the Hana Highway, Route 360 (refer to *Figure D – 2*). The load carrying capacities of these culverts are unknown since as-built drawings are not available for these structures, nor have condition evaluations for them been performed. At the time of the survey, the found culverts were found to be in good condition. It is recommended that the found culverts be investigated to determine their load carrying capacity and code compliancy.

It is recommended that culverts with CRM approach walls have the existing approach walls replaced with a crash-tested reinforced concrete wall with a natural rock façade to match the appearance of the existing CRM wall. For this purpose, a stone masonry guardwall is recommended. It is also recommended to install guardrails and an end treatment at the corners after the stone masonry guardwall, to eliminate the possibility of a blunt end collision.
