**TRAFFIC ANALYSIS REPORT**

**Traffic Analysis Report**  
**Hawaii Commercial Harbors 2020 Master Plan**

Hilo Harbor, Hilo, Hawaii  
Kawaihae Harbor, Kawaihae, Hawaii

Prepared for: State of Hawaii  
Department of Transportation  
Harbors Division  
and  
R. M. Towill Corporation

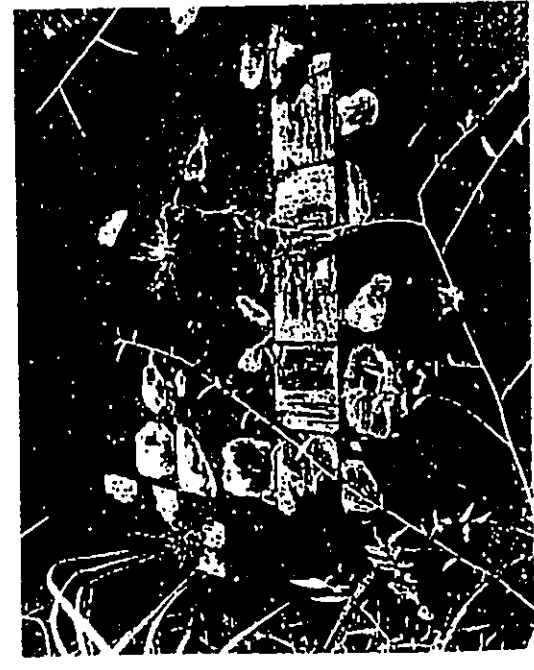
Figure 17. East Project Area - Floor Tiles, View to North-Northwest
