## Kaua'i Emergency Flood Repairs and Cleanup

### Various Locations

### April 2018

### Public Informational Meeting

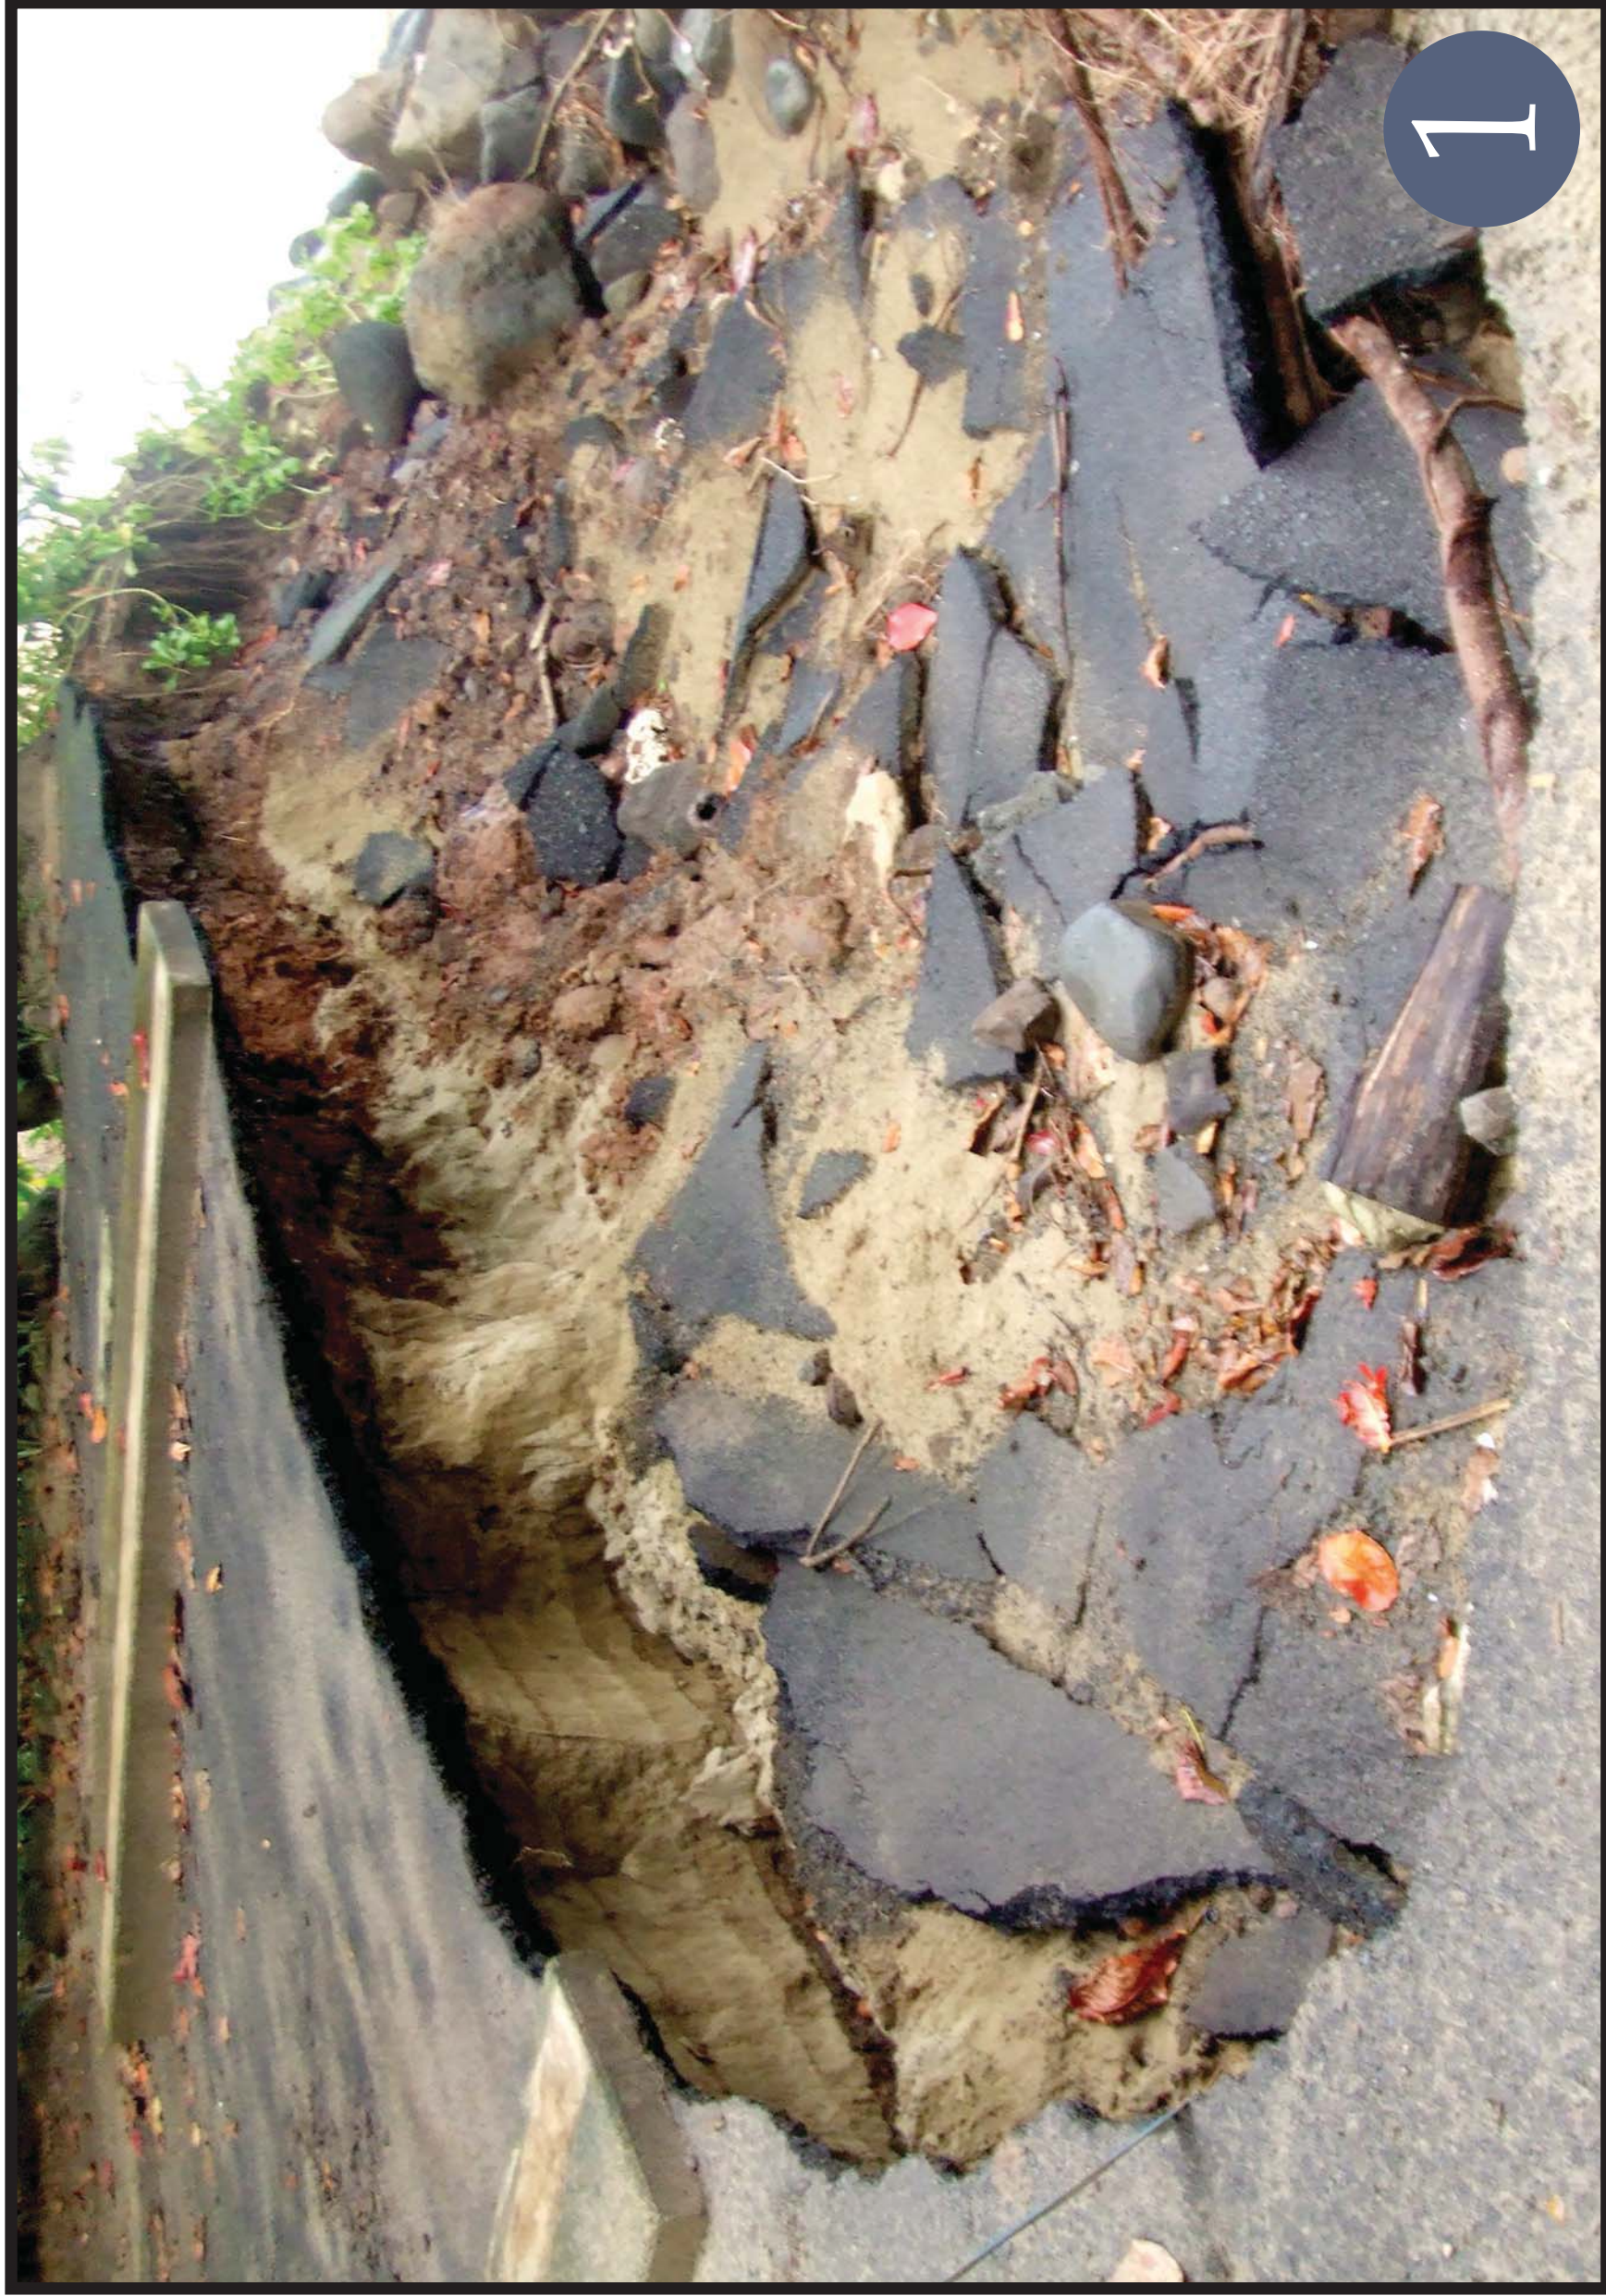
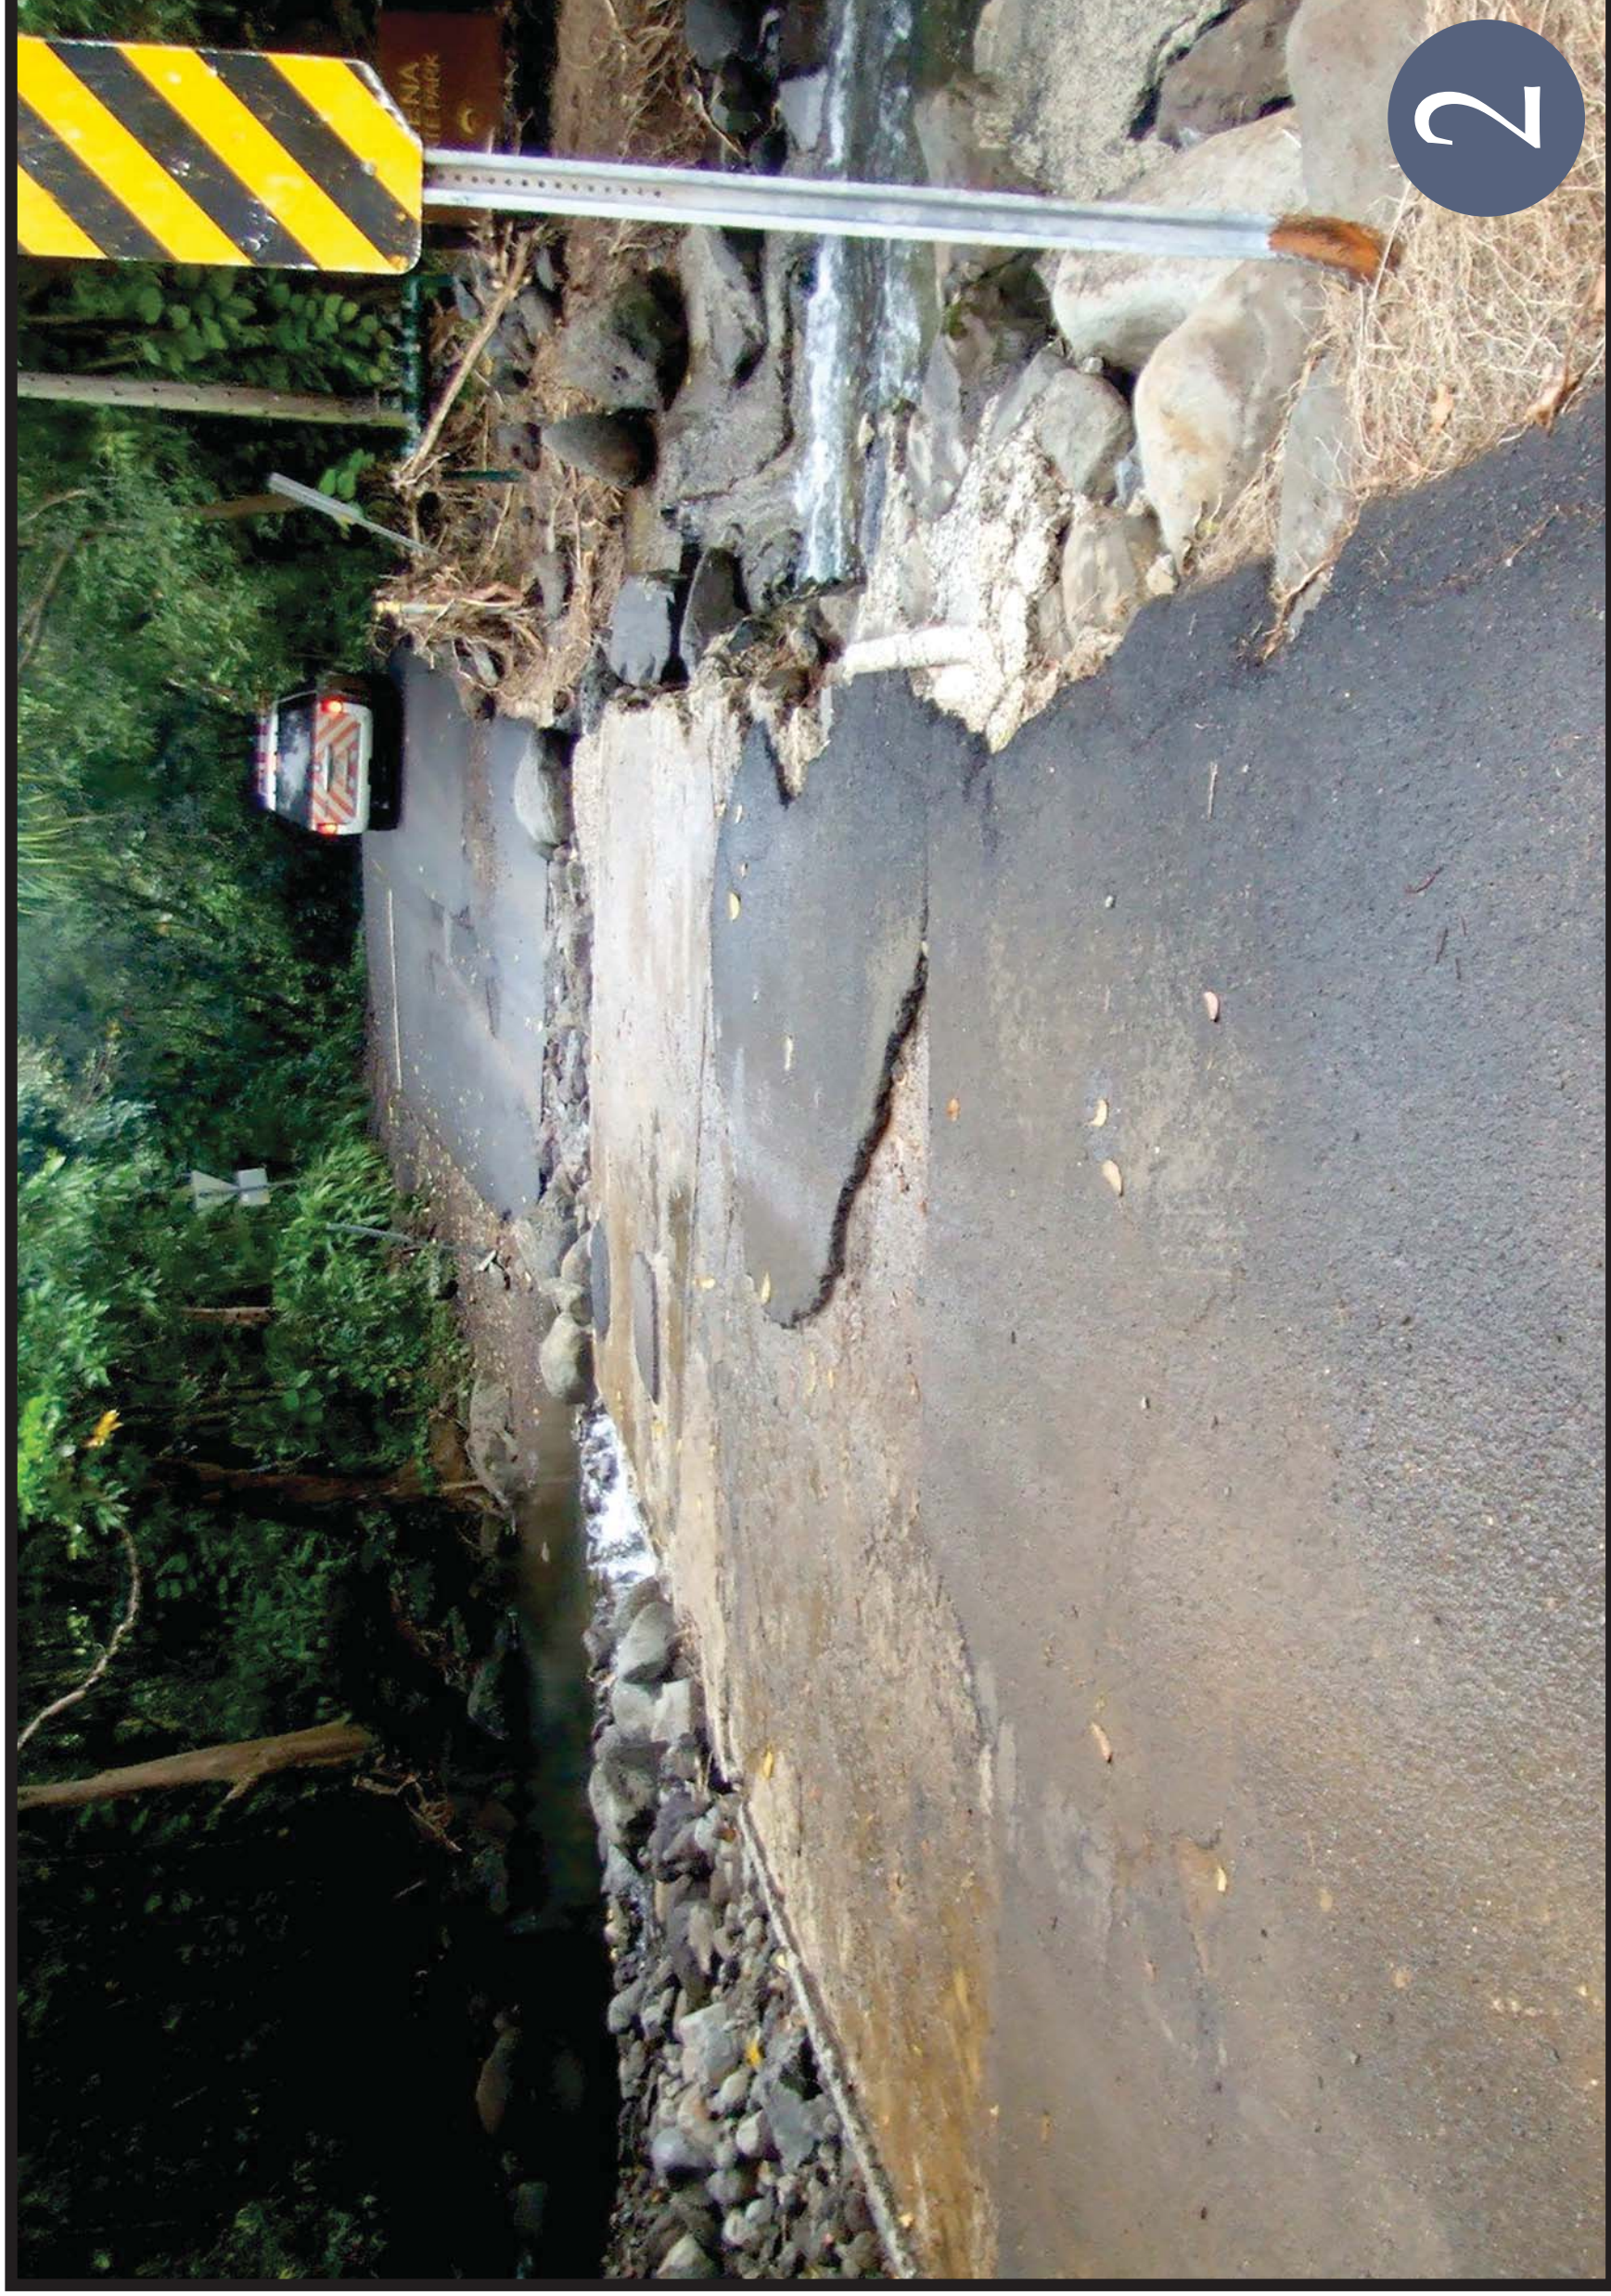
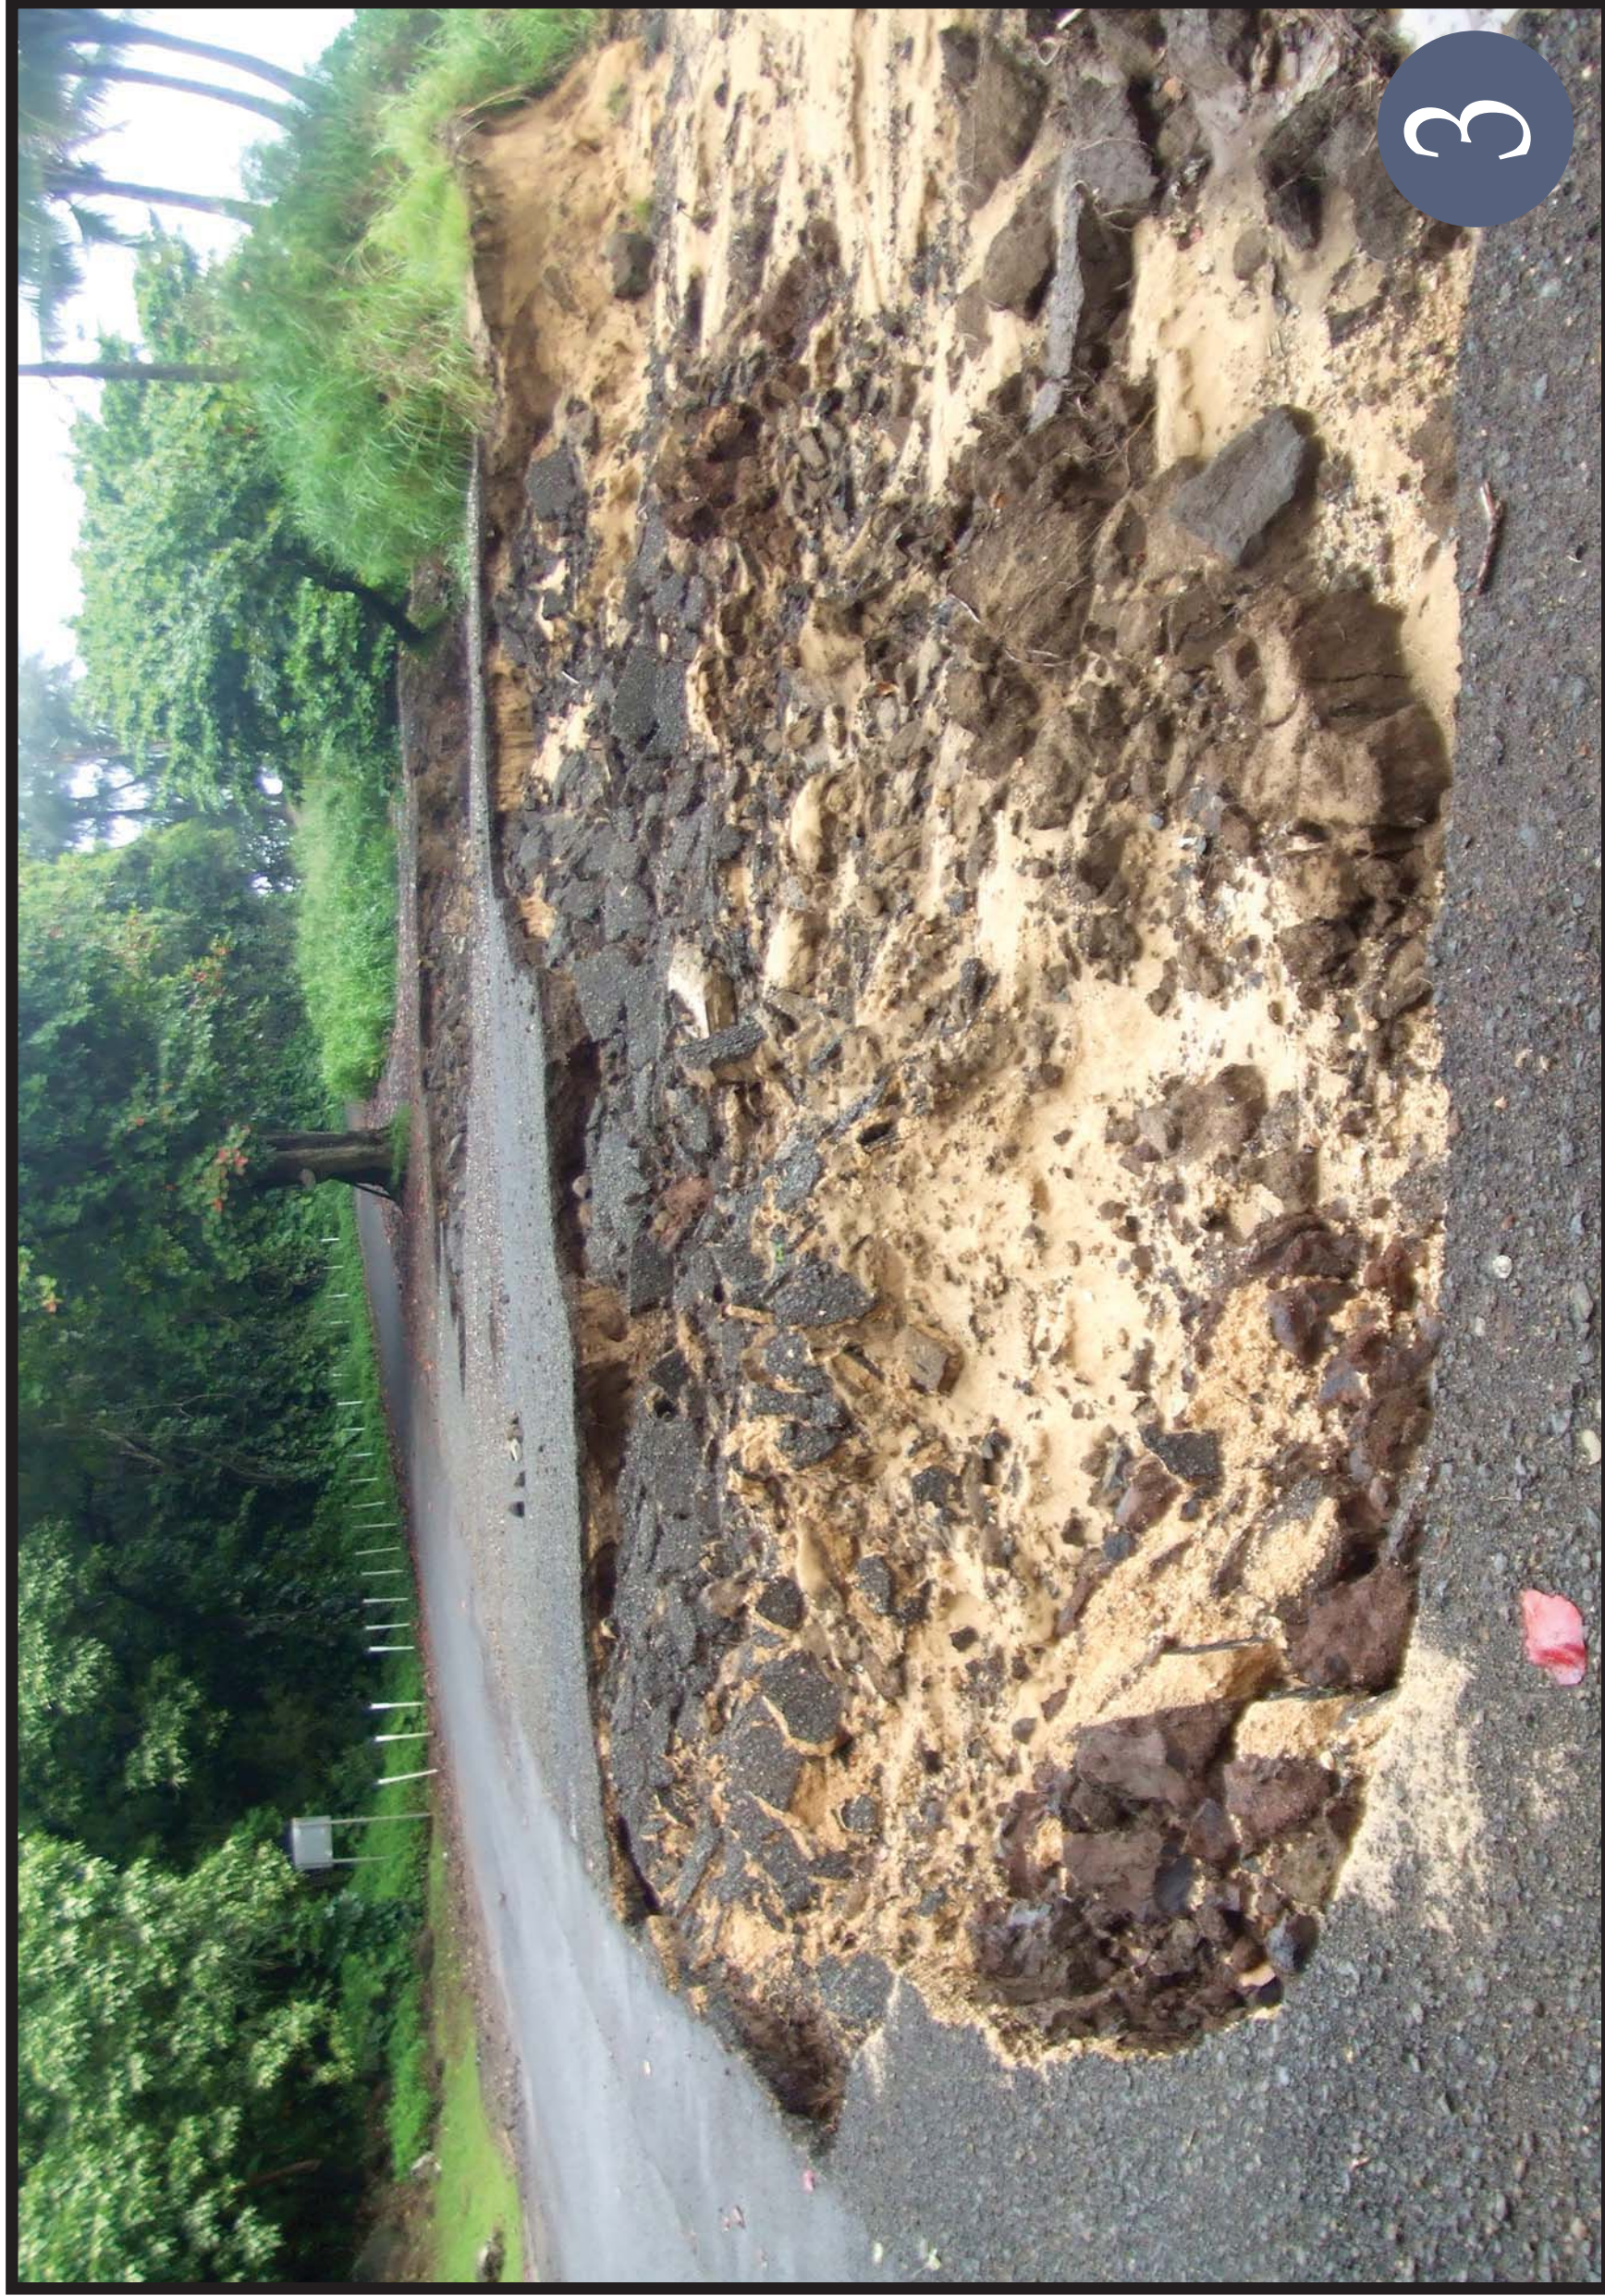
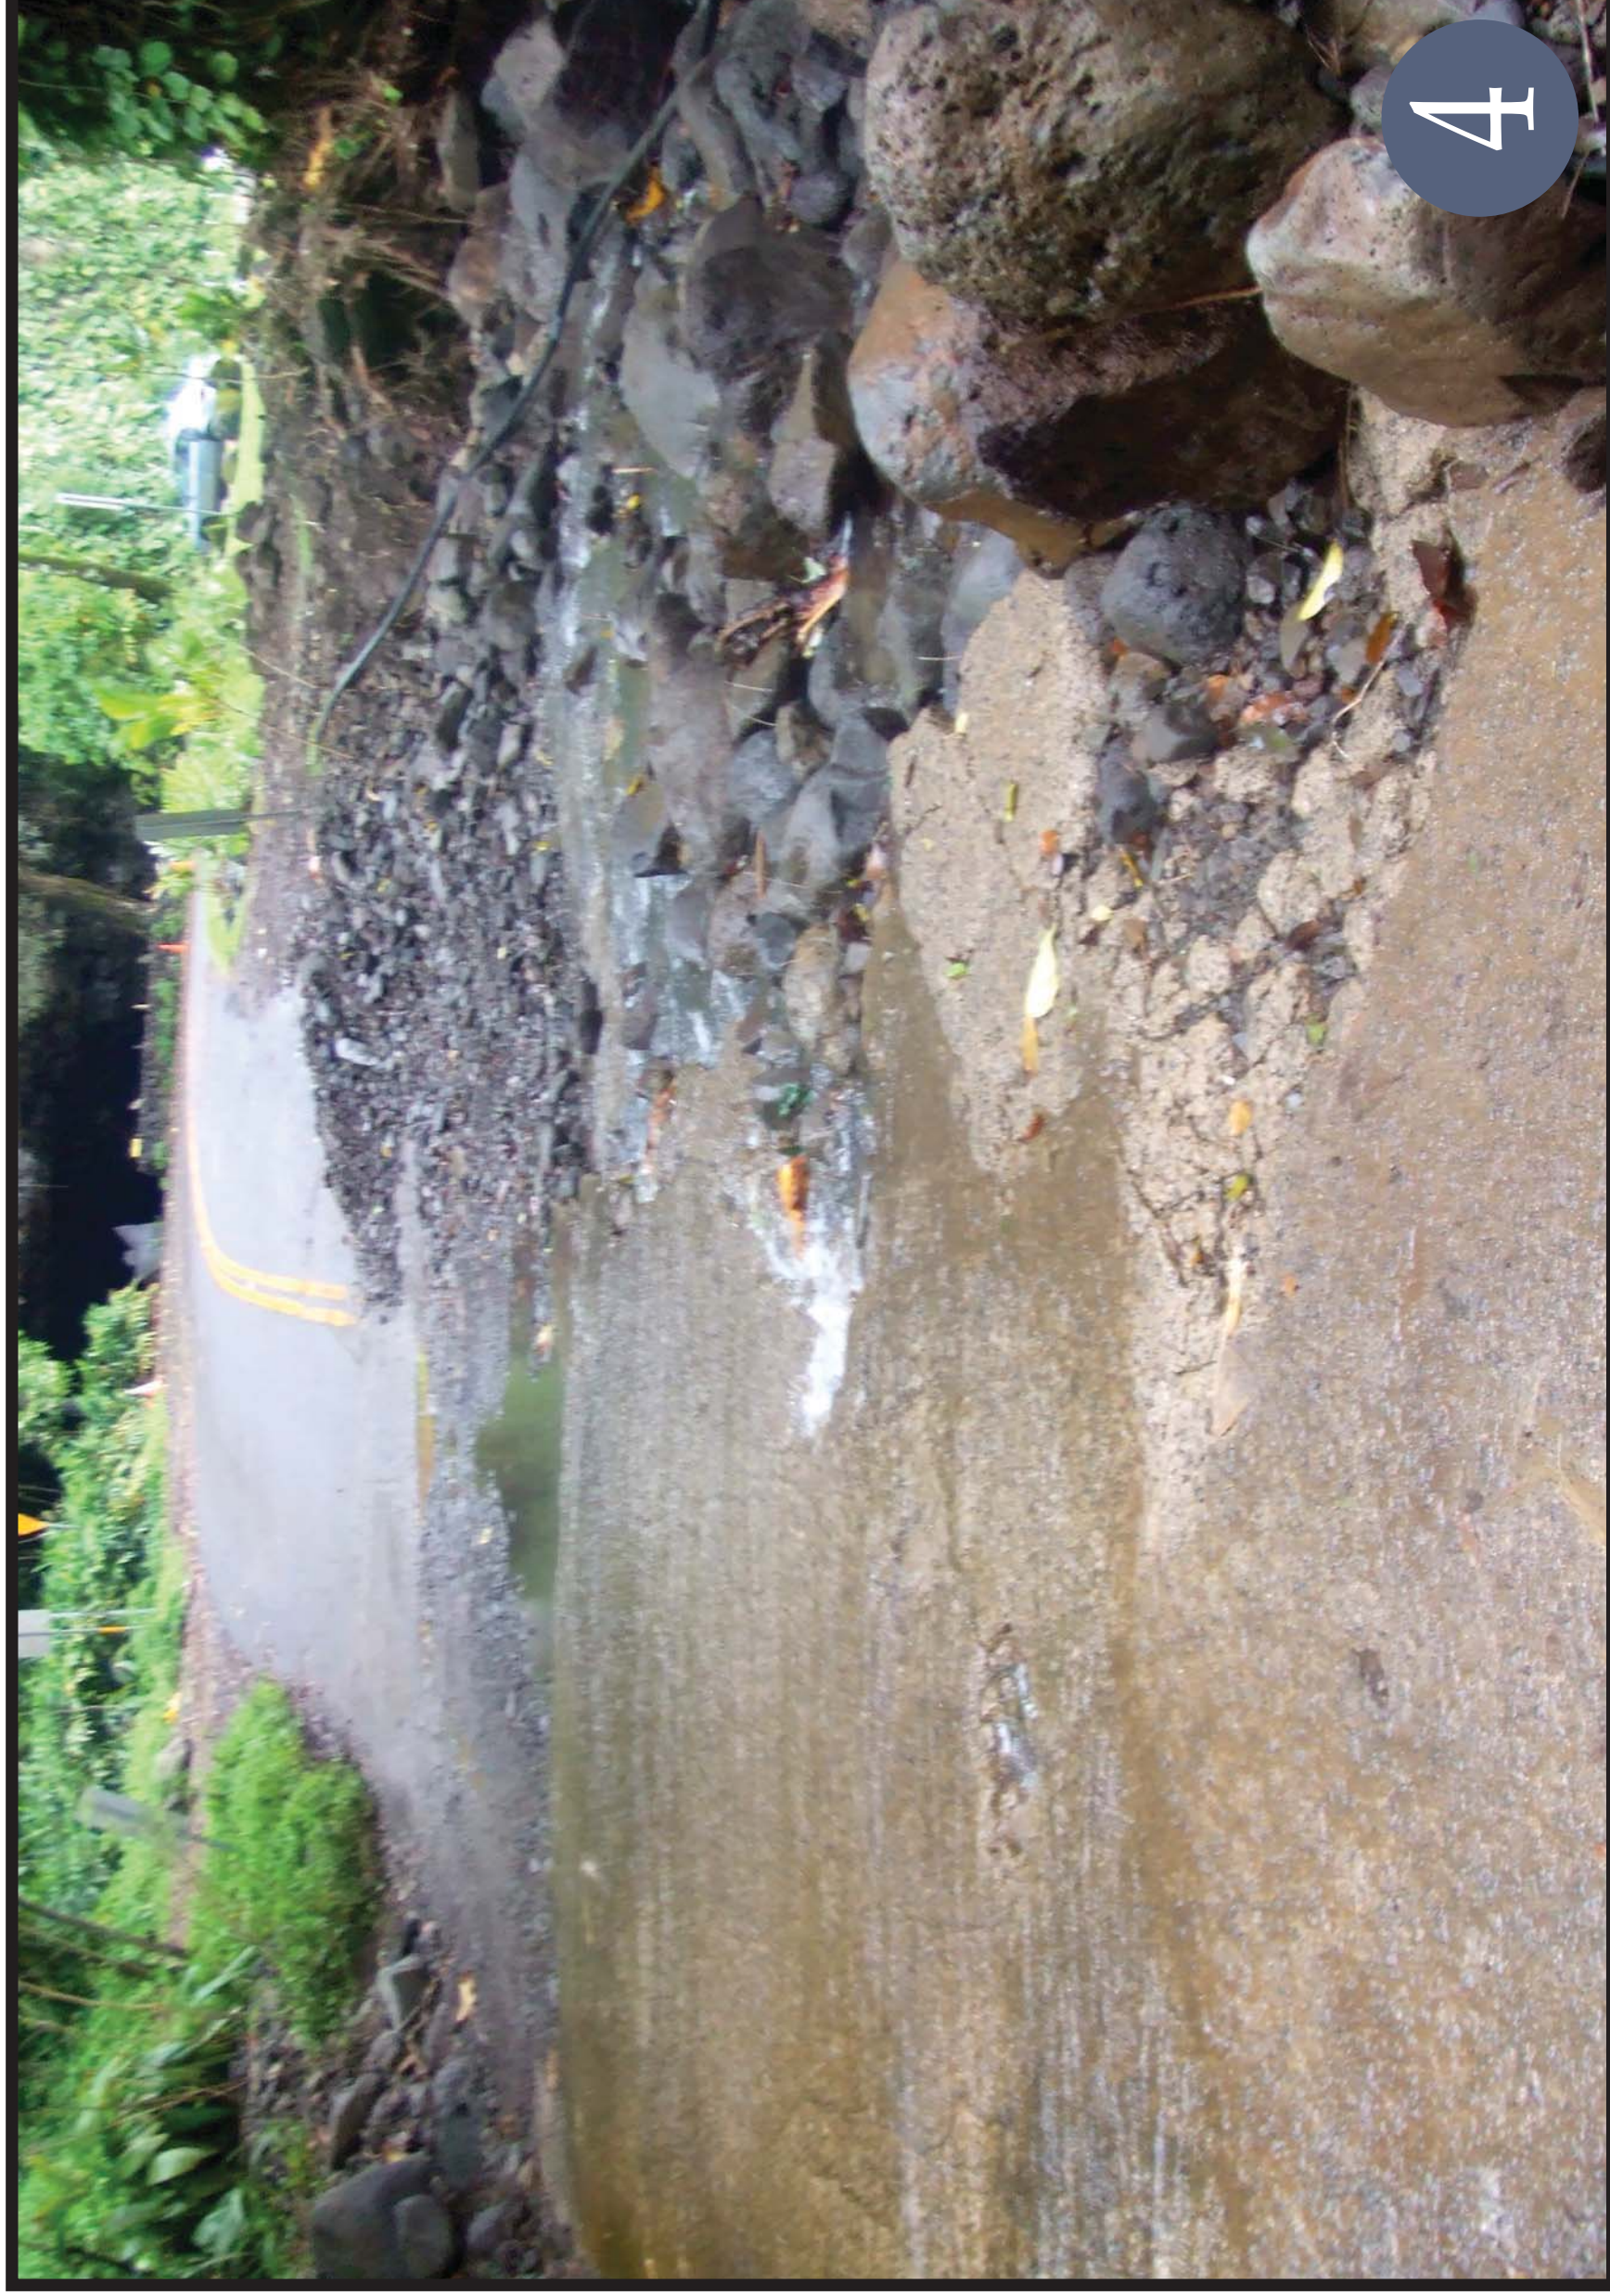
# Kūhiō Highway Repairs near Hā'ena

1. Kūhiō Highway (Route 560), MP 10 at Kē'e State Park:  
Reconstruct roadway;

2. Limahuli Stream Crossing (Route 560), MP 9.55:

Repair concrete section lost in flooding.  
Resurface entire ford crossing.

3. Kūhiō Highway (Route 560), MP 8.87 at Hā'ena Beach Park:

Repair roadway shoulder;

4. Mānoa Stream Ford Crossing (Route 560), MP 8.76 near Hā'ena Beach Park:

Repair the entire crossing.

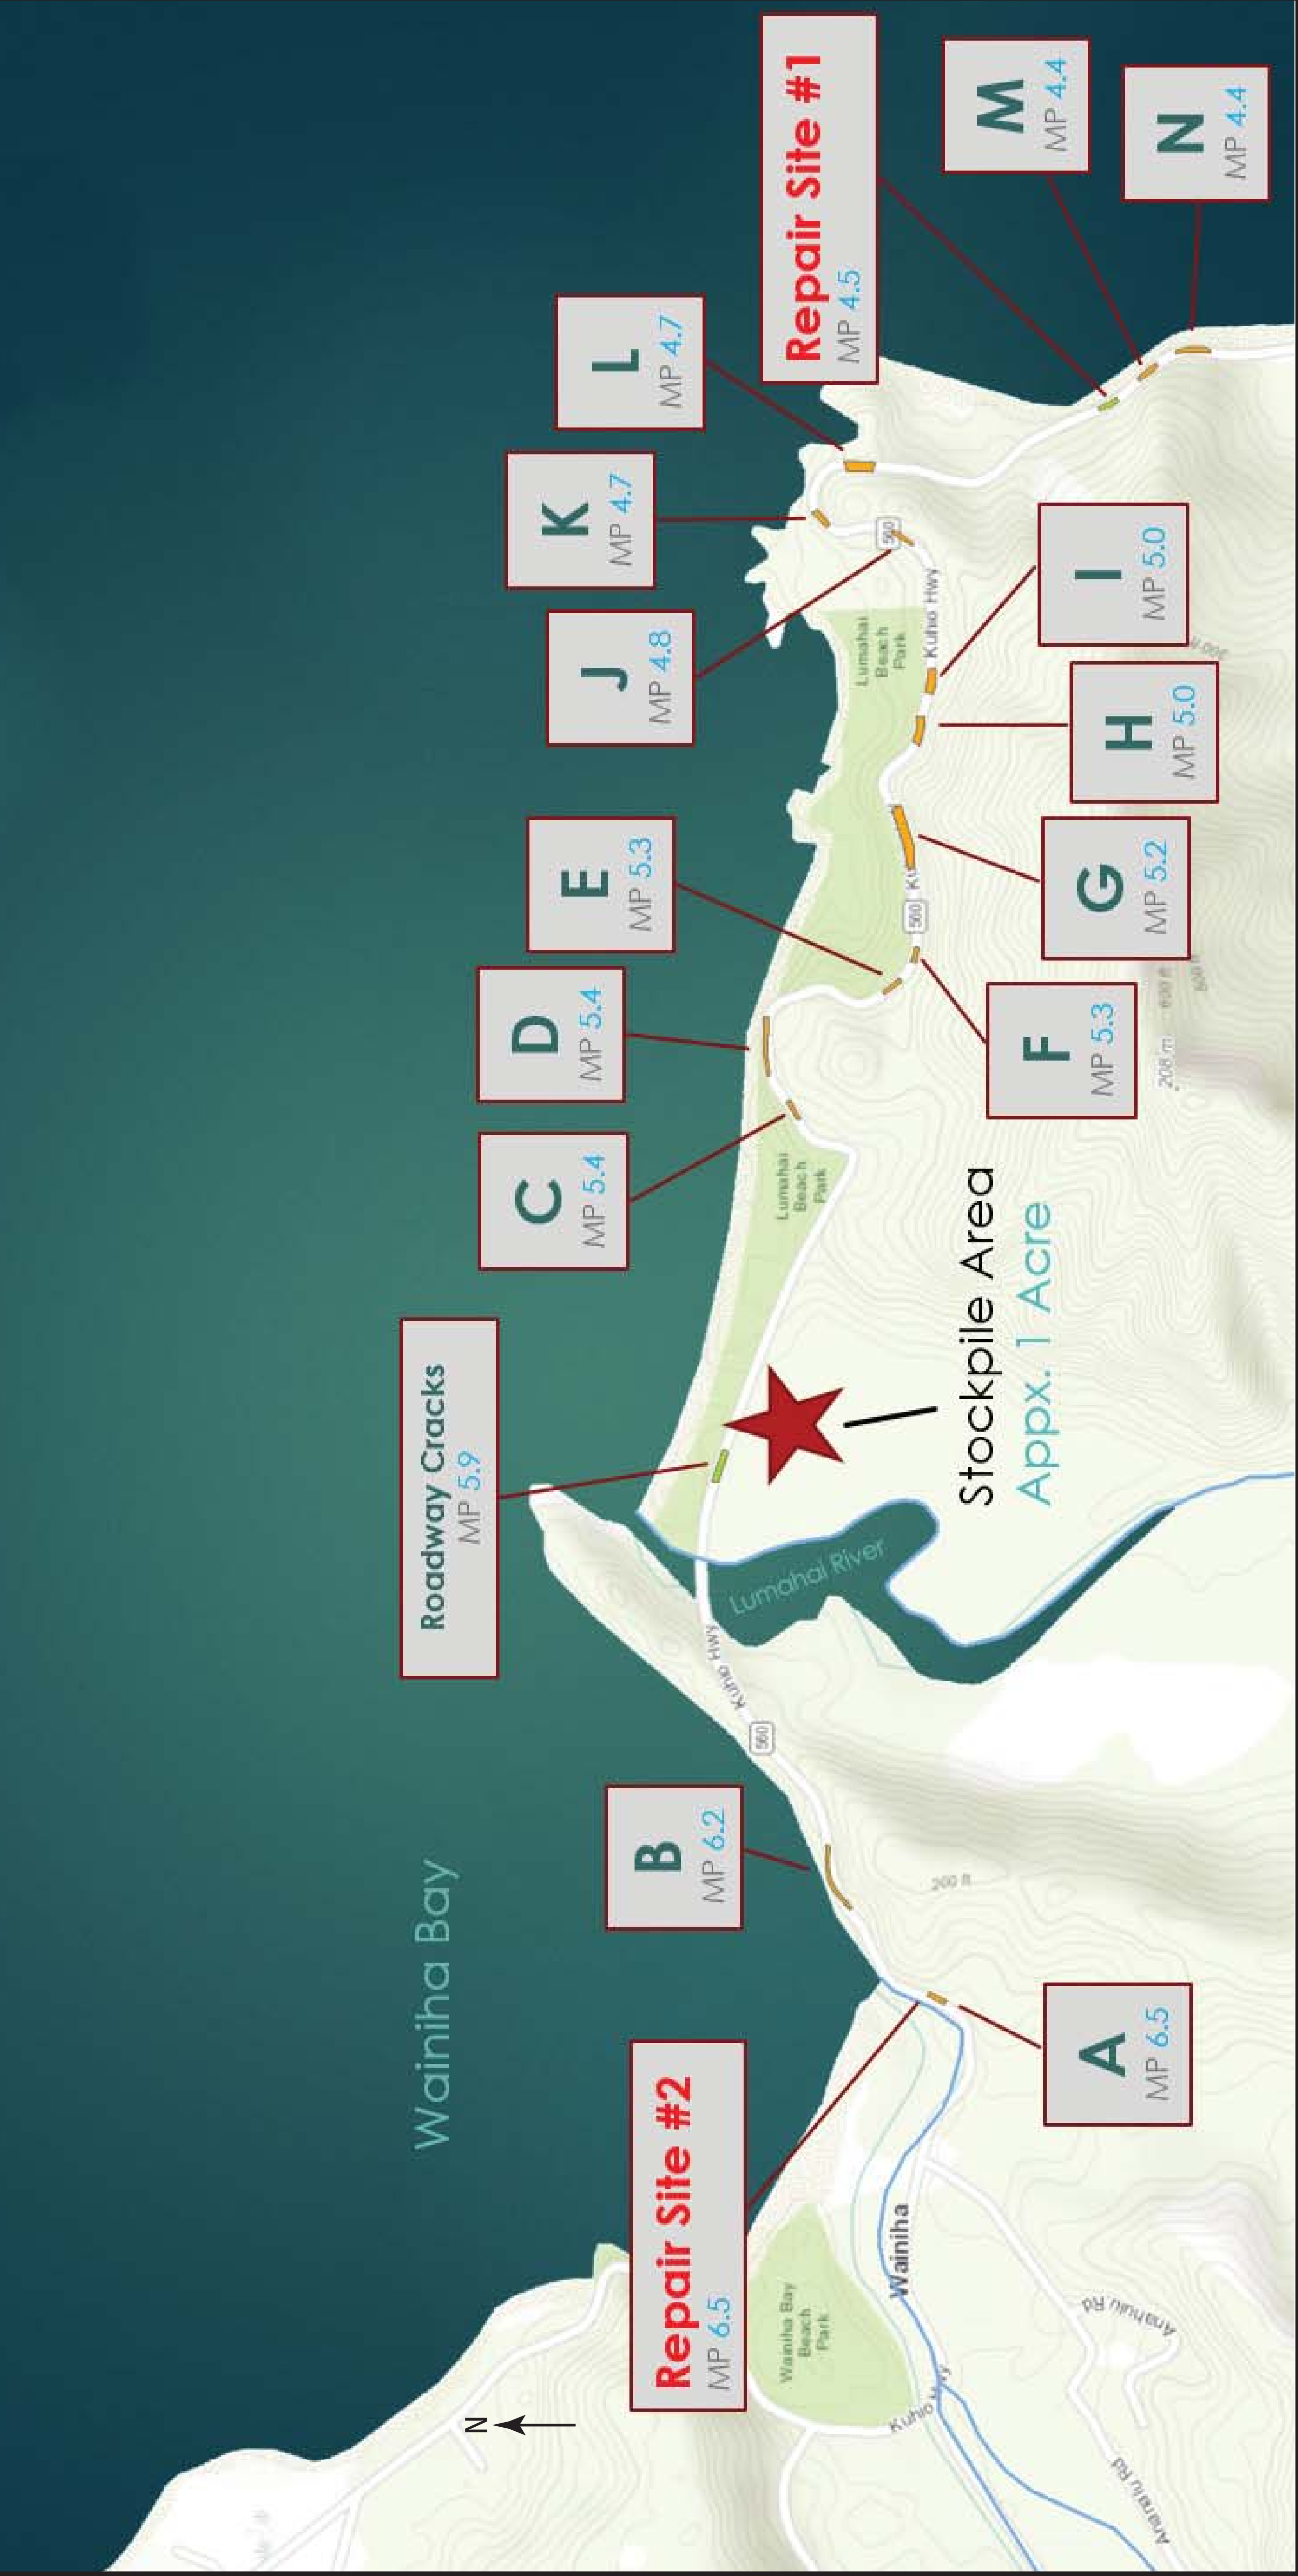
## Landslide and Repair Sites

Over 15 locations from MP 6.5 through MP 4.4 along Kūhiō Highway (Route 560). Landslide zones are noted as Zones A thru N. Individual Repair Sites also occur in this area. All repairs include debris removal, slope scaling, slope stabilization, guardrail replacement, pavement repairs.

**Status:** All landslide repairs are in progress. Repair sites number 1 and 2 are in progress, but require additional permits; heavy equipment and heavy materials to complete.

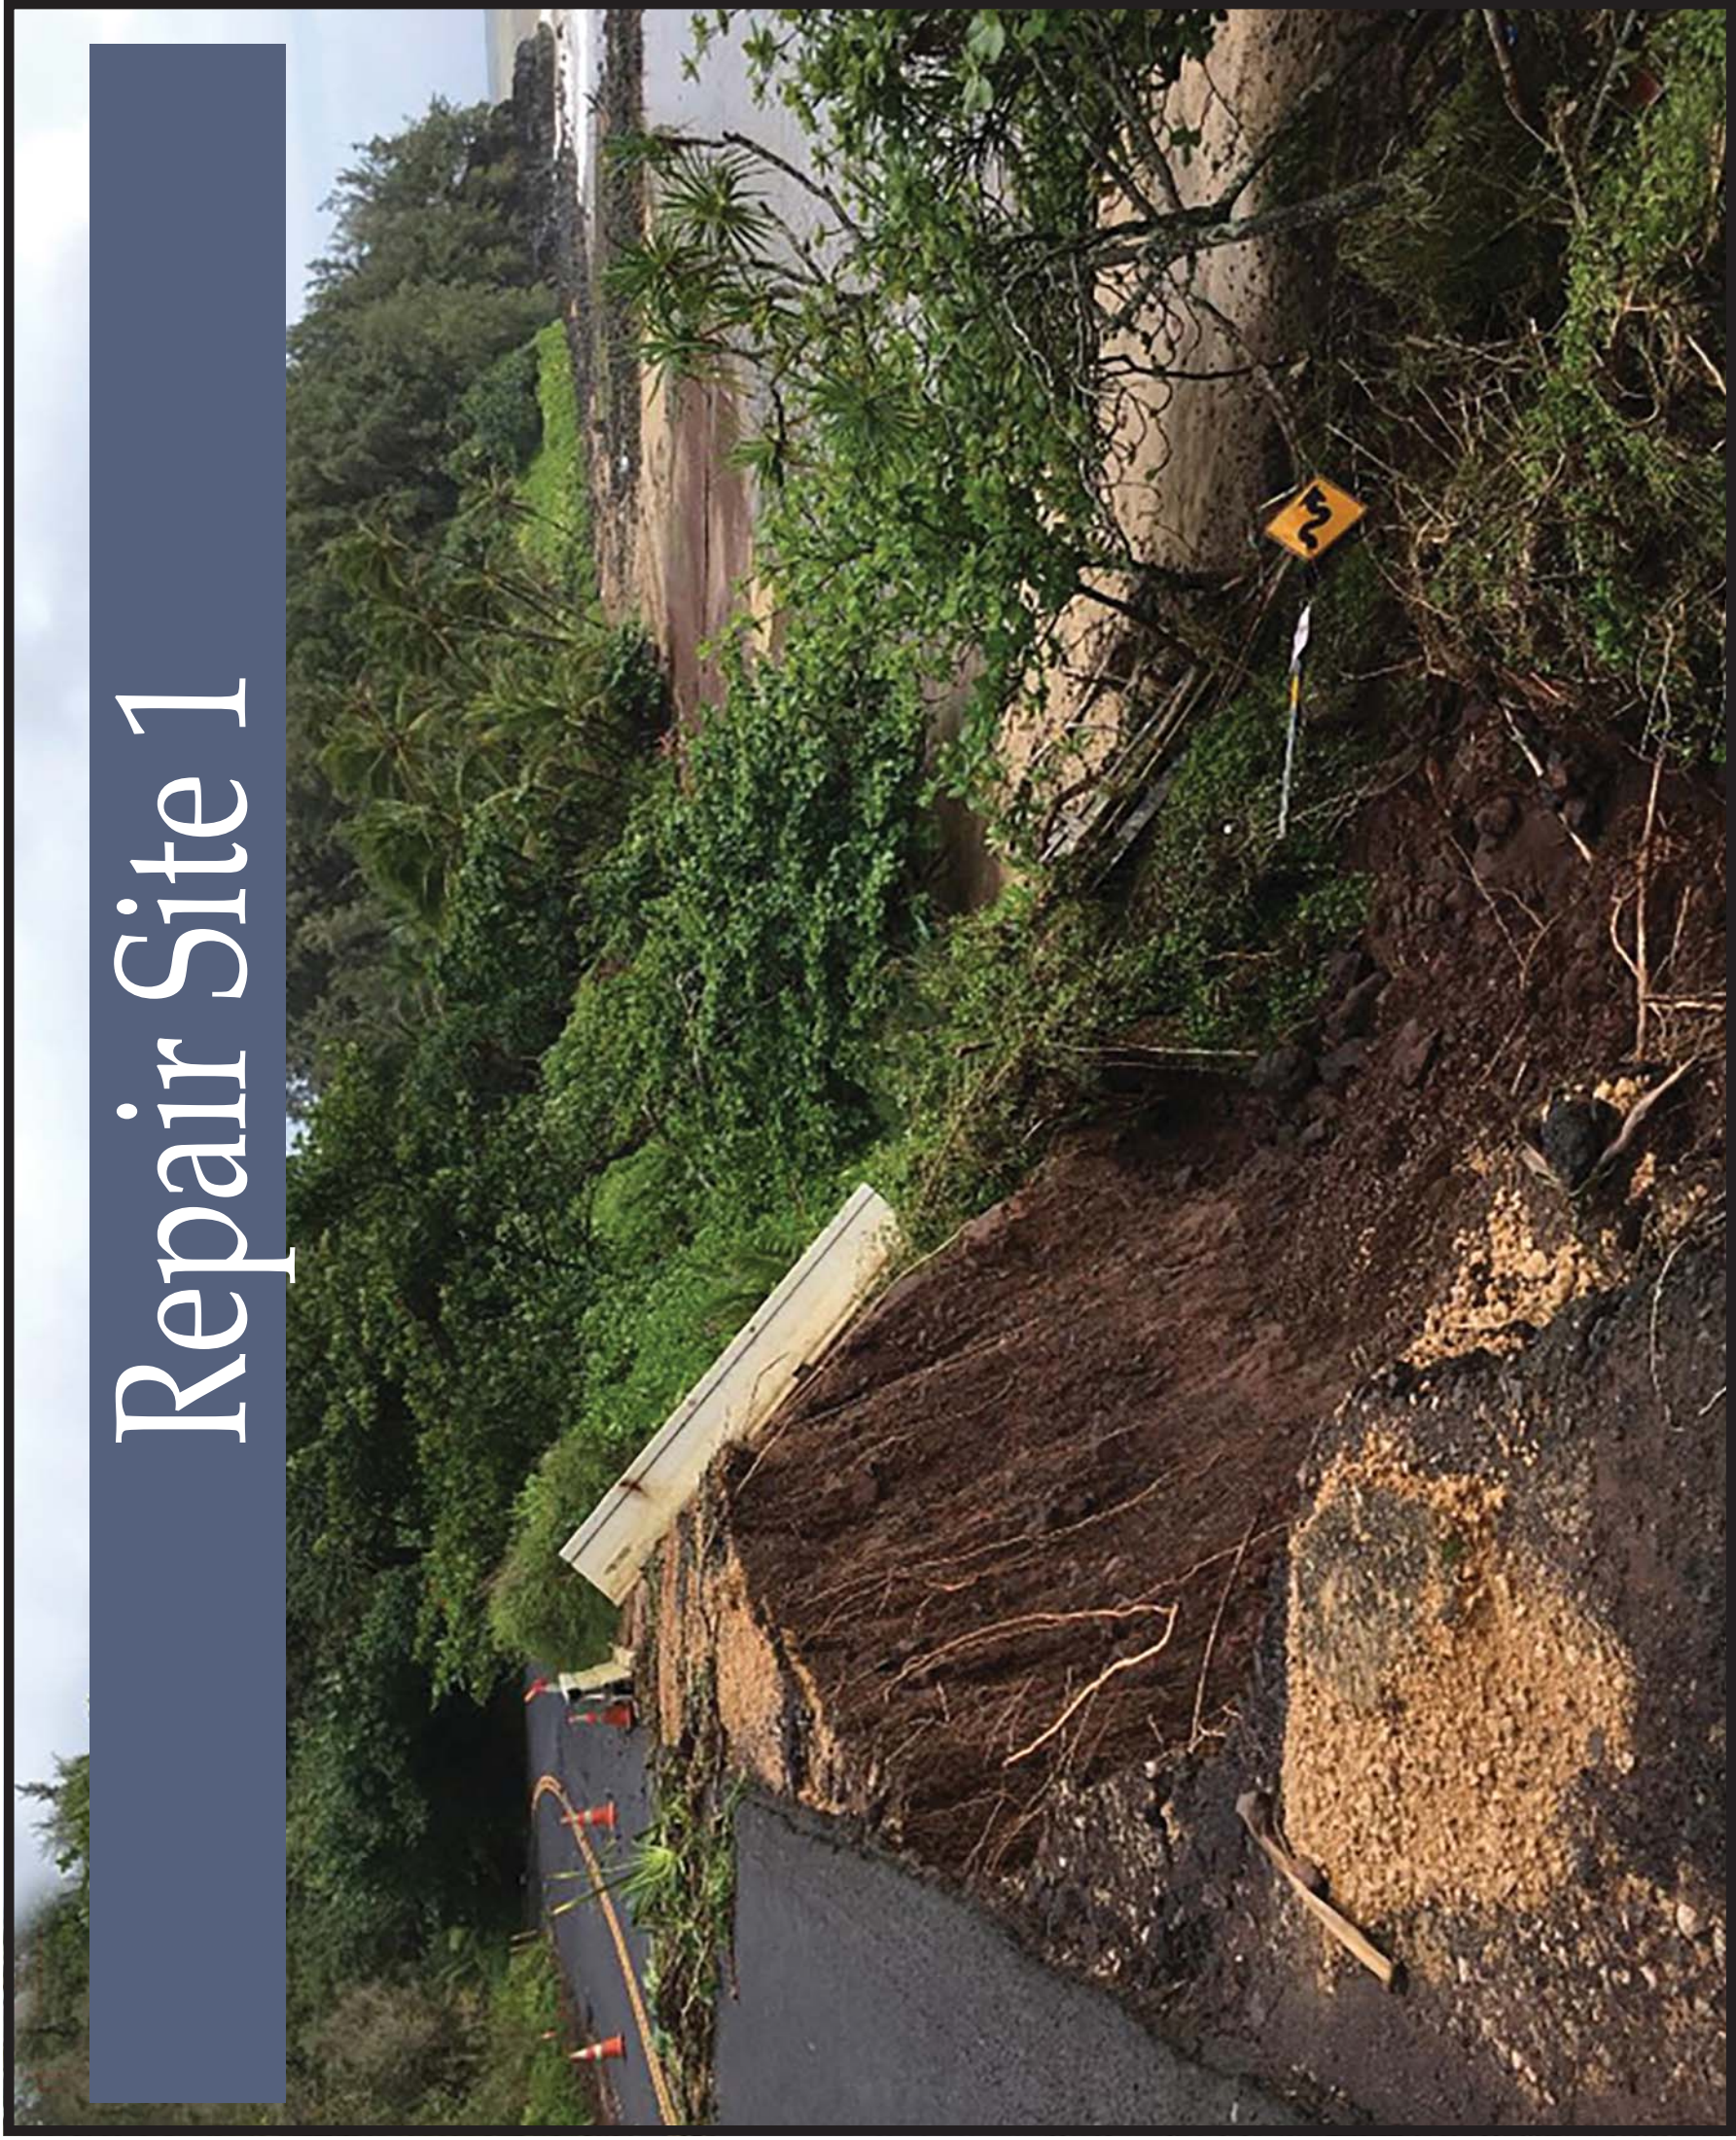
**Description of Repair Site 1:**  
Located at MP 4.5 on Kūhiō Highway, Repair Site 1 is a roadway stabilization area that requires debris removal, slope wall installation including soil nails, foot of slope revetment, guardrail /sign replacement, and pavement repair.

**Status:**  
Construction is in progress for both sites. Environmental review and permitting is being pursued at the same time as the construction repairs occur.

**Est. Construction Completion:**  
Completion is dependent on bridge replacements to allow heavy materials and equipment for revetments.
