## Kaua'i Emergency Flood Repairs and Cleanup

### Various Locations

### April 2018

### Public Informational Meeting

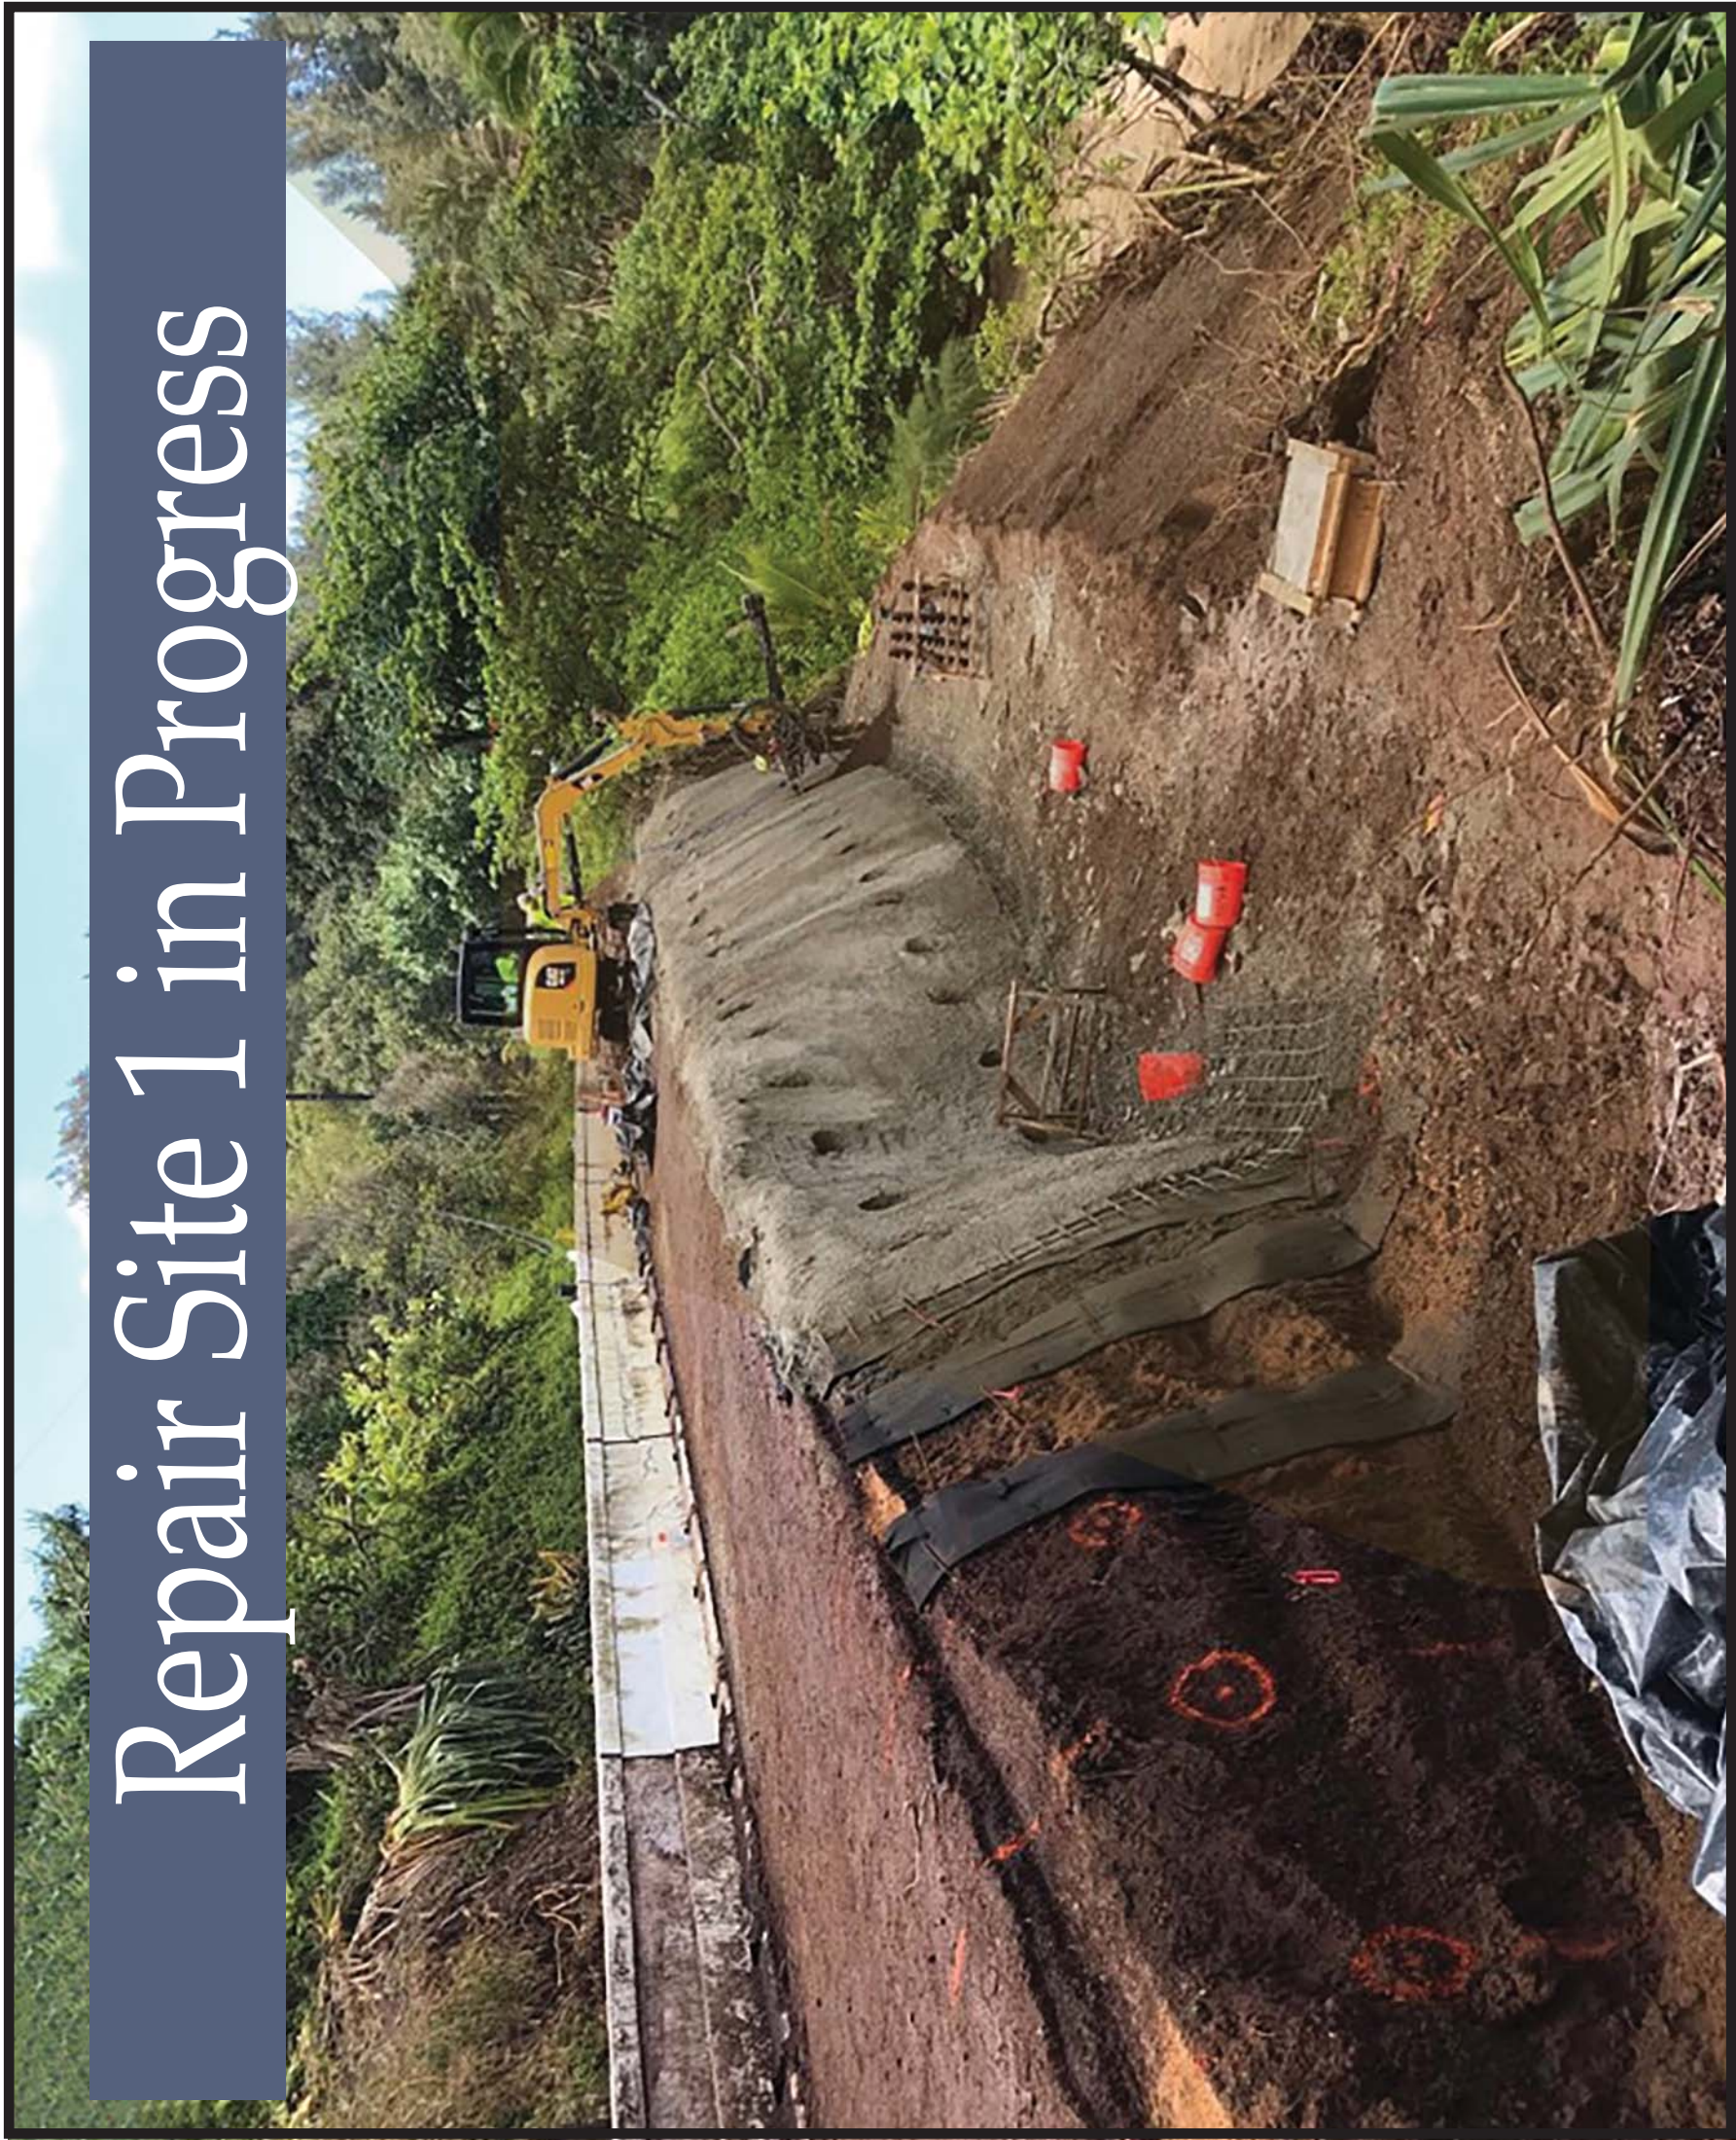
Repair Site 1 in Progress

**Description of Repair Site 1:**  
Located at MP 4.5 on Kūhiō Highway, Repair Site 1 is a roadway stabilization area that requires debris removal, slope wall installation including soil nails, foot of slope revetment, guardrail /sign replacement, and pavement repair.

**Status:**  
Construction is in progress for both sites. Environmental review and permitting is being pursued at the same time as the construction repairs occur.

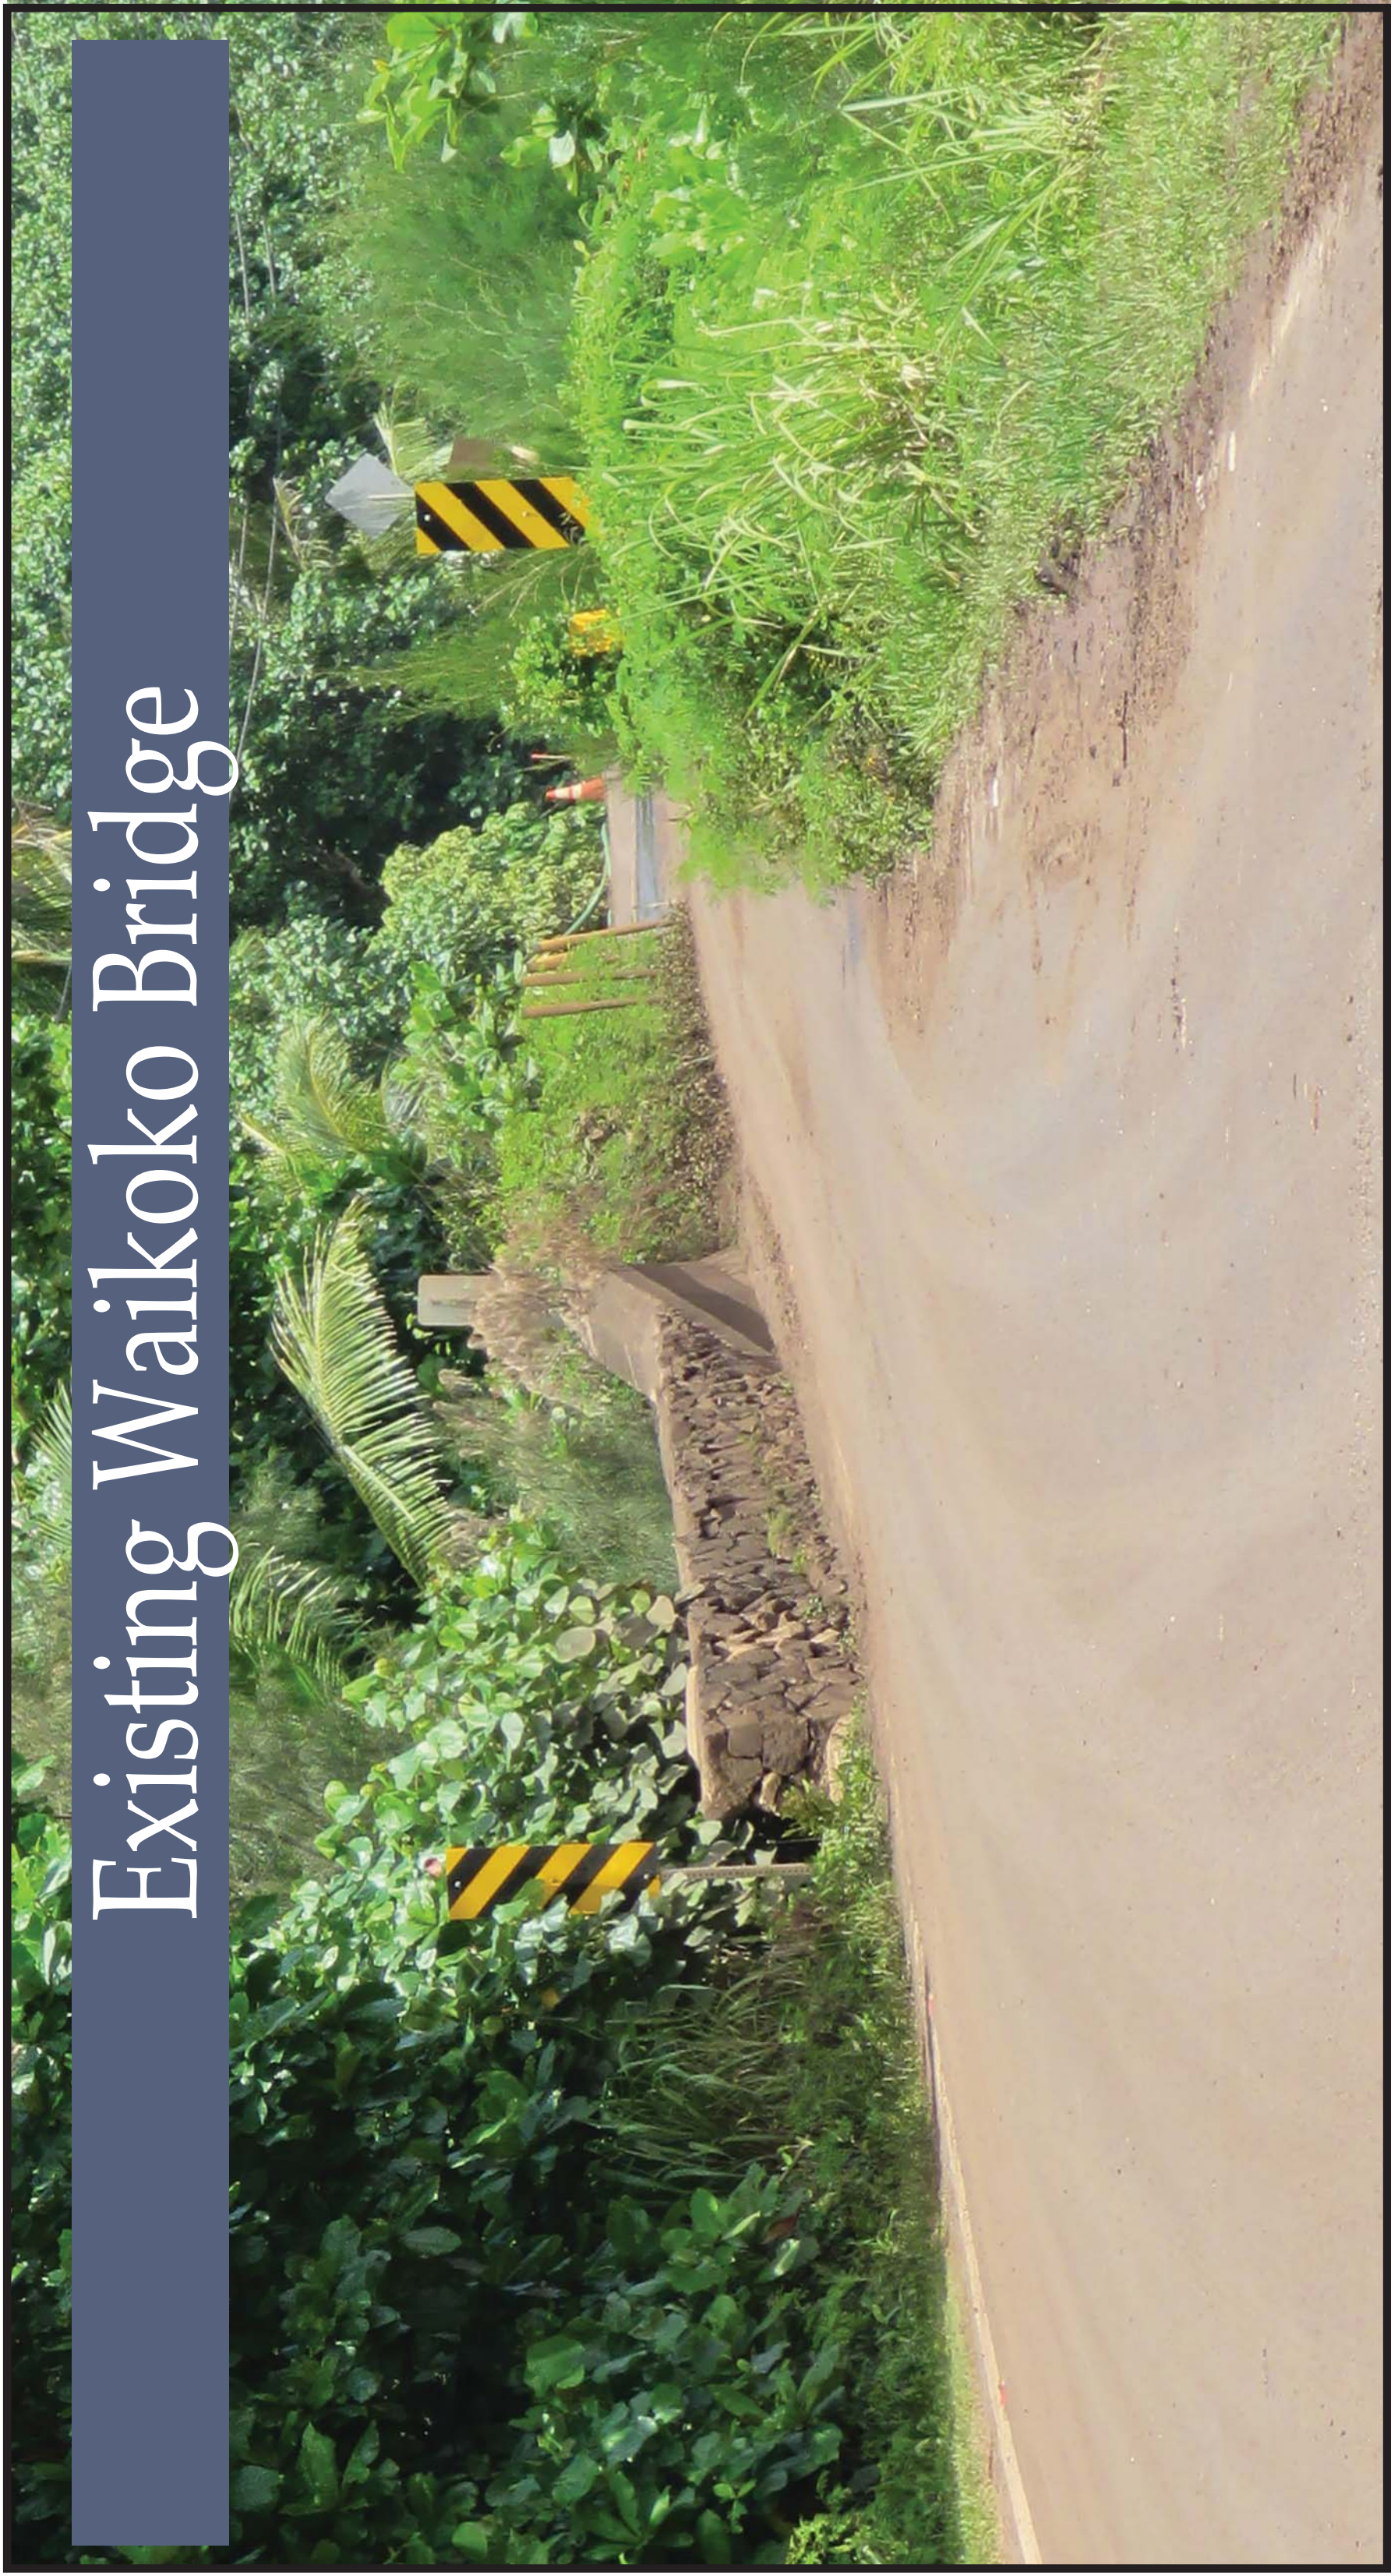
Existing Waikoko Bridge

- Kūhio Highway (Route 560) Historic Roadway Corridor Plan recognizes the deterioration, load-bearing deficiencies, and need for bridge replacement, particularly for Waikoko.
- Current 8-ton load capacity of these bridges do not allow for equipment with enough reach and capacity to remove the dirt material, and place the boulder revetments needed at the repair sites.
- In addition to the revetment repairs, it is anticipated that further stabilization of the up-slope reaches will be conducted over the next two years. Some of these failures reach as high as 70 feet.
- HDOT has considered numerous alternatives, however, those alternatives carry additional environmental impacts and do not address the long-term issues of the bridge deficiencies.
- Replacement of these bridges is considered an adverse effect to these historic resources.

| No. Location on Kūhiō Highway | | Repair Description | Progress |
|---|---|---|---|
| 10 | Waikoko Bridge (Route 560) | Replace existing bridge | In design and permitting, anticipated start late June. |

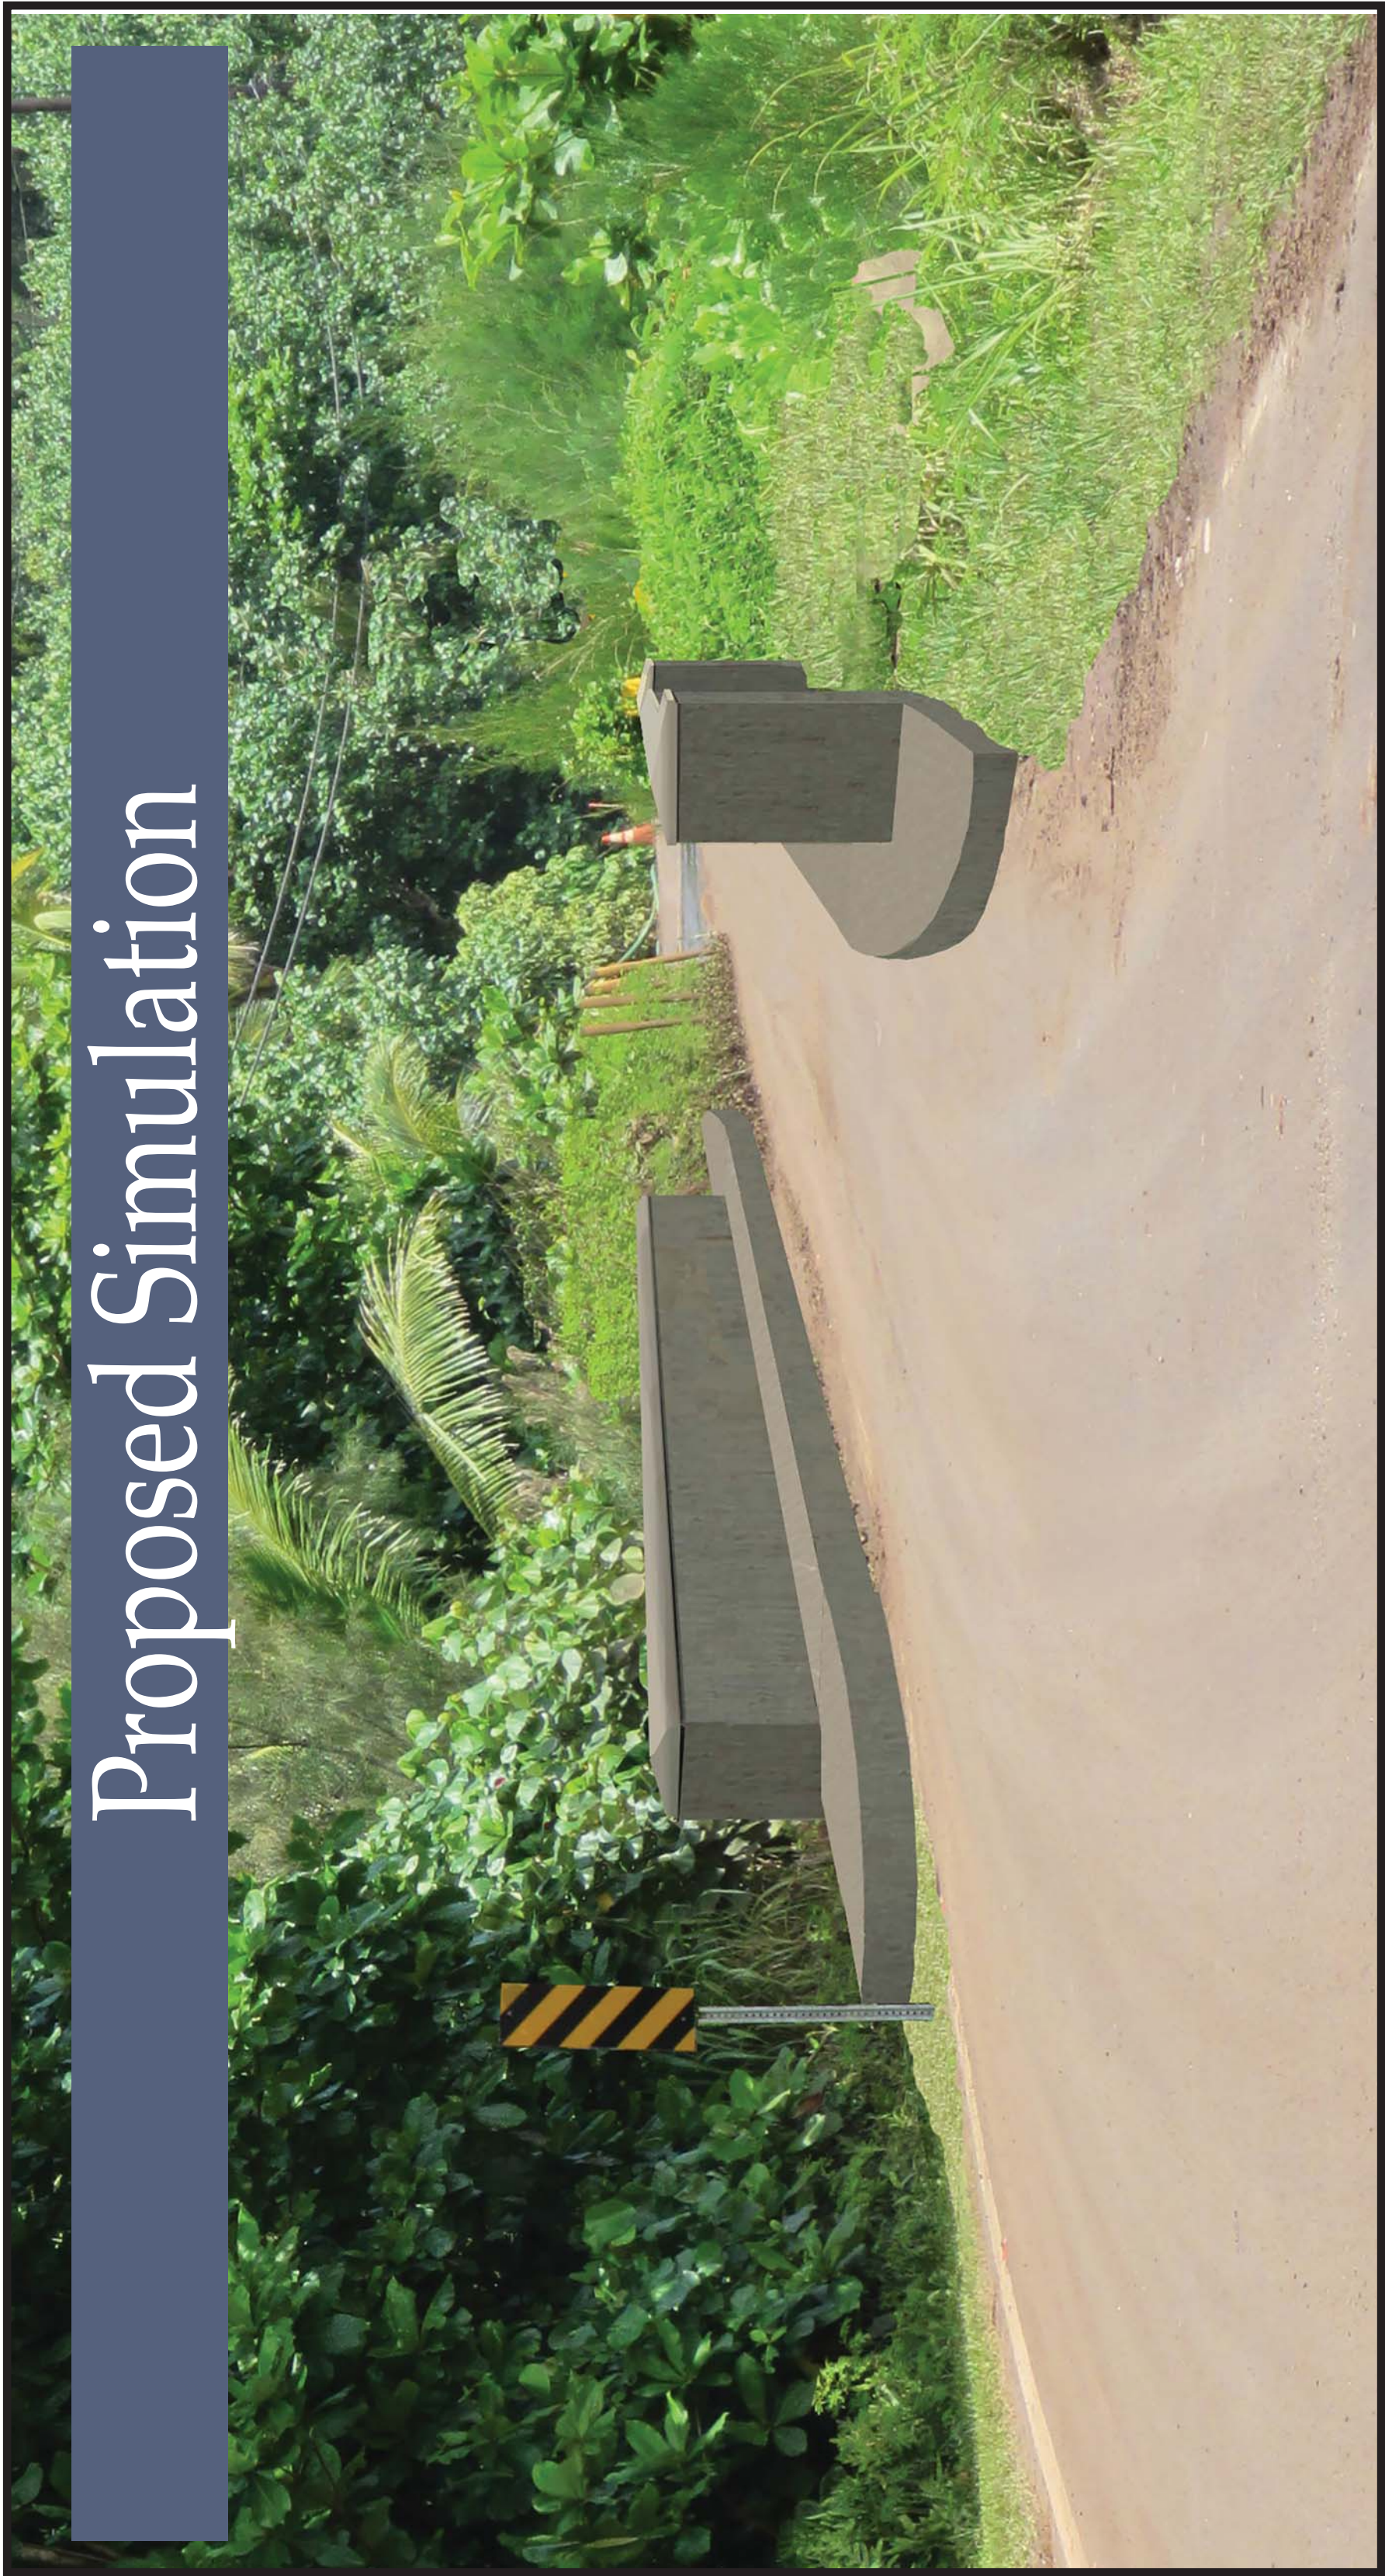
Proposed Simulation

- Designs will maintain the character-defining qualities of the existing bridges: single-lane operations; narrow width no sidewalks; solid reinforced-concrete parapets; and flat slab, or girder structural systems.
- Construction will occur primarily at night to minimize impacts to the community.

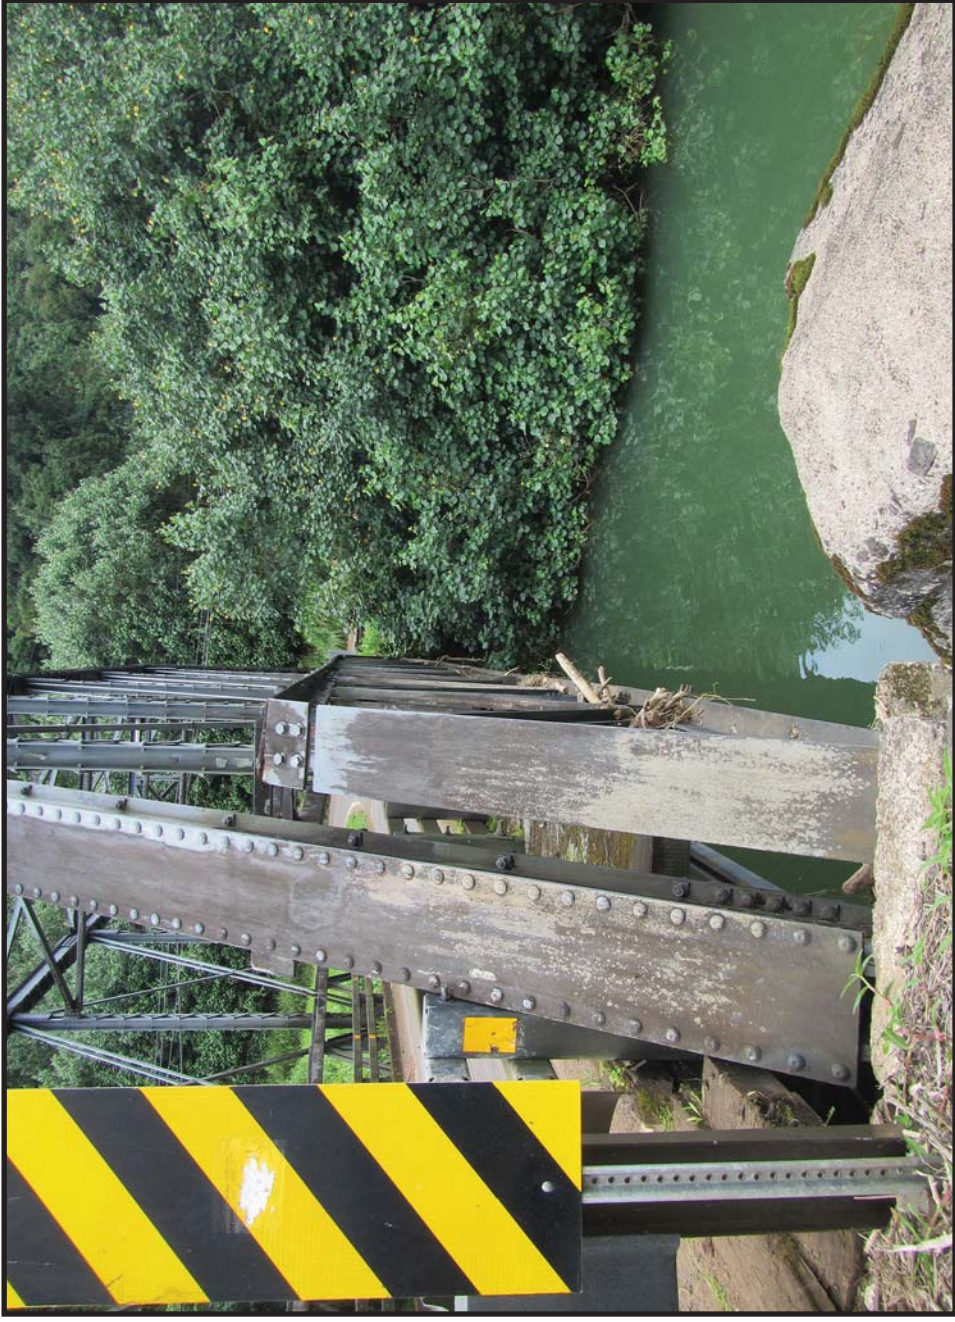
**Description of Repairs:** Repairs at MP 1 include debris removal, slope scaling, guardrail replacement, minor pavement repair. Repairs at MP 0.5, near Hanalei Bridge involve debris removal and slope clean-up.

Debris from flooding on bridge

**Status:** Repairs are complete.

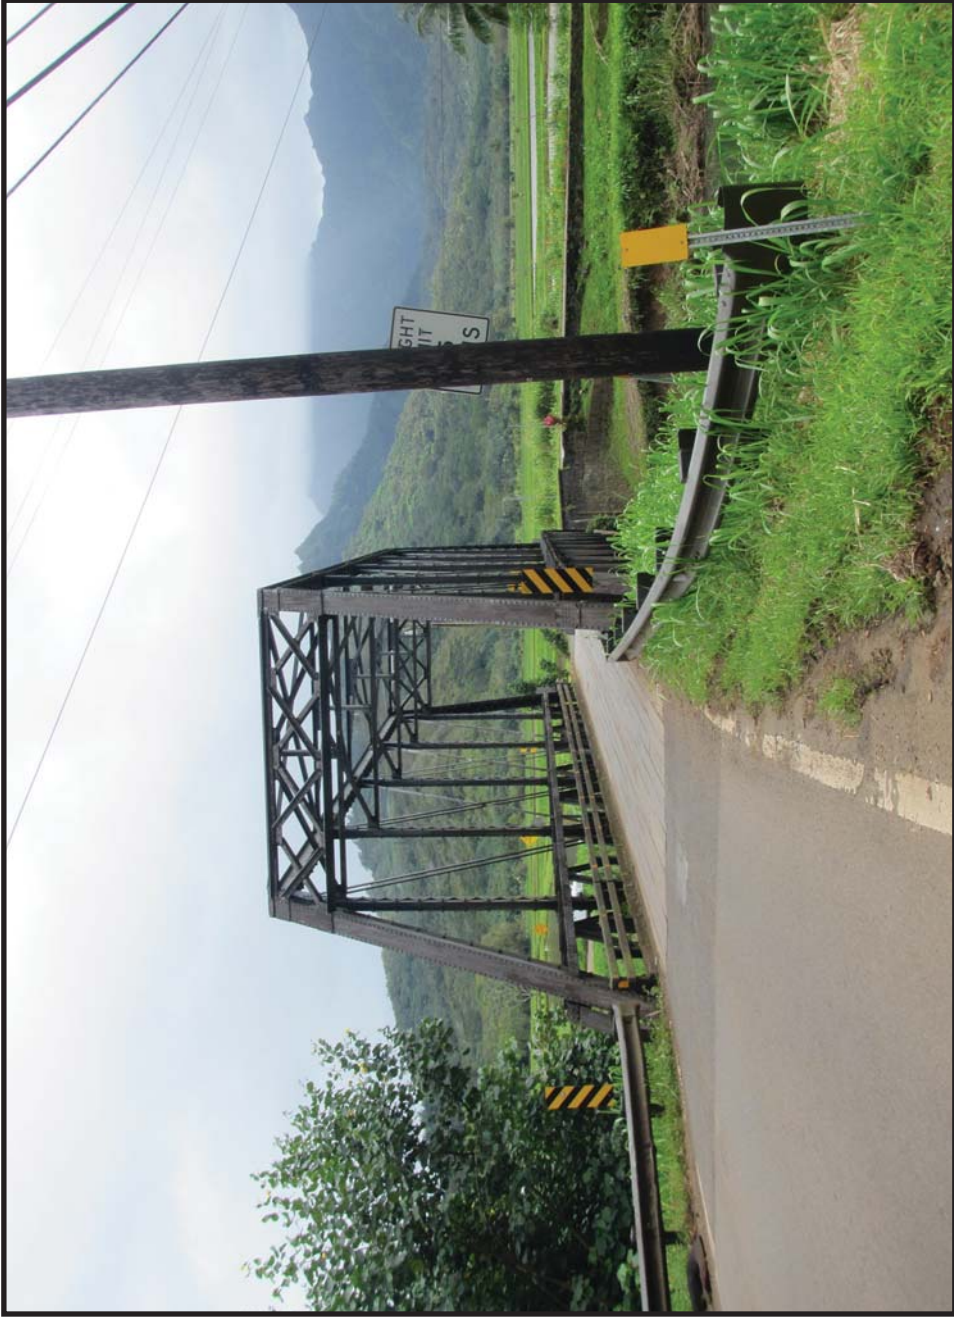
Bridge access
