2014 ANNUAL COMPLIANCE REPORT
STORM WATER MANAGEMENT PROGRAM

HONOLULU HARBOR NGPC HI 03KB482
KALAELOA BARBERS POINT HARBOR NGPC HI 03KB488

DEPARTMENT OF TRANSPORTATION, HARBORS DIVISION
79 South Nimitz Highway
Honolulu, Hawaii 96813

January 28, 2015

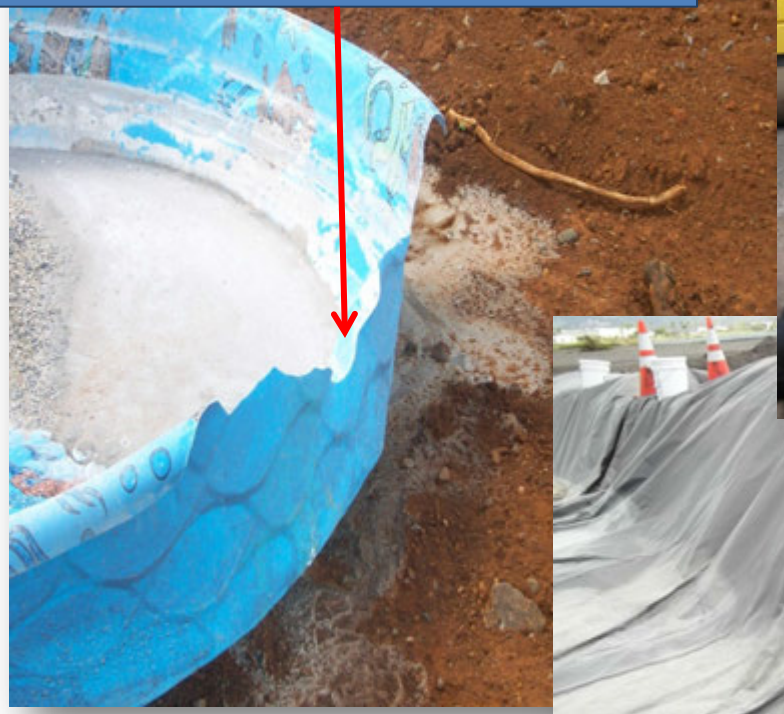
Kiddy pools degrade quickly due to corrosive washwater.

Cover / dispose when full.

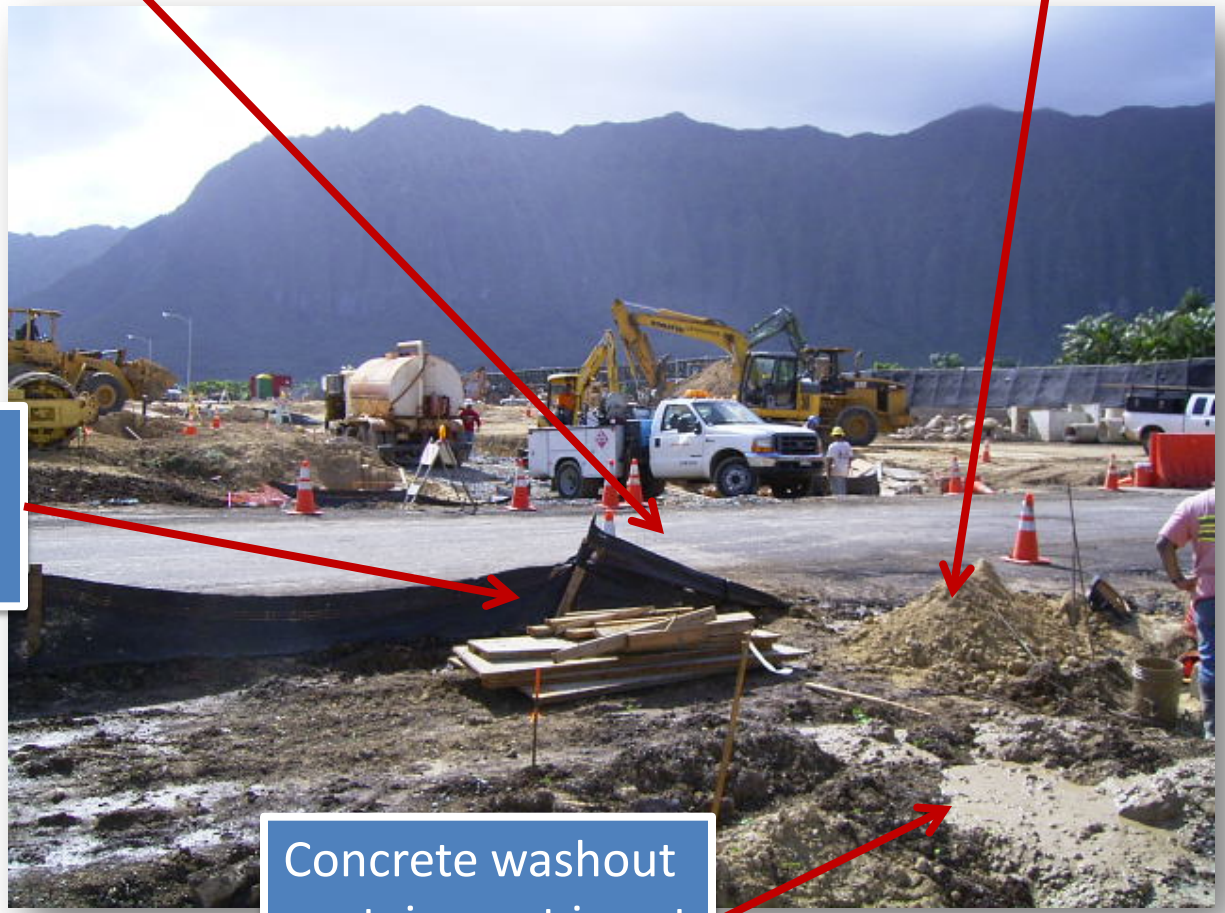
Stockpile is not contained.

Silt fence is not properly installed or maintained.

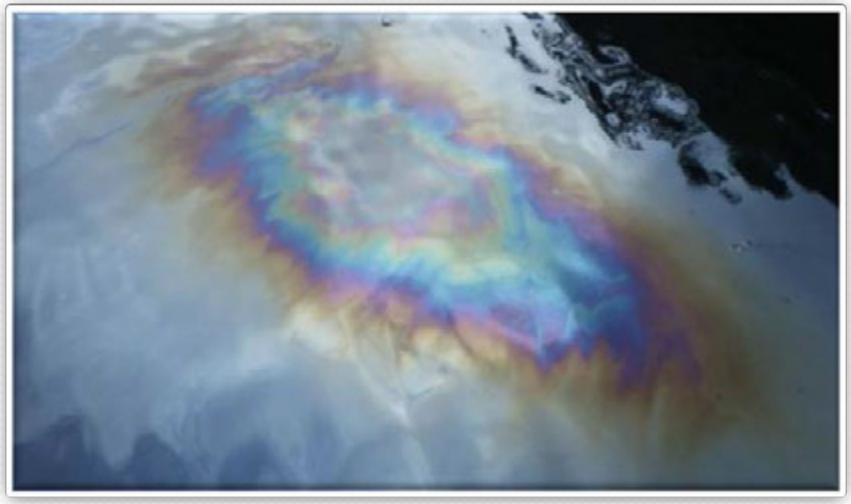
✓Petroleum Sheen During Rain Events and Debris from Painting Operations

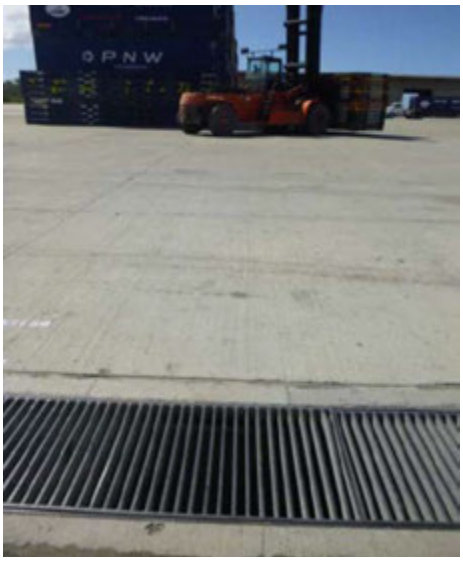
Outfall ID		**BP-01**	
Pier			
Land Use		Industrial	
Type		Closed Pipe	
Material		RCP	
Shape		Box	
Grouping		Single	
Dimensions		72 in x 18 in	
Submerged	Partially	Open Drainage	No
Outfall Characterization		Unlikely

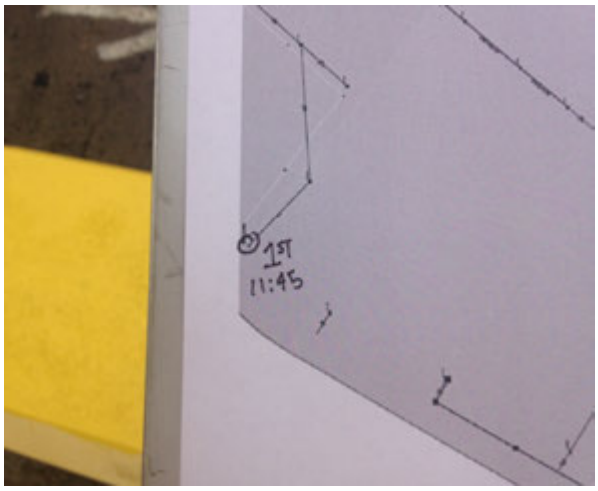
Photo 1 Description: Photo showing location data and notes.	**Photo 2 Description**: View of parking lot from outfall SDD 0170. Perimeter of construction site is outlined by the black dust fence highlighted above.
Photo 3 Description: Foot marker 1750 denoting where outfall SDD 0170 is located.	**Photo 4 Description:** Photo of outfall SDD 0170 taken directly overlooking the pier. A slight sheen is seen on the water in and around the outfall.

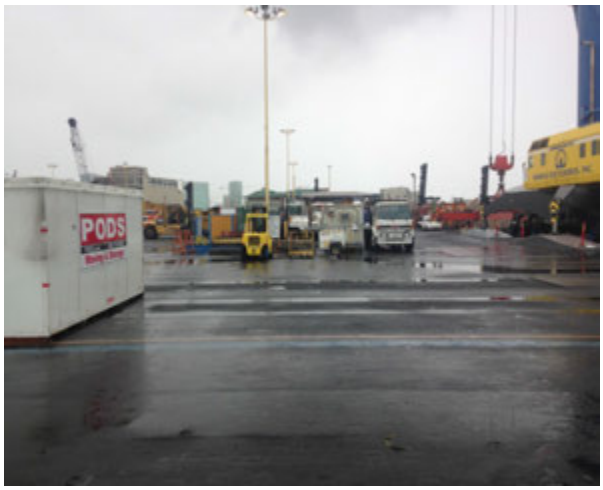
Photo 1 Description: View of pier deck from outfall "To Be Verified (DI 0202)".	**Photo 2 Description**: Foot marker 2200 denoting where "To Be Verified (DI 0202)" is located.
Photo 3 Description: View of water from directly above the pier. A slight sheen is seen in and around the outfall location with some leaves scattered on top of the water.	**Photo 4 Description:** A closer look at the slight petroleum sheen observed at outfall "To Be Verified (DI 0808)". Leaves are seen scattered on top of the water.
