Preliminary Baseline Assessment of Reef Coral Community Structure in the Vicinity of the Wharf in Hāna Bay

**PRELIMINARY BASELINE ASSESSMENT OF REEF CORAL COMMUNITY STRUCTURE
IN THE VICINITY OF THE WHARF IN HANA BAY
HANA, ISLAND OF MAUI**

June 15, 2010

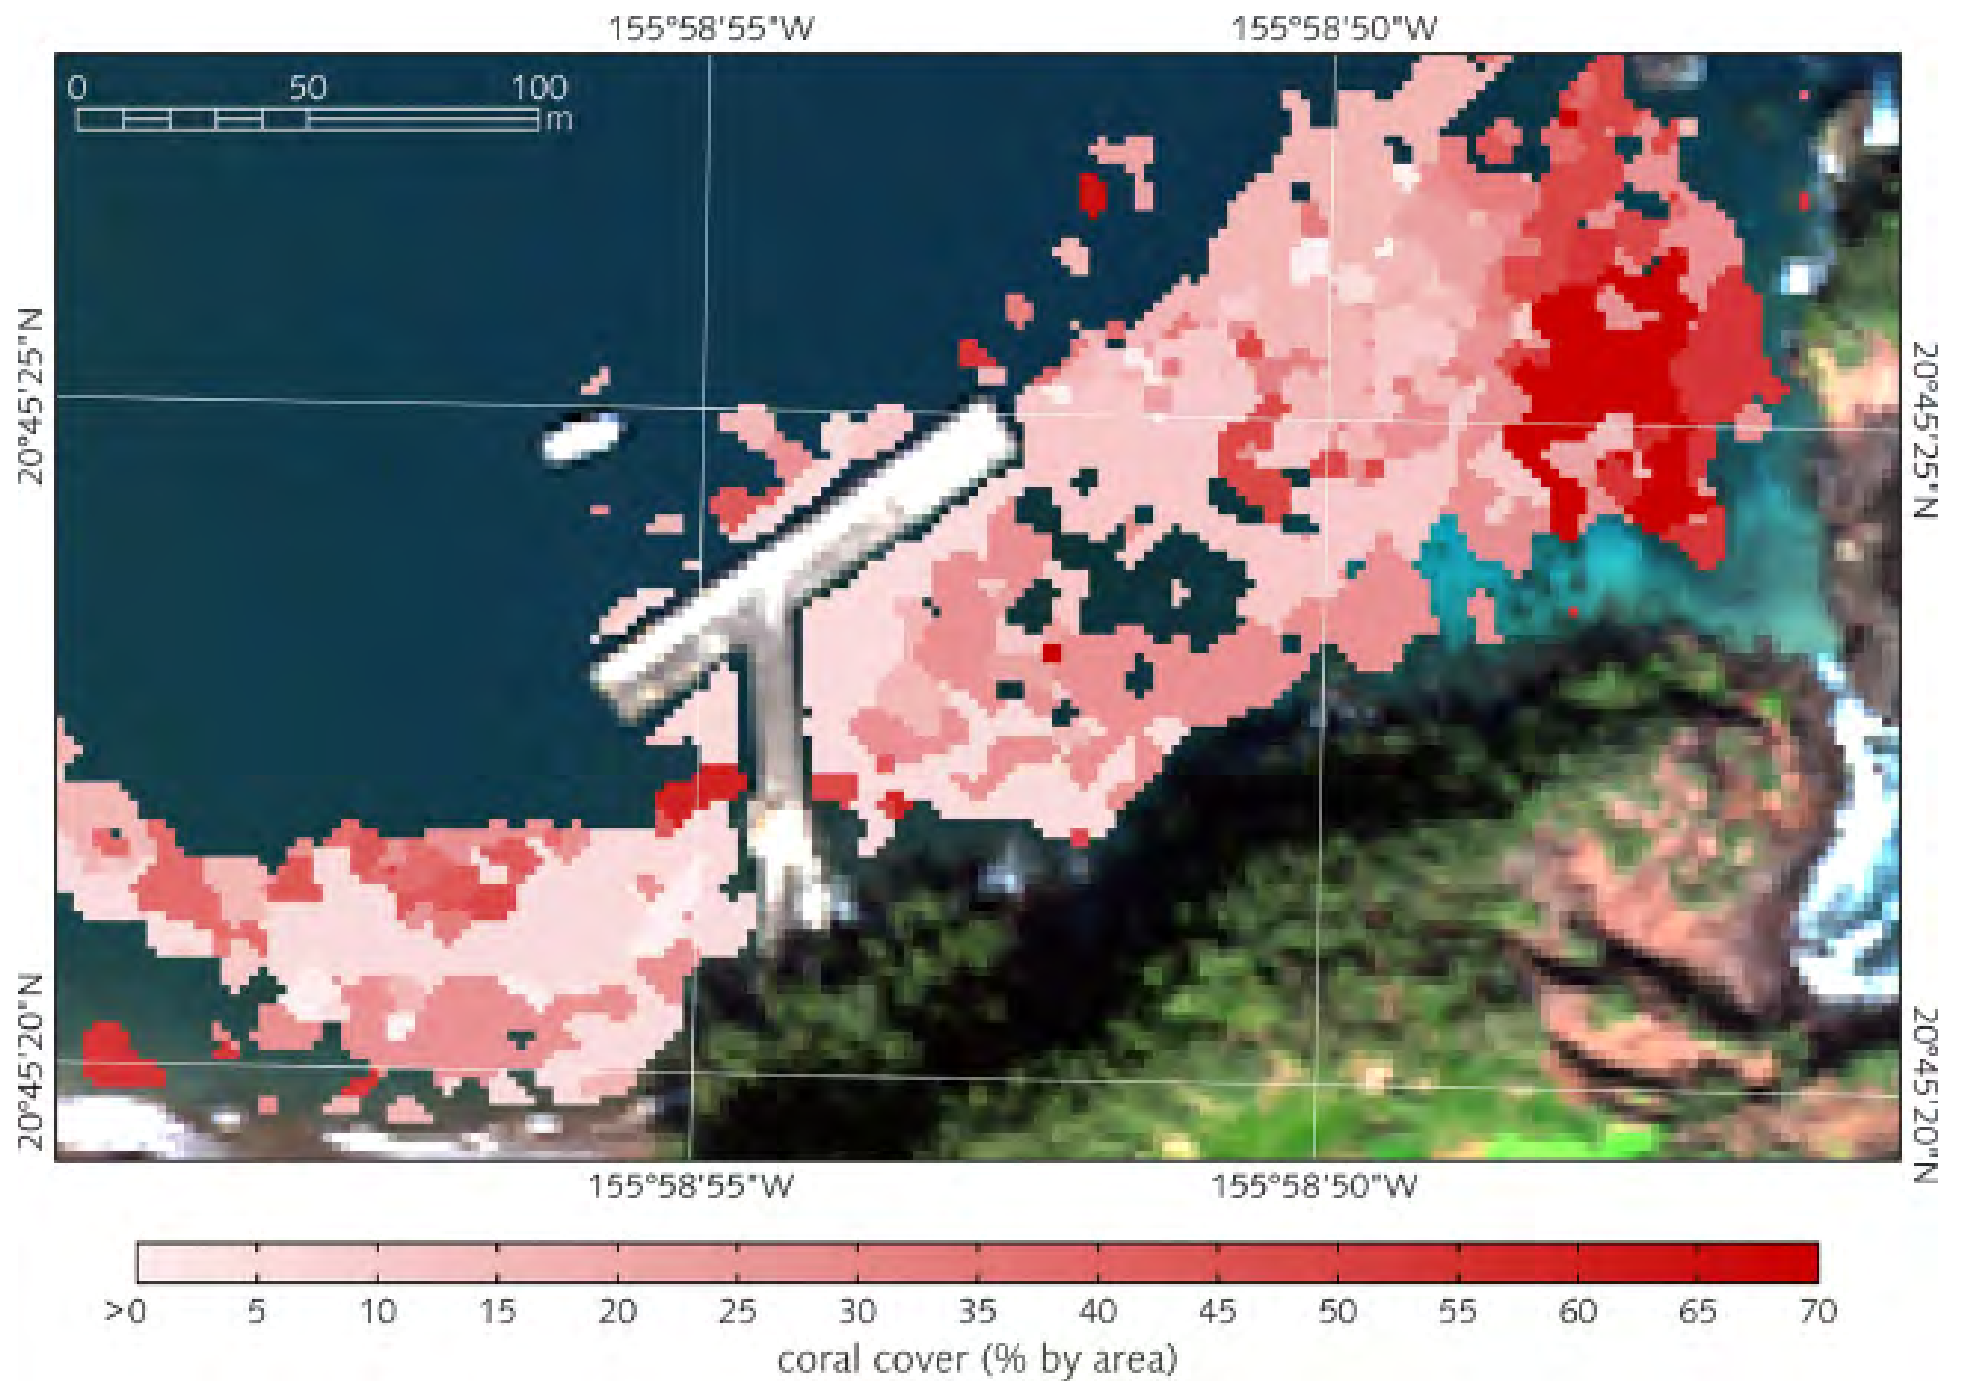
Composition of the bottom, both in terms of living community structure and abiotic bottom types varies substantially throughout the study area. Distribution of coral throughout the survey area is shown in the map in Figure 4. It can be seen that coral cover is highest in the northeastern end of the study area with various zones of abundance throughout the area.

FIGURE 4. Worldview II satellite image of southeastern section of Hana Bay, Maui showing color-coded abundance of coral throughout survey area. Areas with no coral show as green; areas with coral show as shades of pink to red.

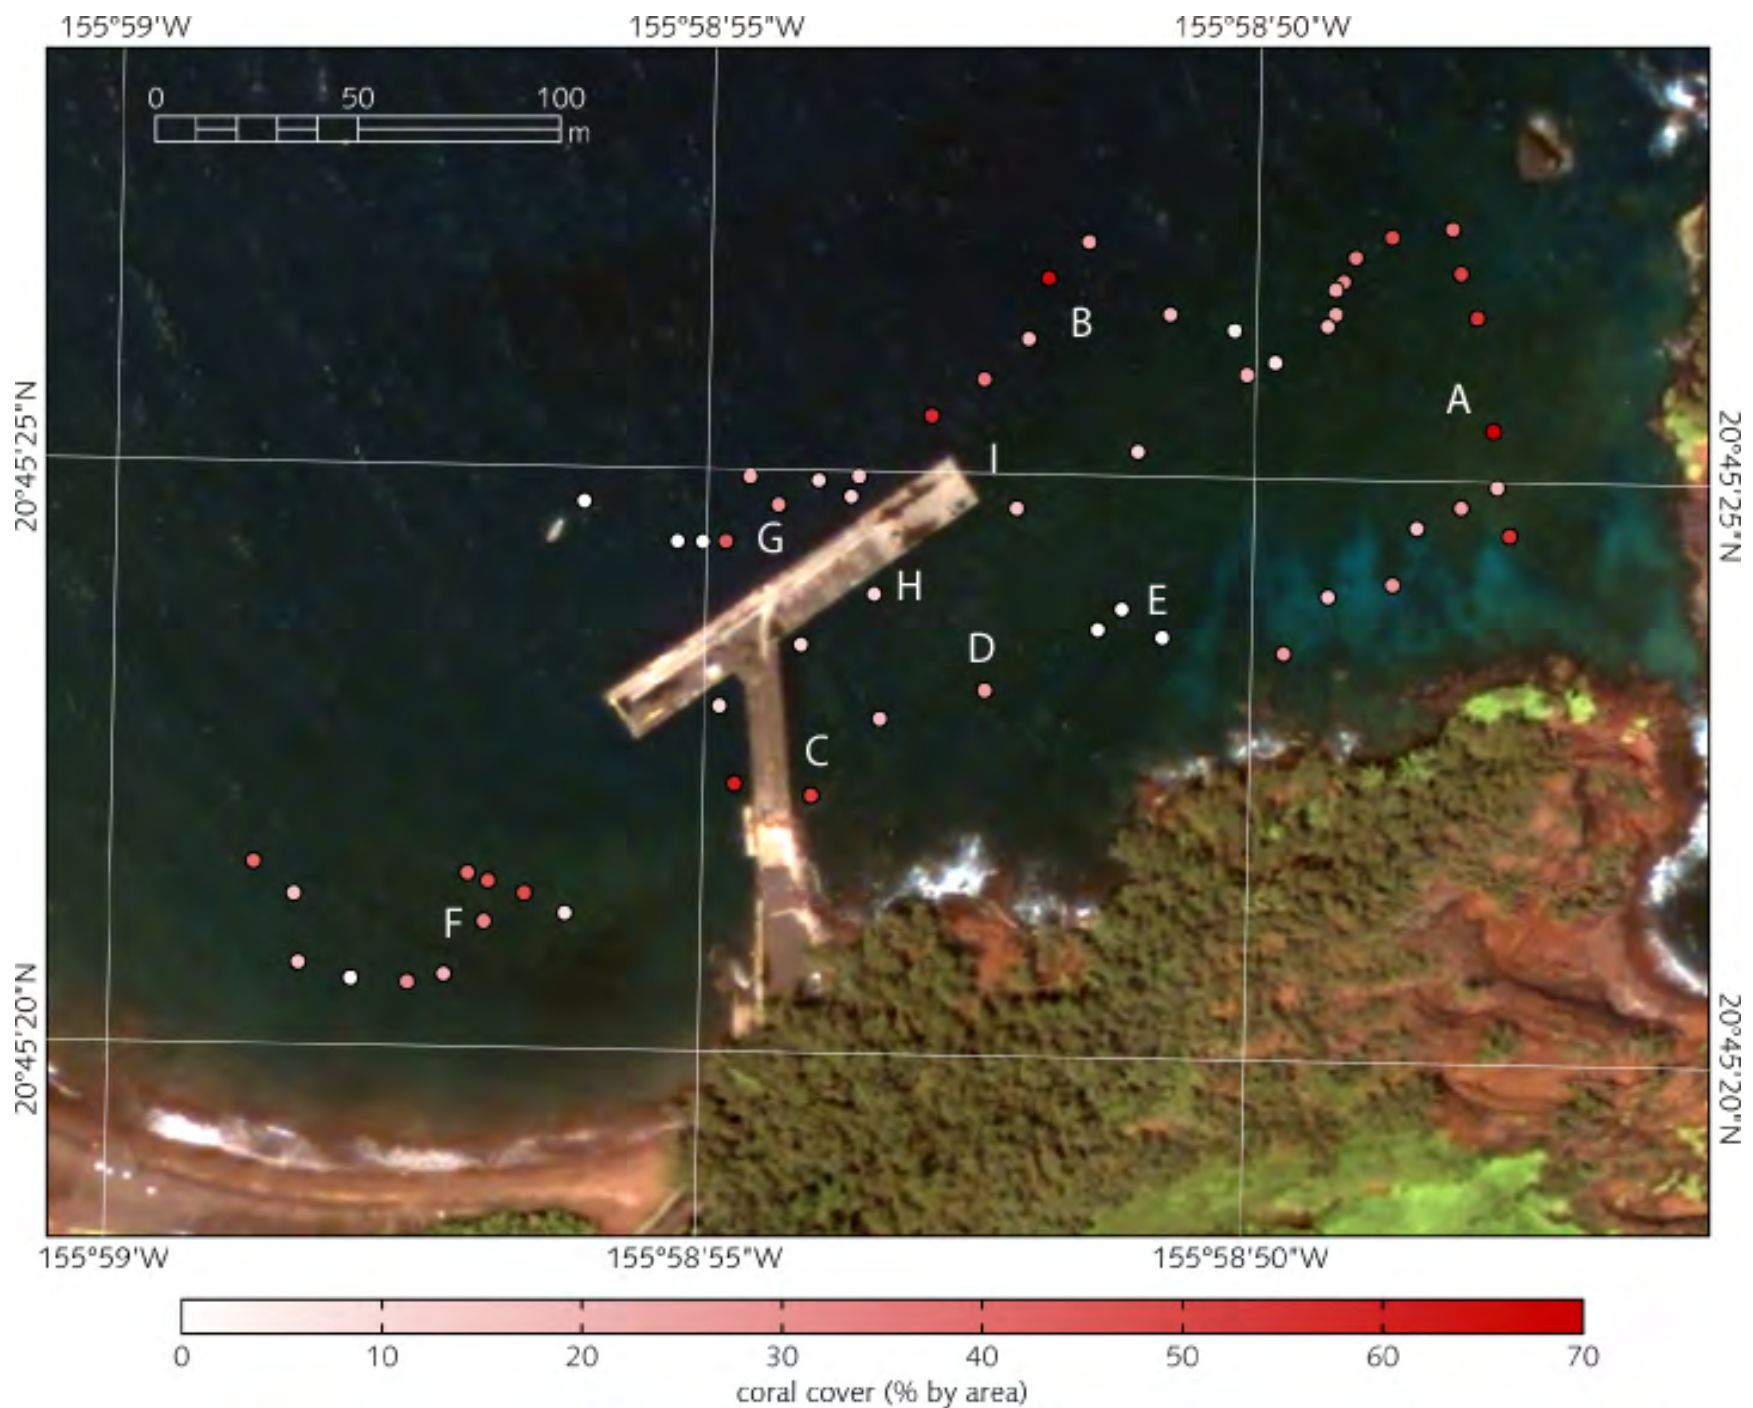
FIGURE 5. Satellite image of southeastern region of Hana Bay showing wharf and surrounding reef areas. Circles show locations of survey calibration/validation points color coded to indicate percentage coverage of the bottom with living coral. Letters A-F designate various benthic zones discussed in text.

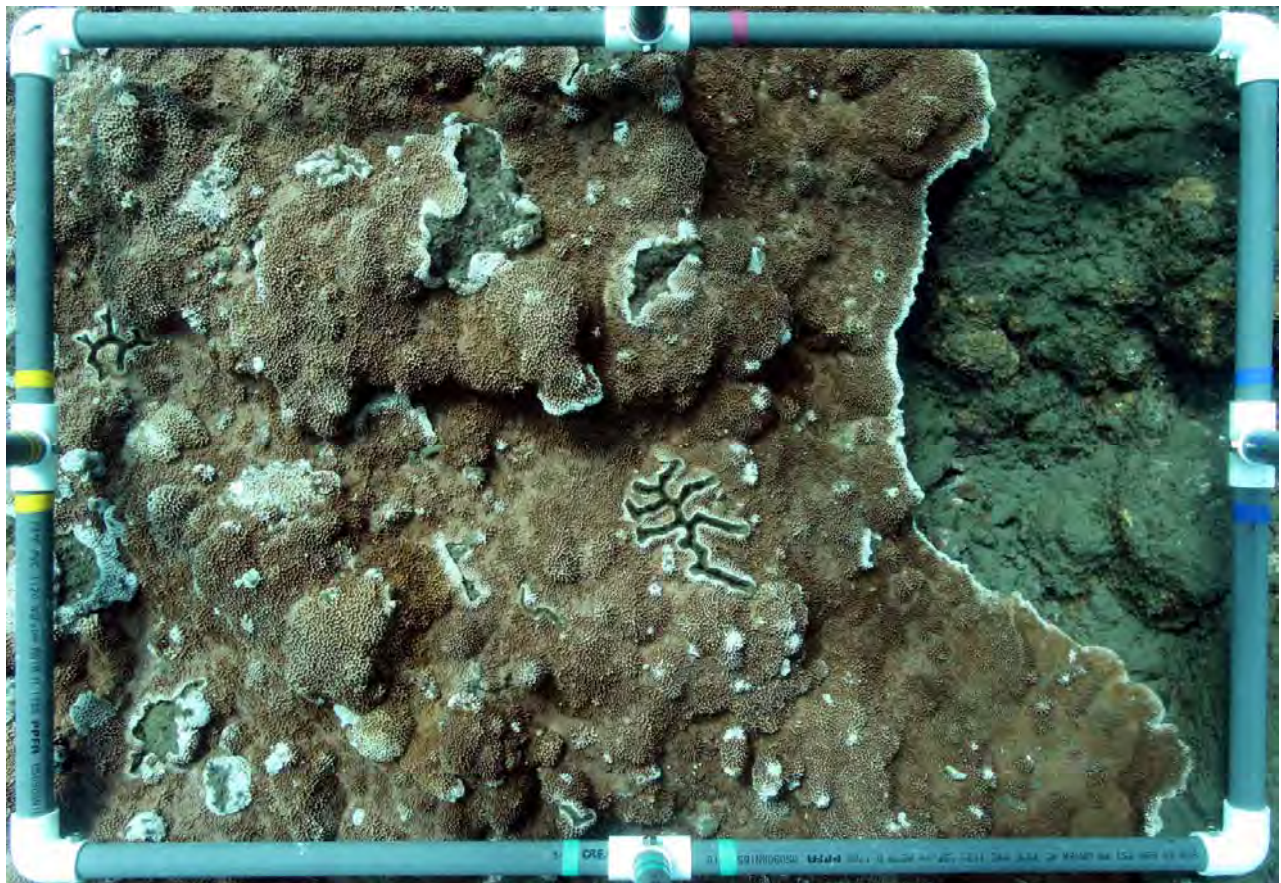
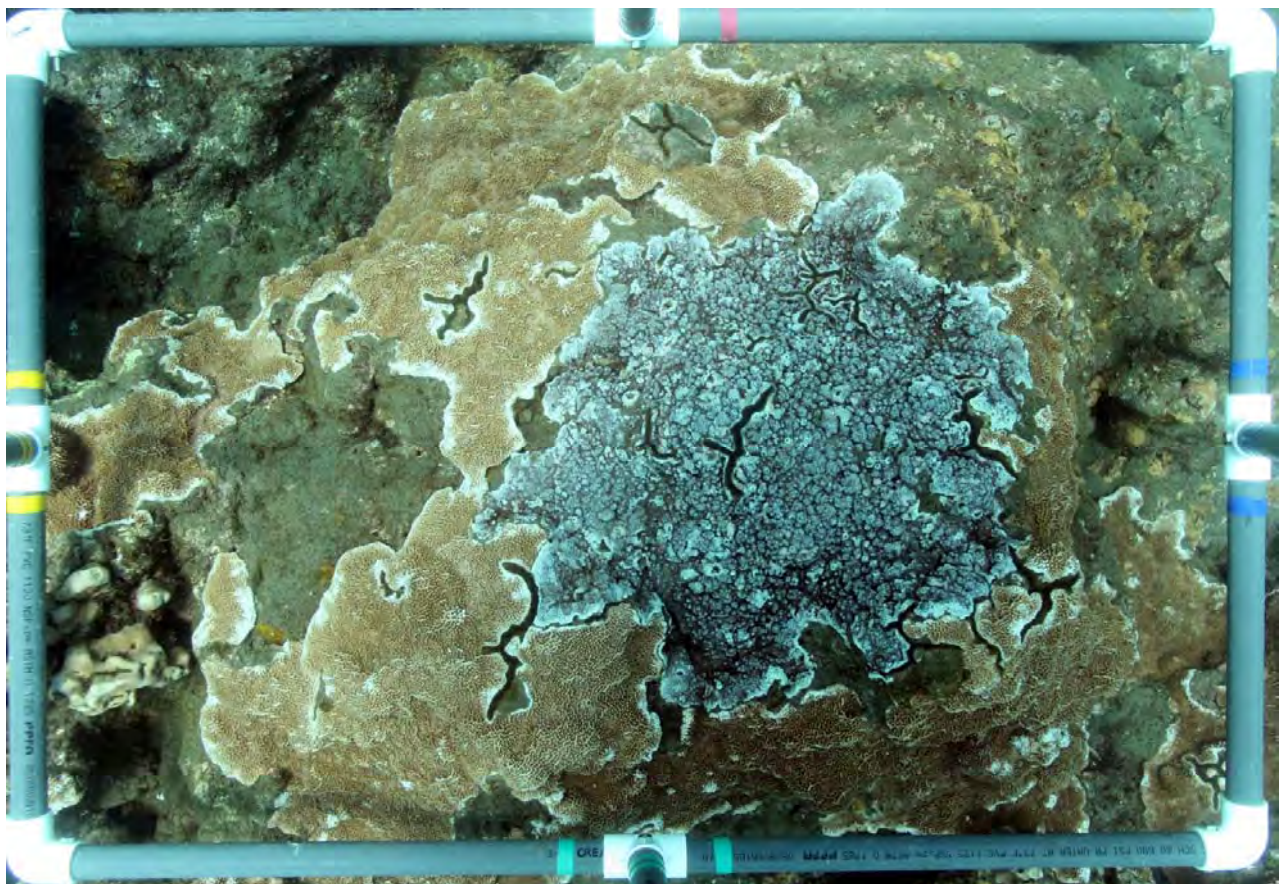
FIGURE 8. Two photo-quadrats showing encrusting colonies of *Montipora capitata* (brown) and *Montipora flabellata* (blue). Photo-quadrats were collected at sites off the west side of wharf in Hana Bay, Maui (Region G in Figure 5).

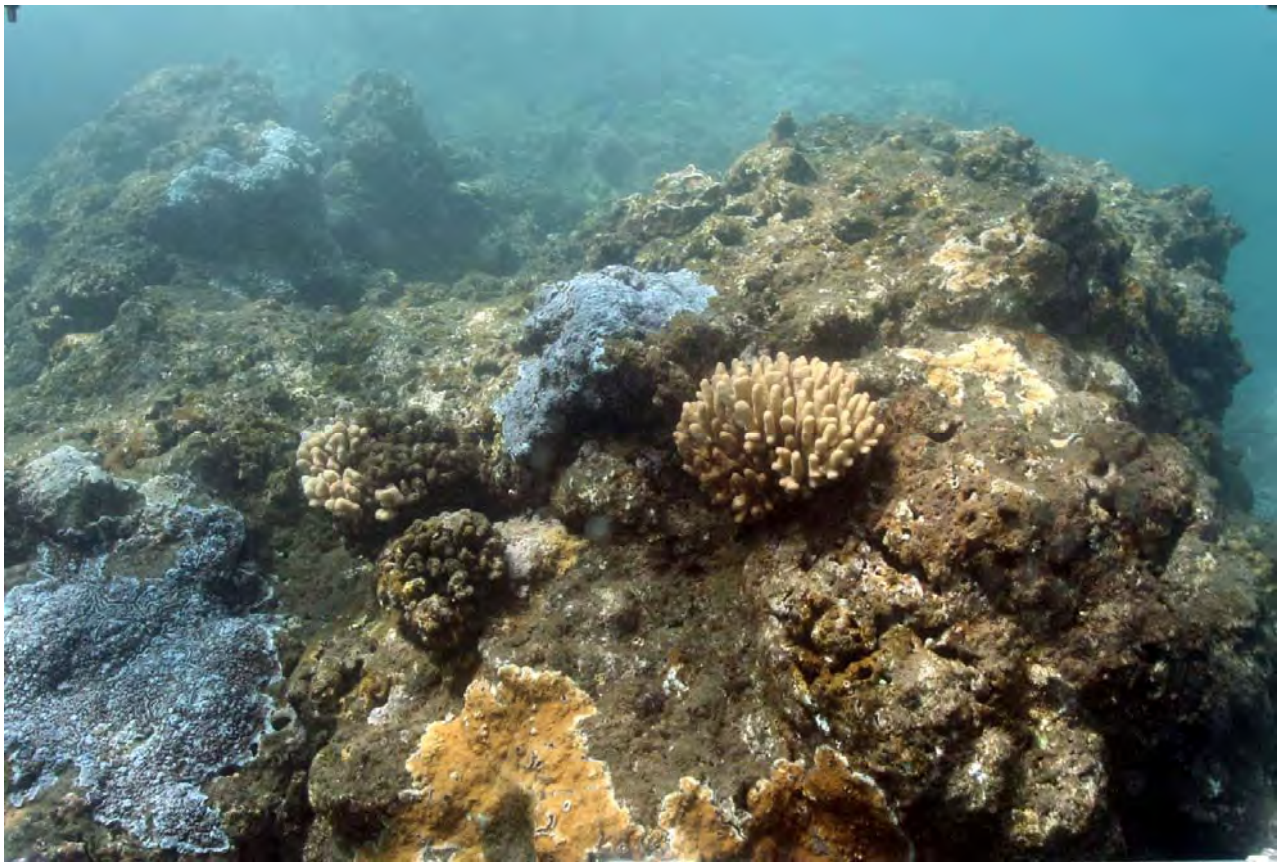
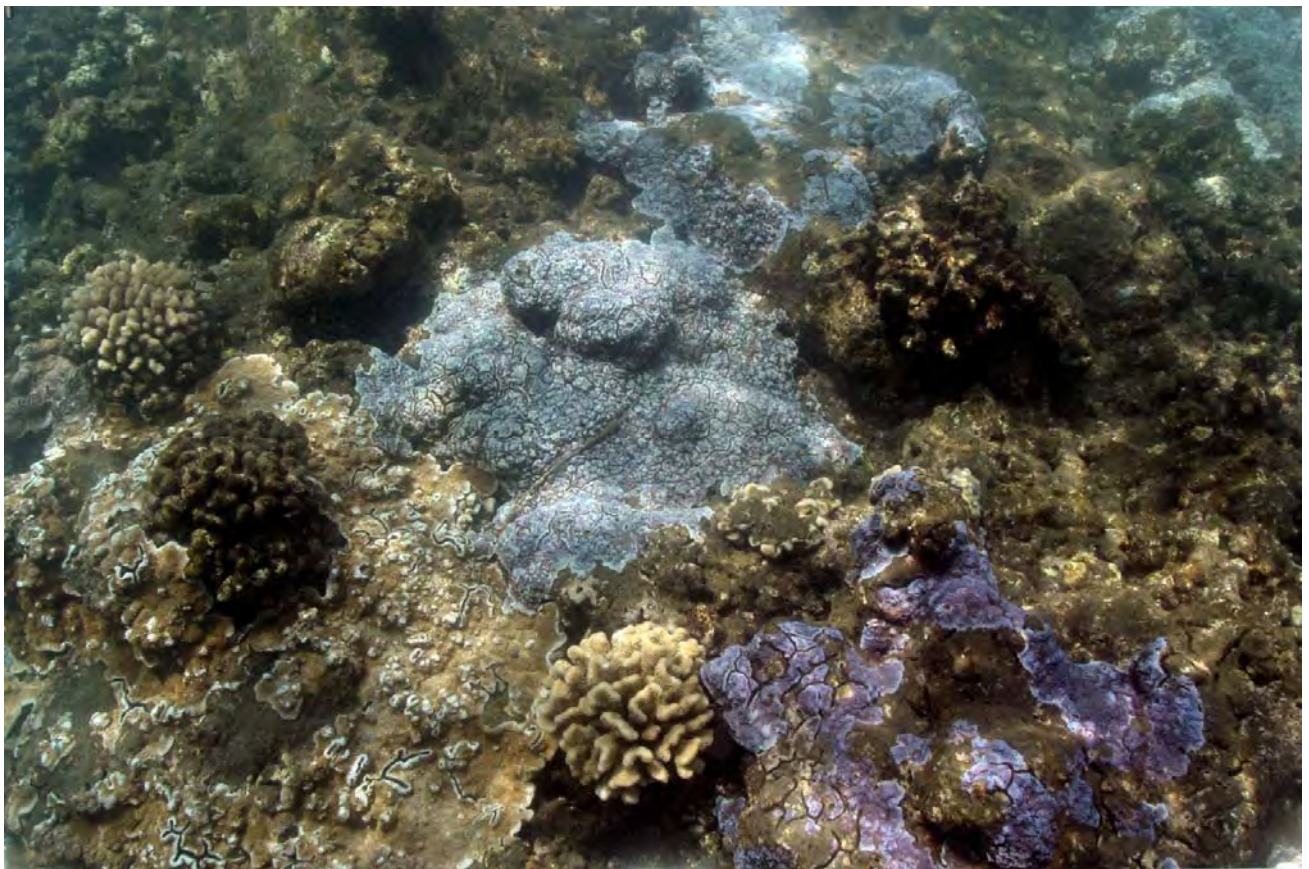
Moving toward the wharf on the outer edge of the reef platform, bottom angle slopes sharply to the sand channel floor (Region B in Figure 5). The reef slope is colonized by a variety of coral species, particularly “mats” of the short branched coral *Pavona duerdeni* (Figure 9). In addition, dominant coral species on the outer reef edge and slope are large dome-shaped colonies of *Porites lobata*, hemispherical branching colonies of *Pocillopora meandrina*, and extensive encrustations of *Montipora flabellata* (Figures 9 and 10). Percentage coral cover in this zone ranged from approximately 20-60% (Table 3).

FIGURE 10. Edge of outer reef northeast of wharf in Hana Bay, Maui (Region B in Figure 5) Hemispherical branching coral in both photos is *Pocillopora meandrina*; purple encrusting coral if *Montipora flabellata*.

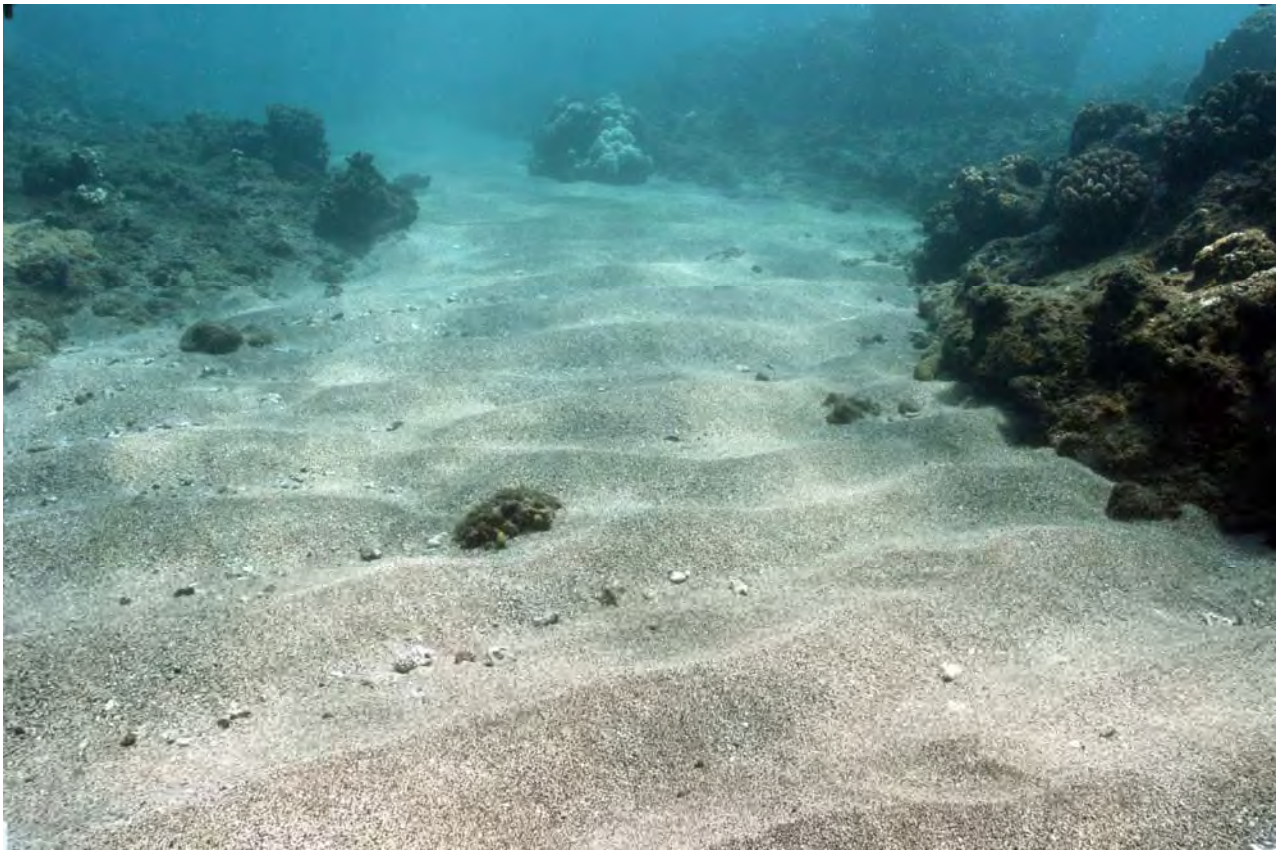
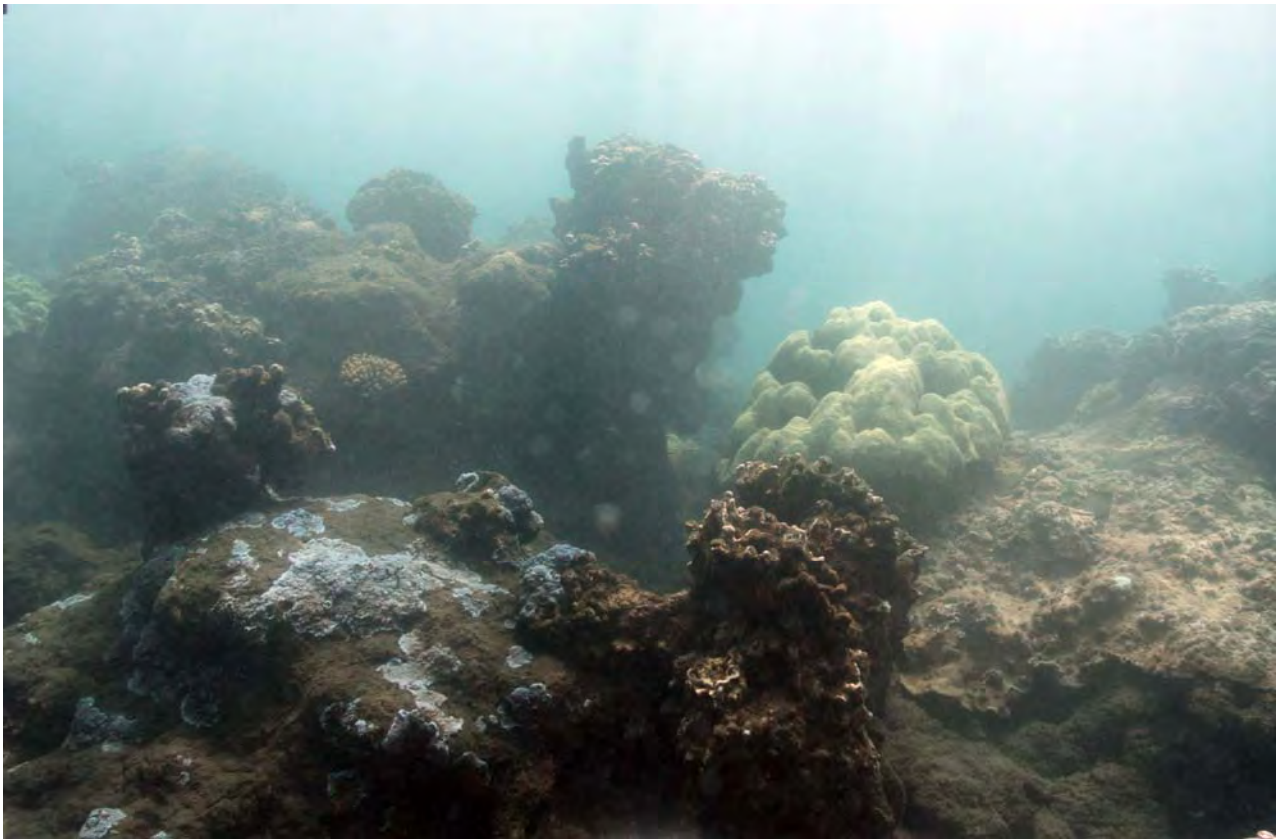
In the area adjacent to the inner walkway to the main wharf (Region C in Figure 4), reef composition consists of large limestone mounds primarily covered with various growth forms of *Montipora capitata* (Figure 11). Within the area bounded by the outer section of the wharf and shoreline (Region D in Figure 4) coral mounds are interspersed within sand channels (Figure 12). In the center of this area (Region E in Figure 5) no corals occur and bottom composition consists entirely of coarse marine sands.

FIGURE 12. Two views of coral mounds located between Hana Wharf and shoreline (Region D in Figure 5). This region consists of alternating coral mounds and sand channels.

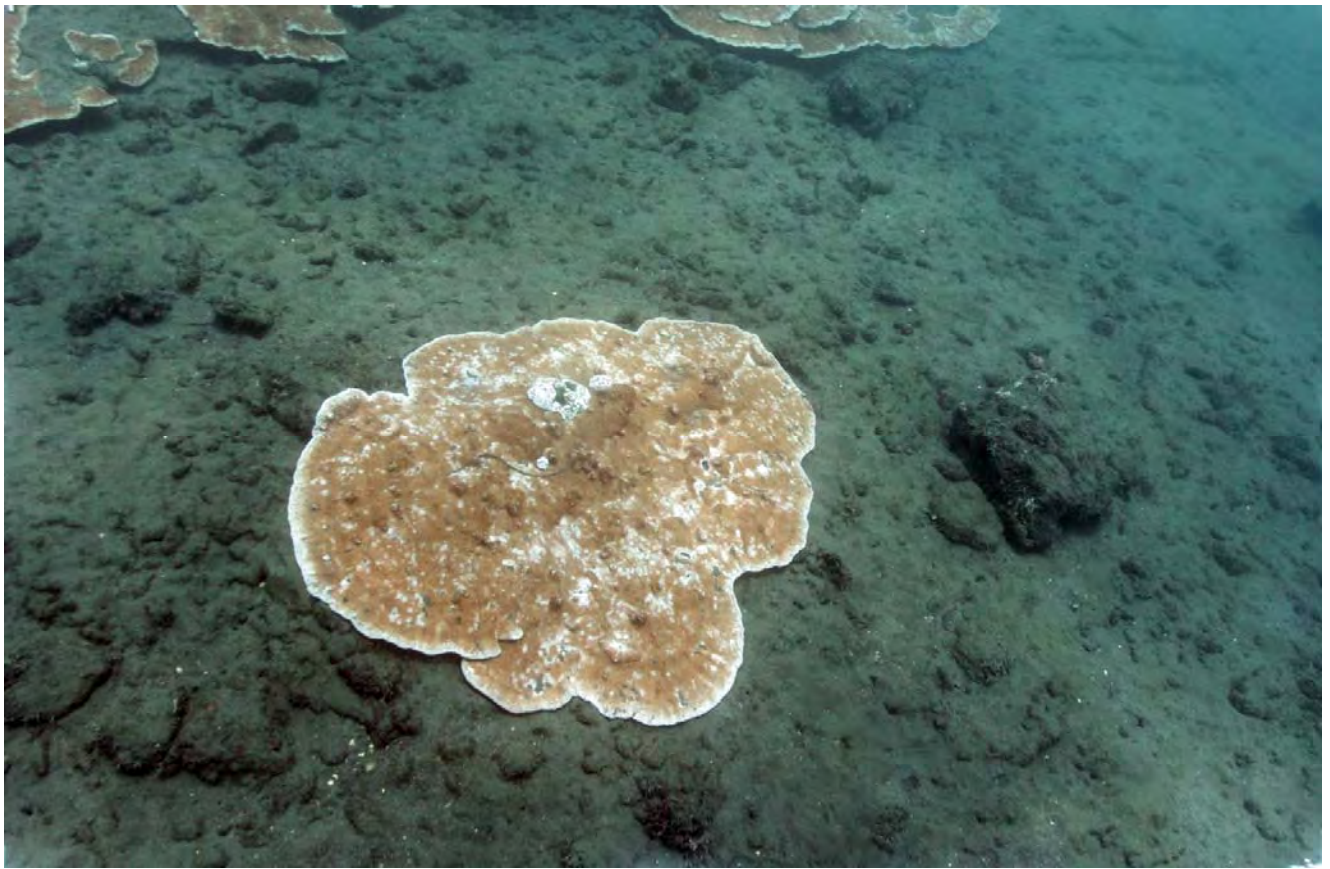
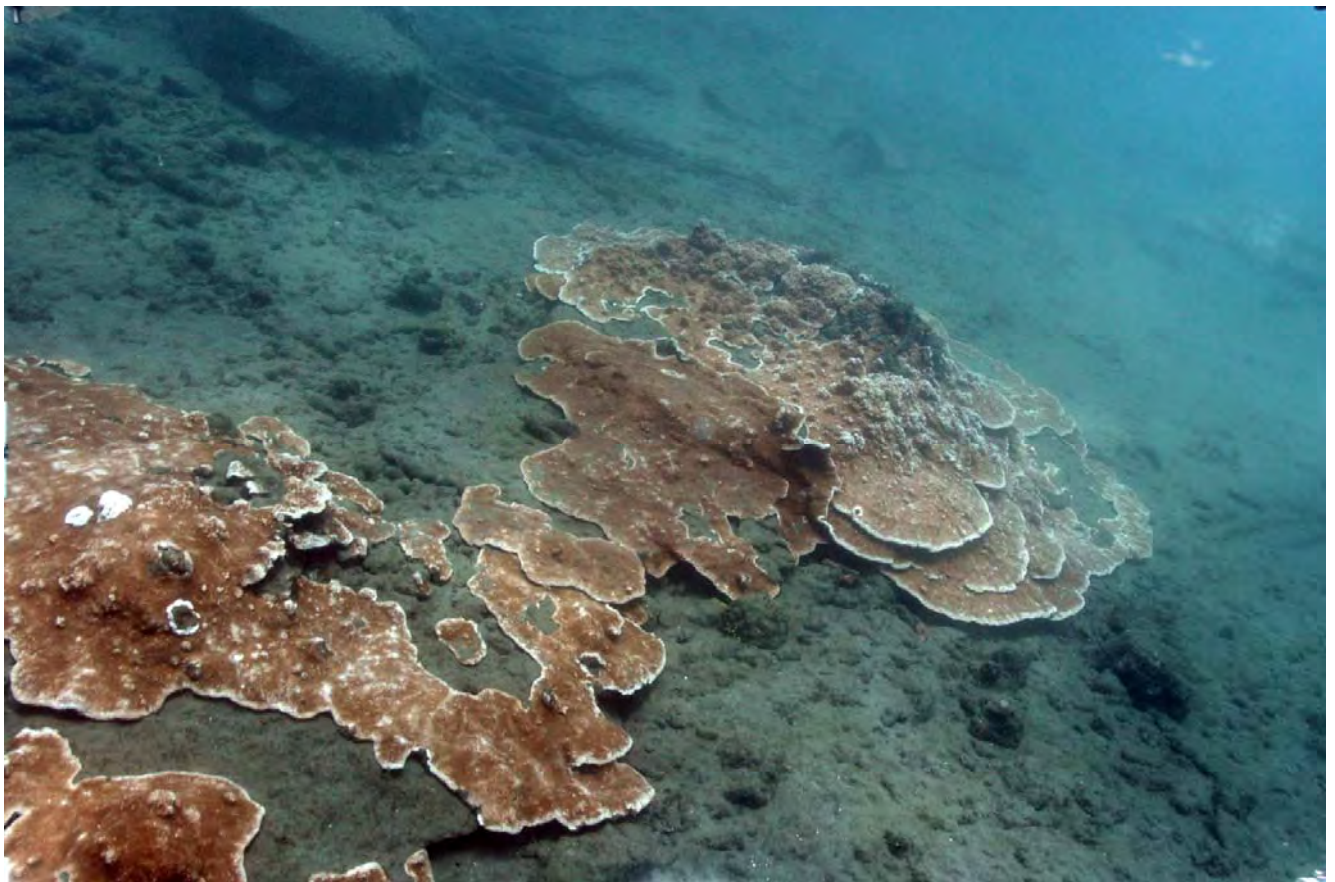
FIGURE 14. Colonies of *Montipora capitata* growing on reef platform adjacent to northwest side of wharf in Hana Bay, Maui (Region G in Figure 5). Water depth is approximately 20 feet.

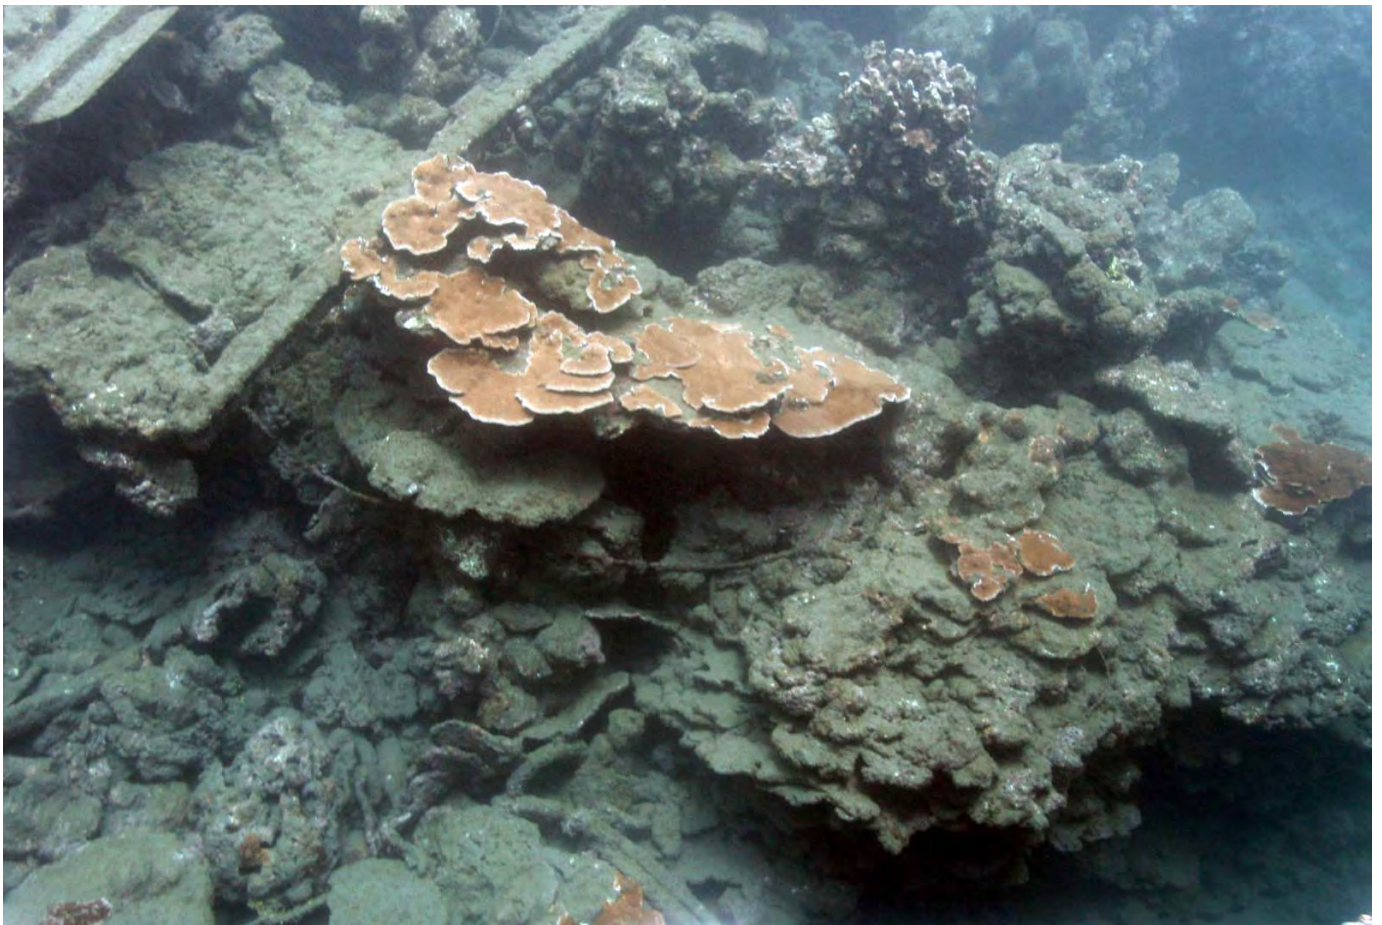
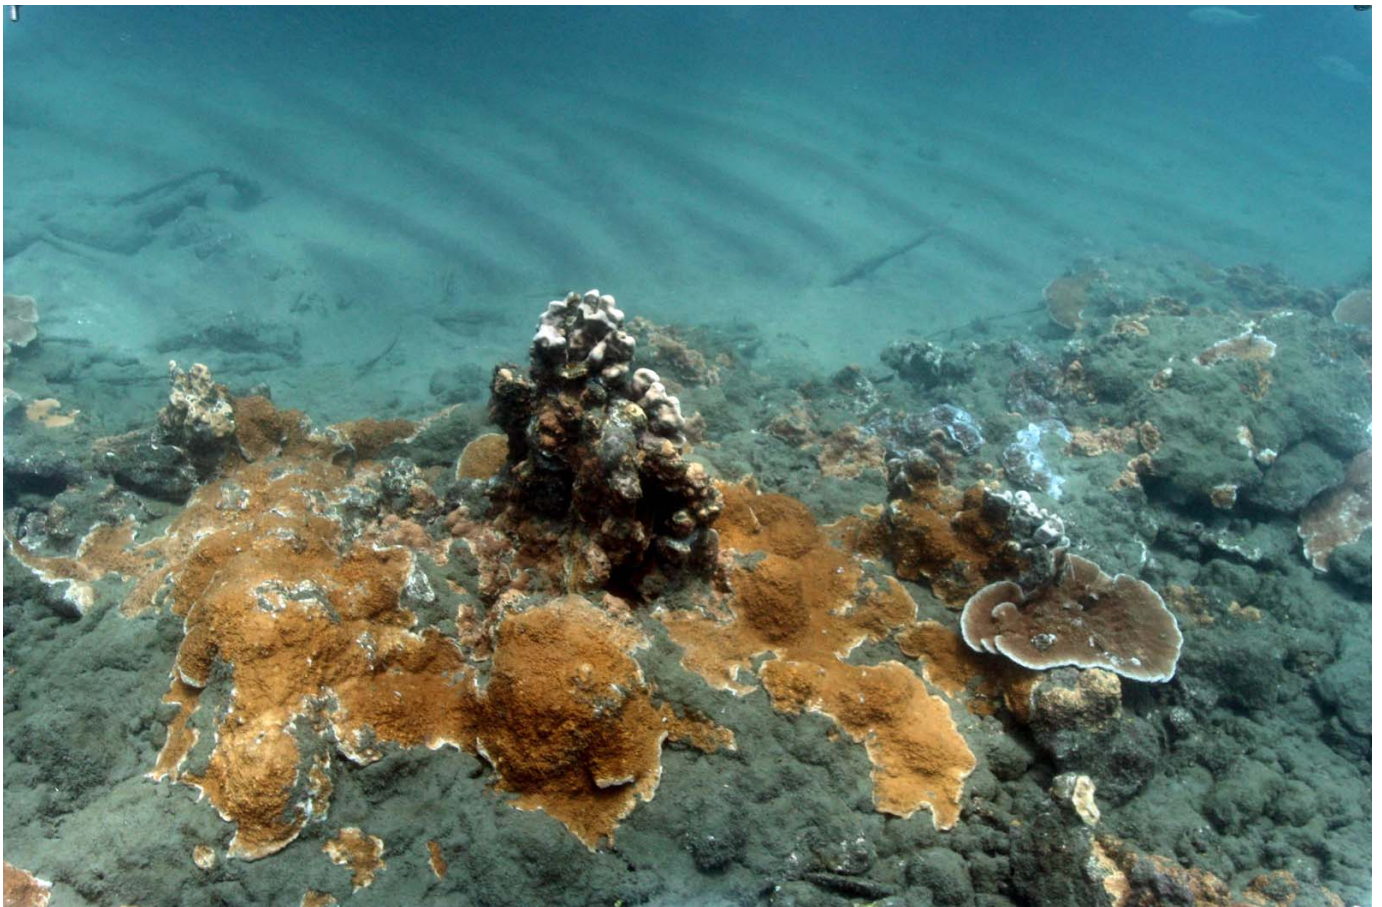
FIGURE 15. Edge of hard-bottom reef adjacent to sand bottom on northwest side of wharf in Hana Bay, Maui (Region G in Figure 5).

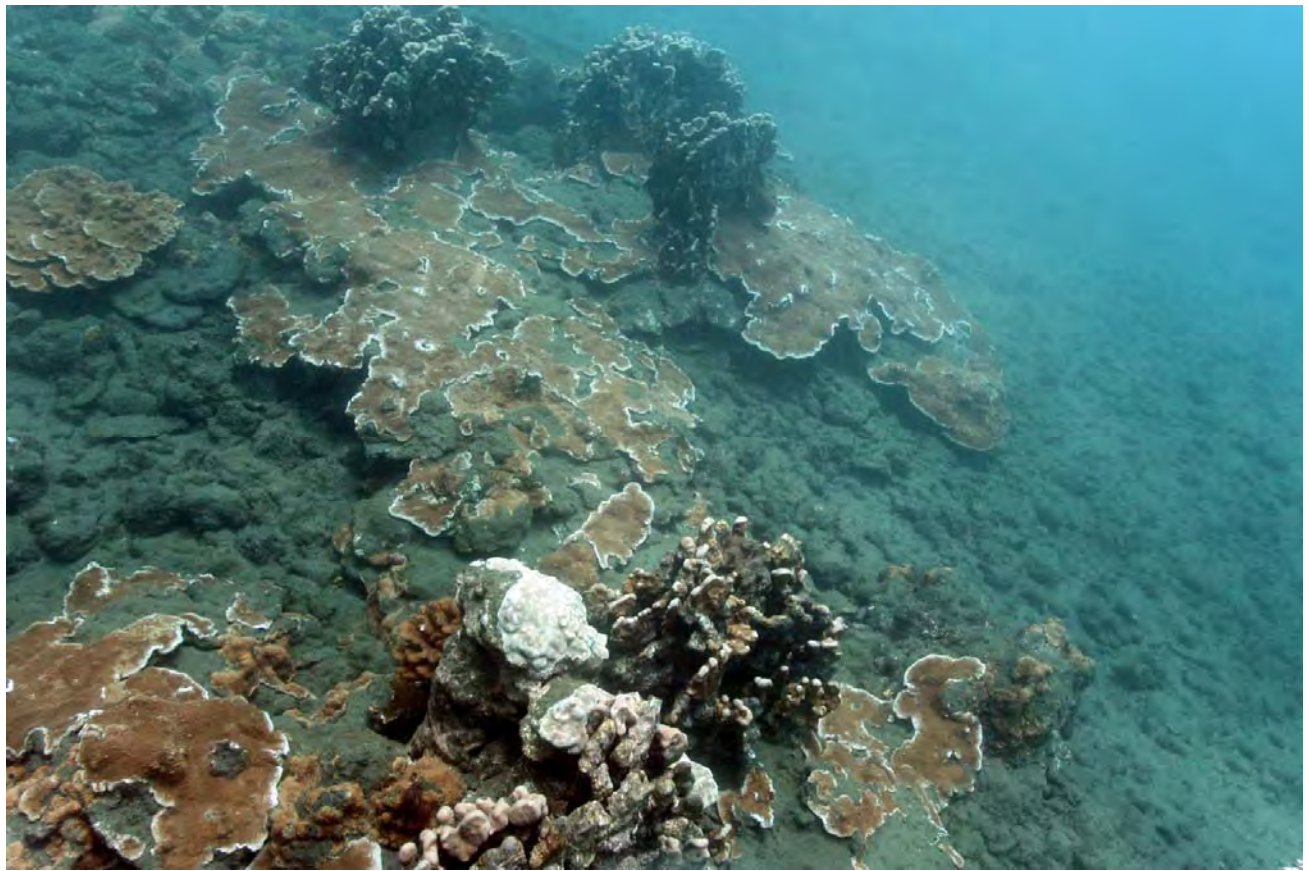
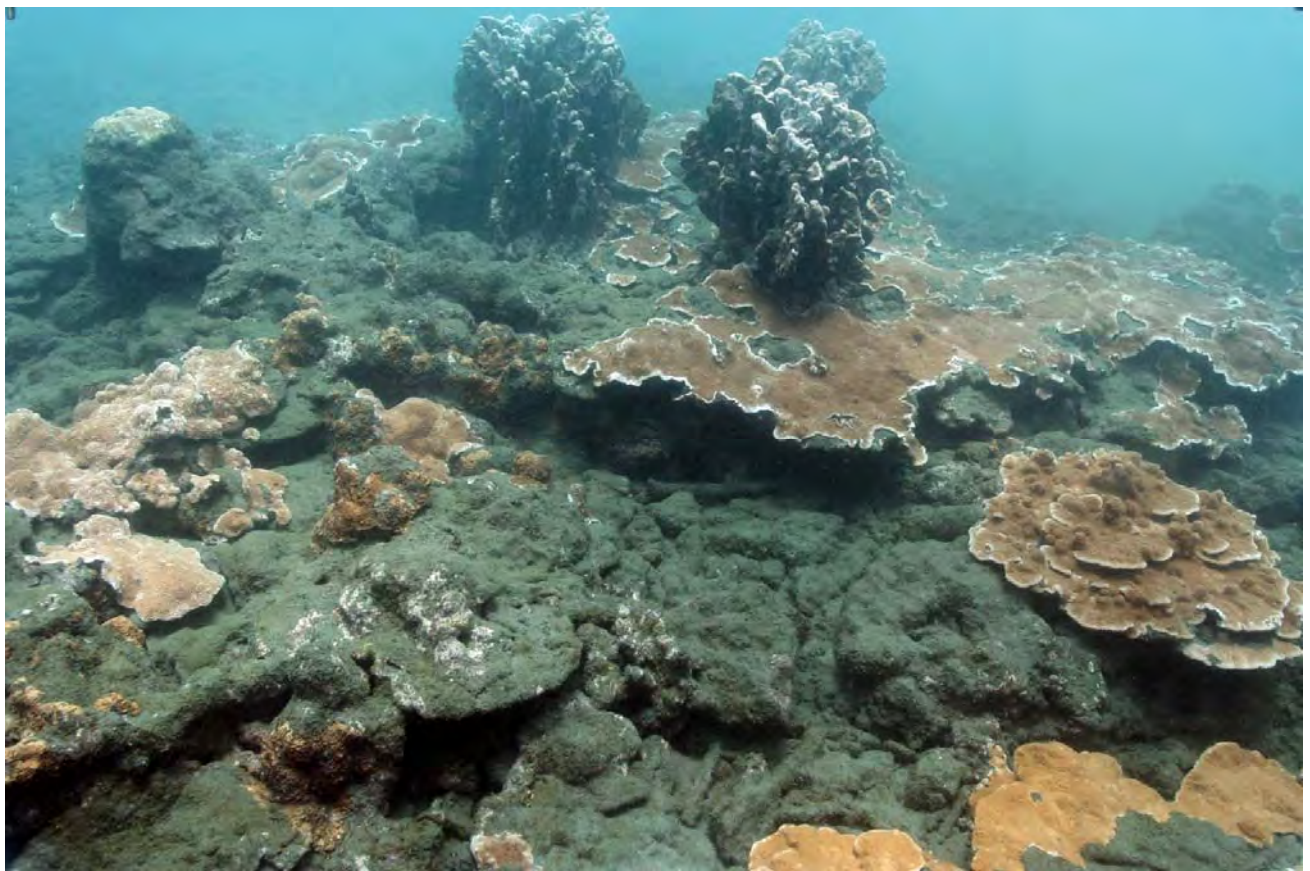
FIGURE 16. Two views of reef slope near northeast end of wharf in Hana Bay. Water depth is approximately 25 ft.

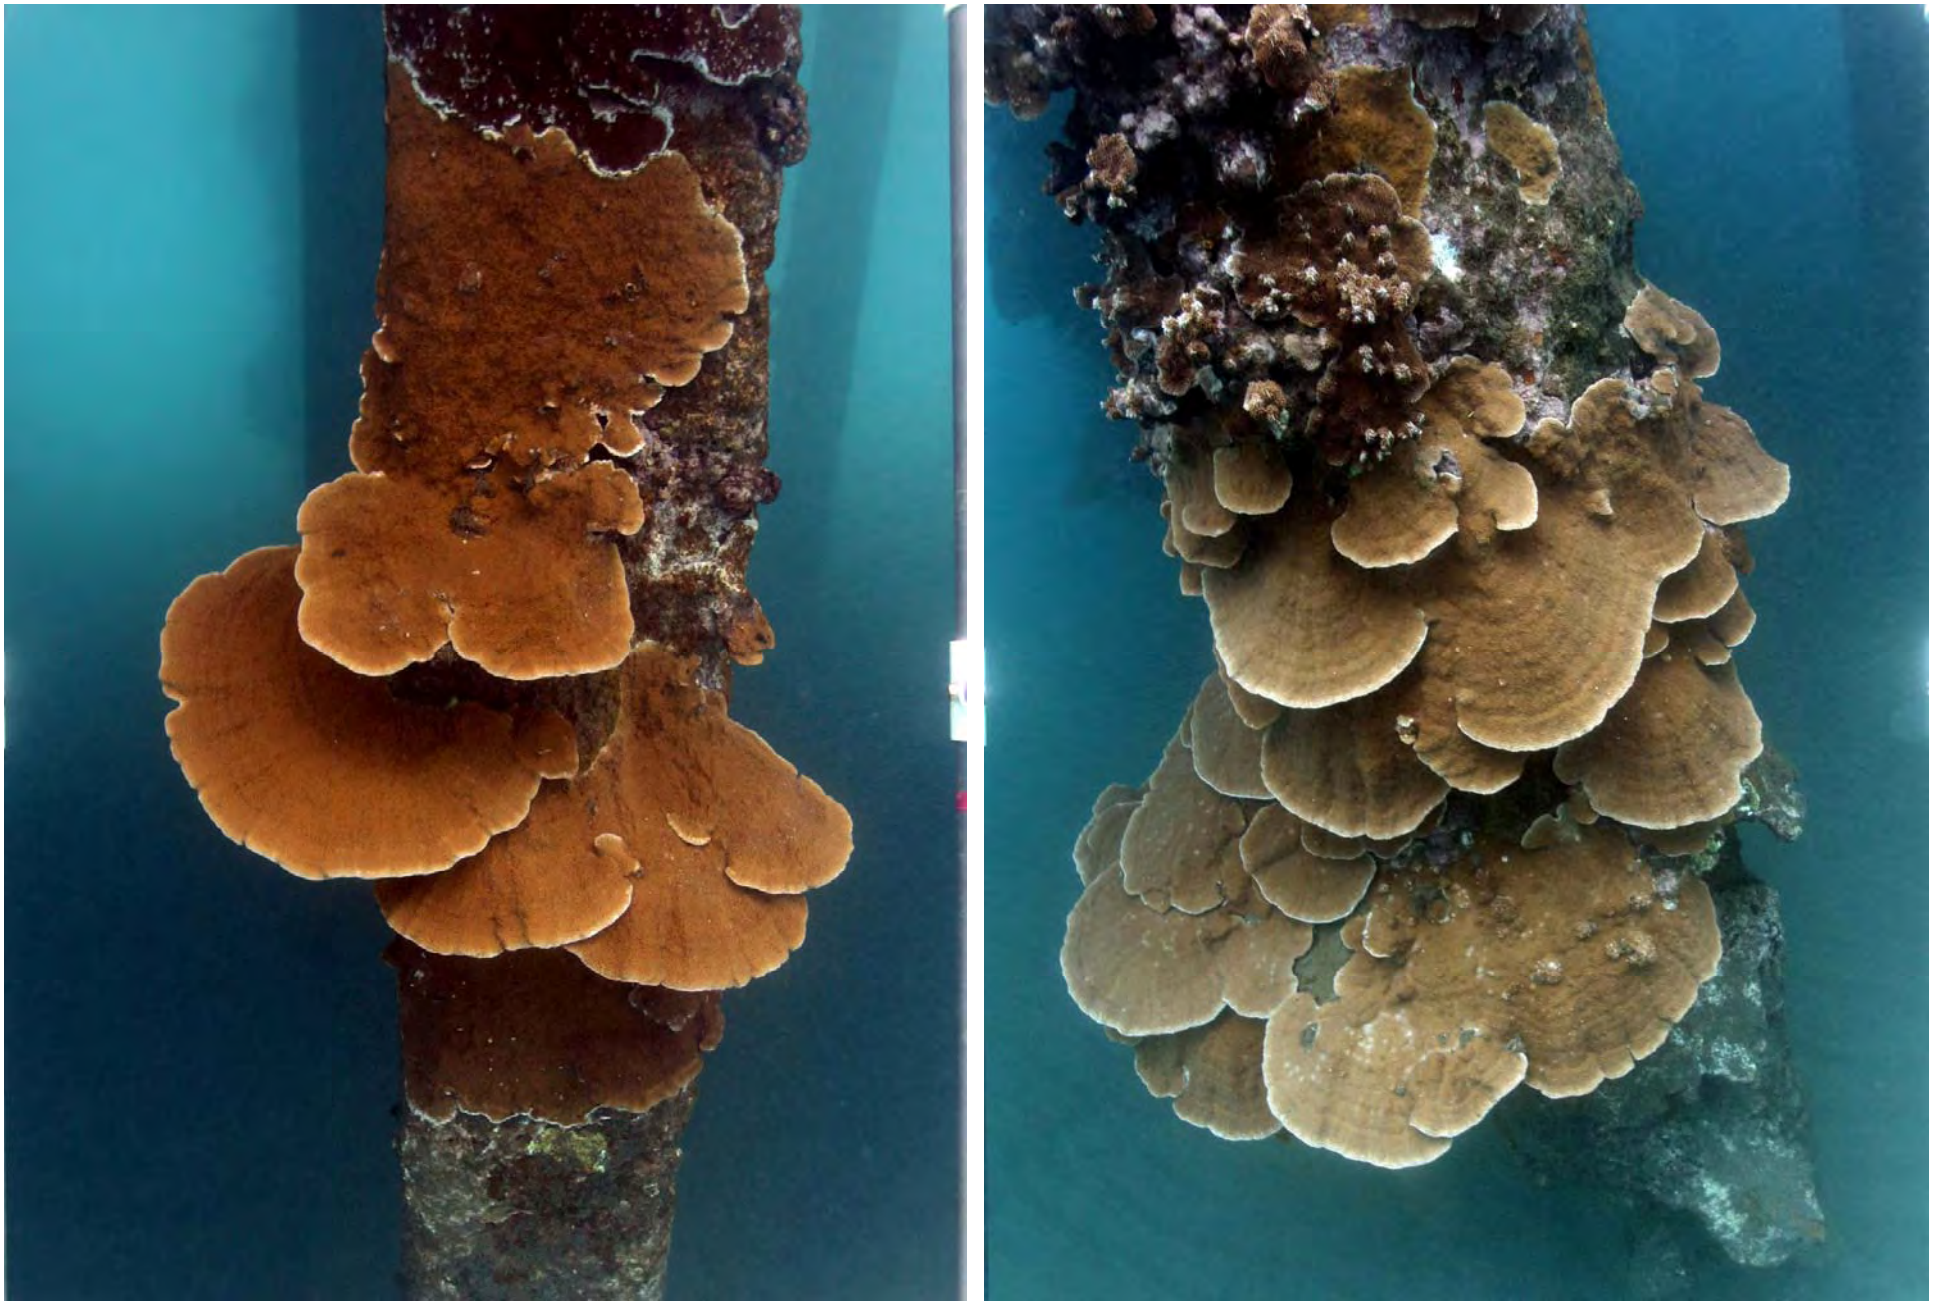
A substantial portion of the vertical surfaces of the pilings on the outer edge of the wharf (visually estimated at ~20%) are colonized with extensive overlapping plates of *Montipora capitata*. Similar growth of the same species has been observed on submerged piling within Kahului Harbor. Pilings interior to the edge of the wharf are essentially barren of coral colonization, likely as a result of lack of exposure to light. Surprisingly, virtually no other macro-organisms were observed on any of the pilings. Pilings on the outer edge of the south side of the wharf were not colonized by overlapping plates of *Montipora*; rather this coral occurred in circular encrustations. Toward the end of the wharf, remnant dead and eroding plates were observed.

FIGURE 19. Two pilings on northwest side of wharf in Hana Bay, Maui showing overlapping plating coral *Montipora capitata*.
