Preliminary Baseline Assessment of Reef Coral Community Structure in the Vicinity of the Wharf in Hāna Bay

**PRELIMINARY BASELINE ASSESSMENT OF REEF CORAL COMMUNITY STRUCTURE
IN THE VICINITY OF THE WHARF IN HANA BAY
HANA, ISLAND OF MAUI**

June 15, 2010

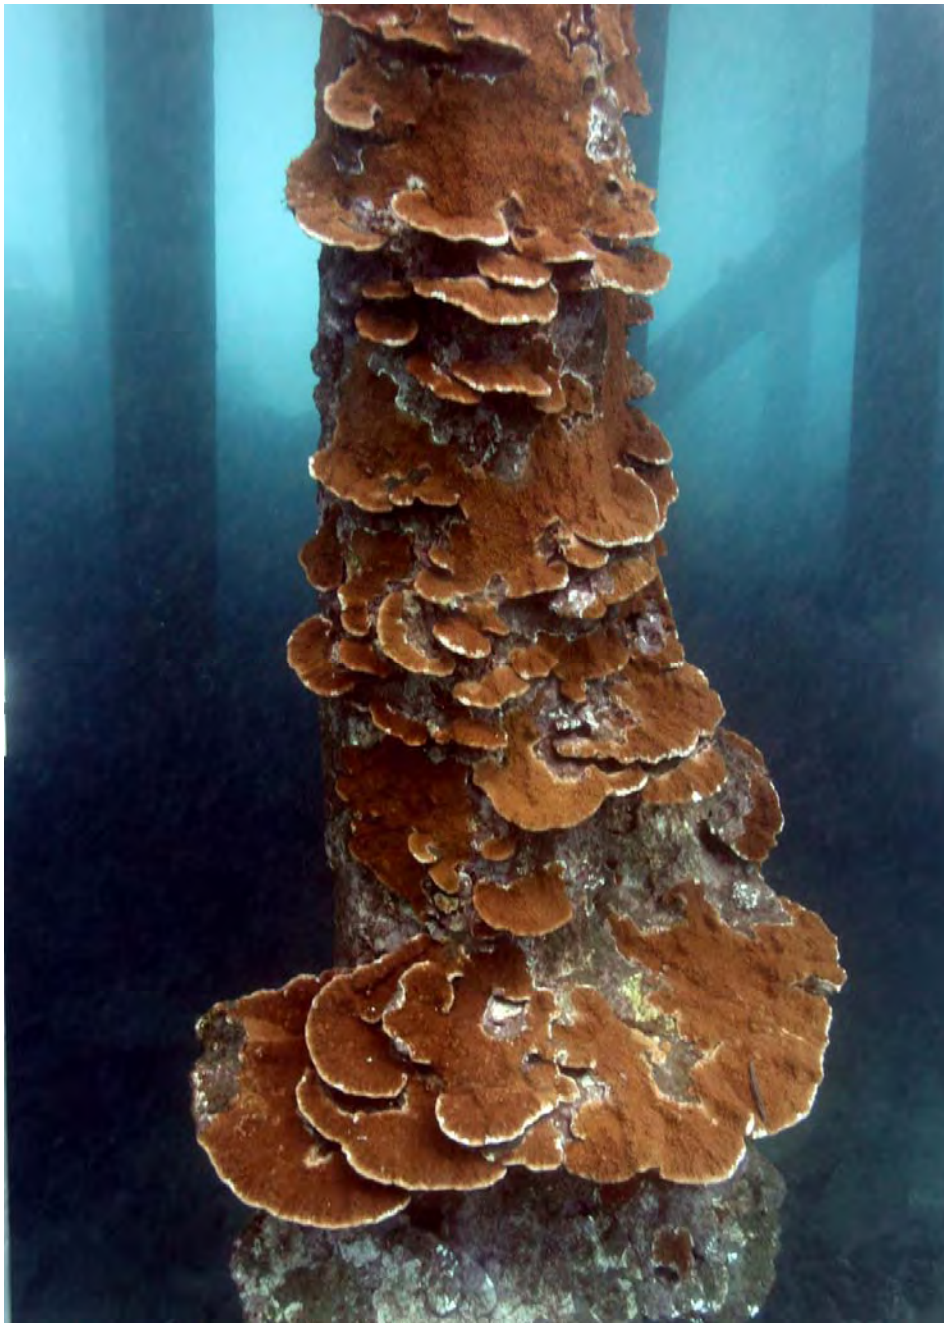
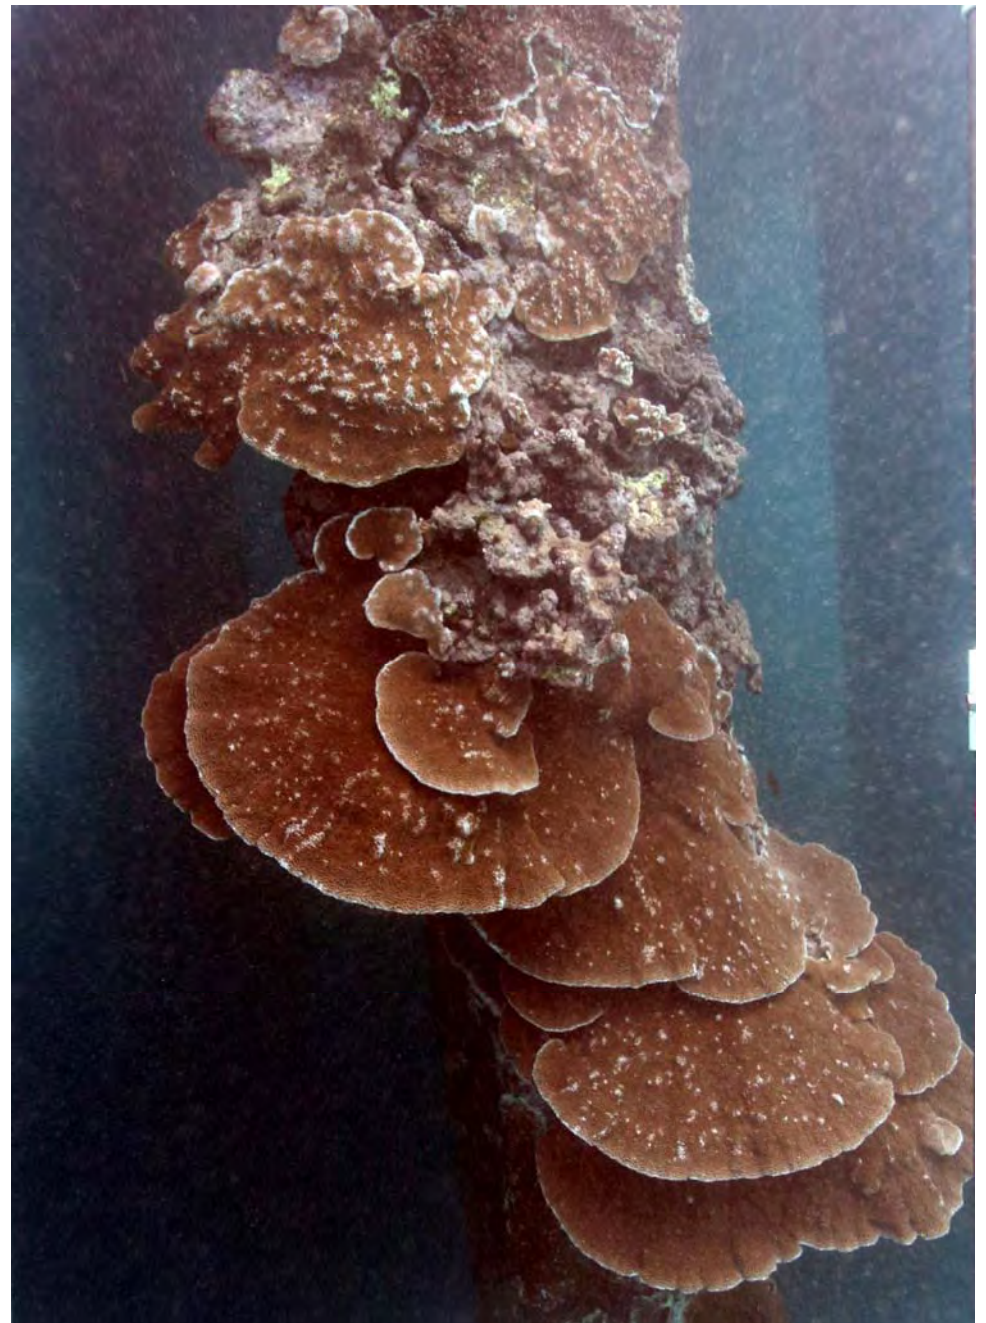
A substantial portion of the vertical surfaces of the pilings on the outer edge of the wharf (visually estimated at ~20%) are colonized with extensive overlapping plates of *Montipora capitata*. Similar growth of the same species has been observed on submerged piling within Kahului Harbor. Pilings interior to the edge of the wharf are essentially barren of coral colonization, likely as a result of lack of exposure to light. Surprisingly, virtually no other macro-organisms were observed on any of the pilings. Pilings on the outer edge of the south side of the wharf were not colonized by overlapping plates of *Montipora*; rather this coral occurred in circular encrustations. Toward the end of the wharf, remnant dead and eroding plates were observed.

FIGURE 20. Two pilings on northwest side of wharf in Hana Bay, Maui showing overlapping plating coral *Montipora capitata*.

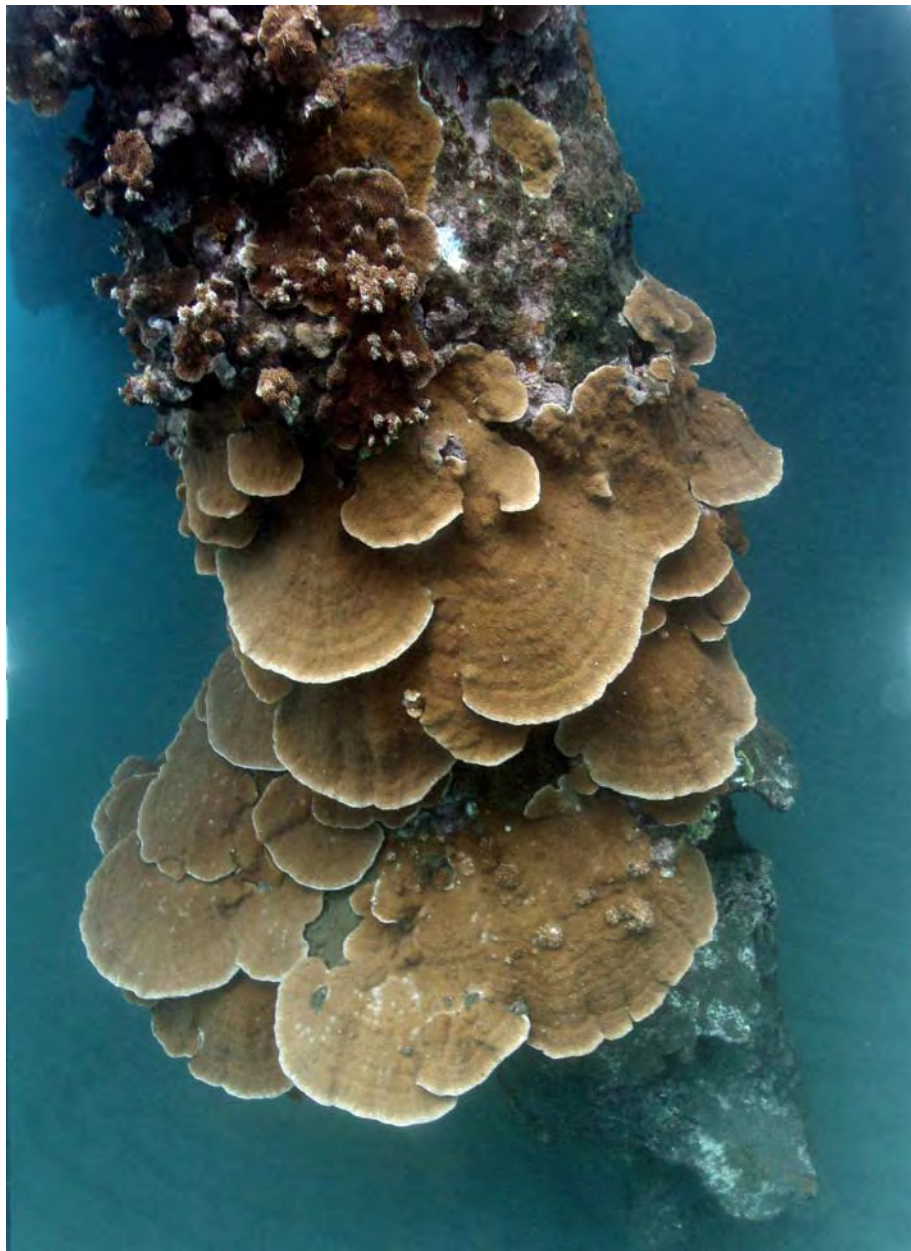
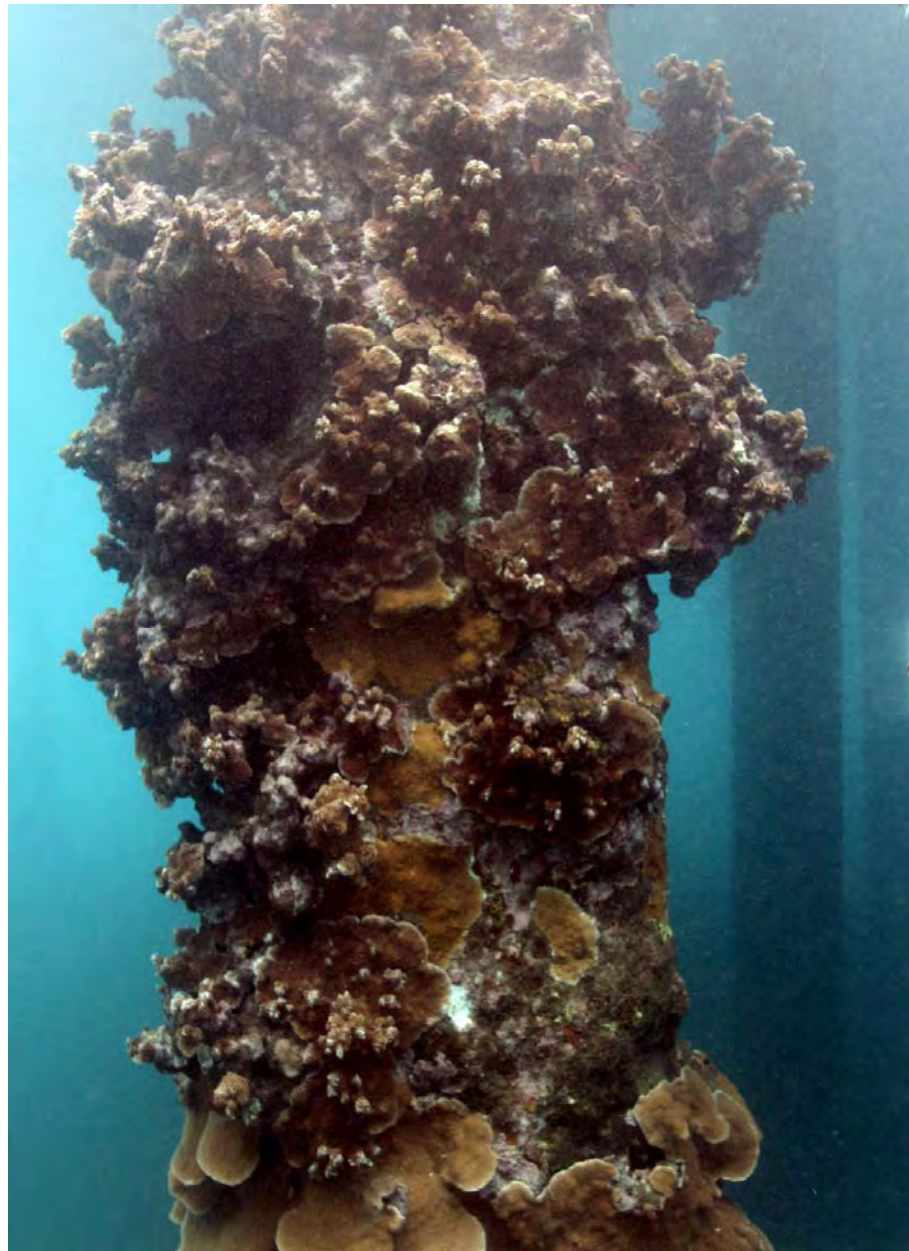
FIGURE 21. Two pilings on northwest side of wharf in Hana Bay, Maui showing *Montipora capitata* in overlapping plating growth form at left, and branching growth form at right.

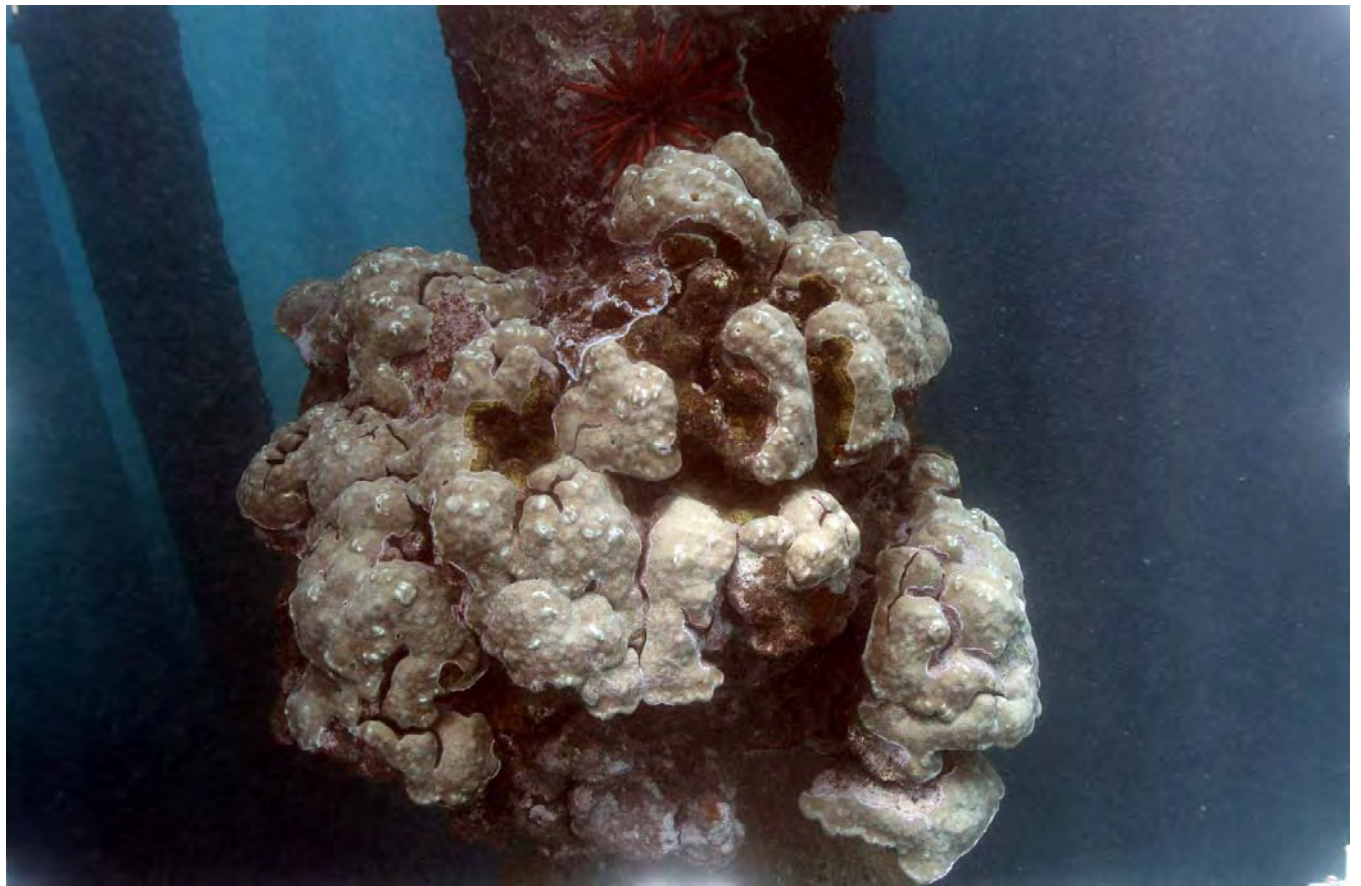
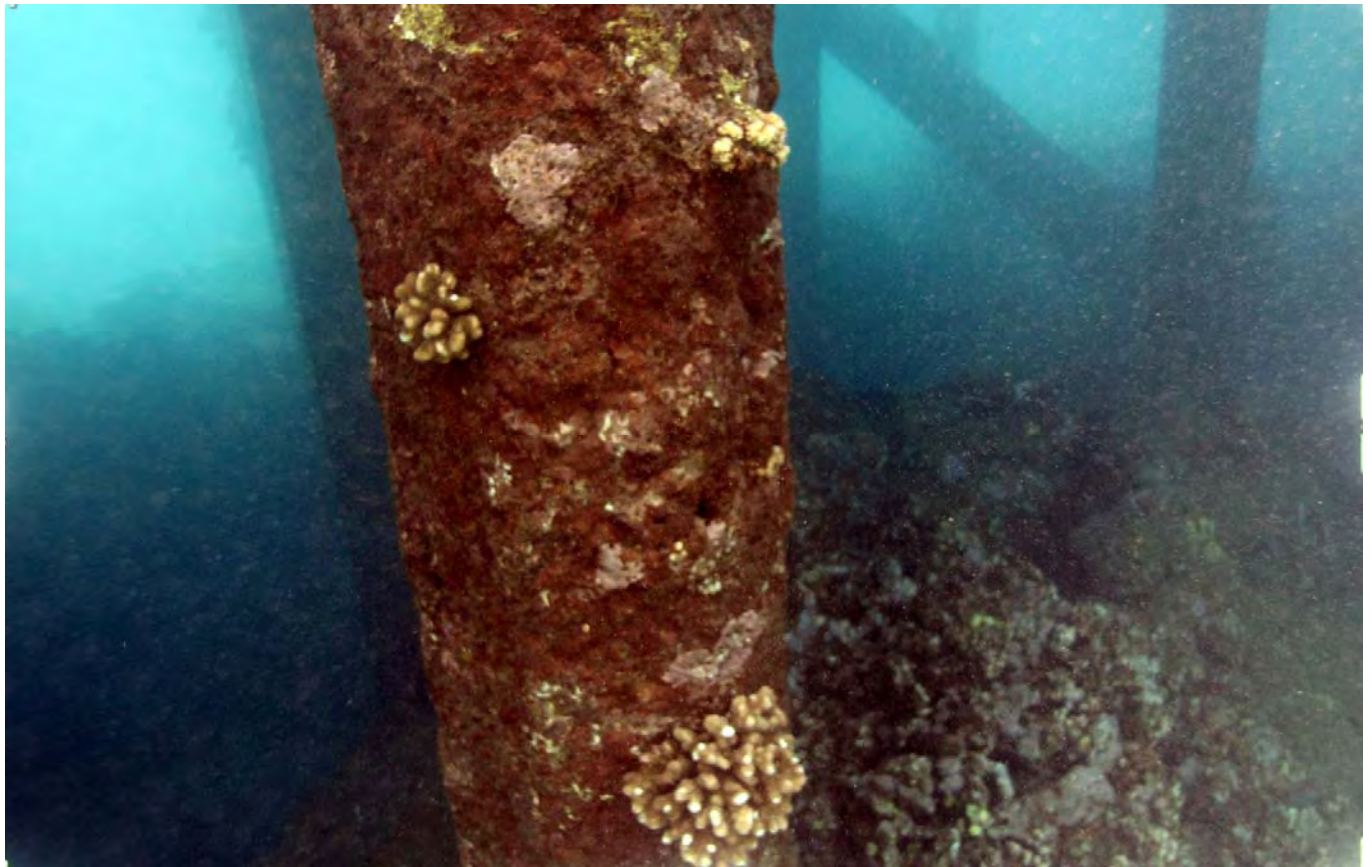
FIGURE 24. Multi-lobed colony of *Porites lobata* growing on piling on south side of wharf in Hana Harbor (top). *Porites lobata* was rare on piles. Several colonies of *Pocillopora meandrina* on piling on south side of pier (bottom).
