FACT SHEET

PFAS Impacted Soil and Groundwater Kahului Airport Aircraft Rescue and Fire Fighting Training Area Kahului, Maui, Hawai'i

TMK: (2) 3-8-001:019. 1 Keolani Place, Kahului, Maui, Hawai'i

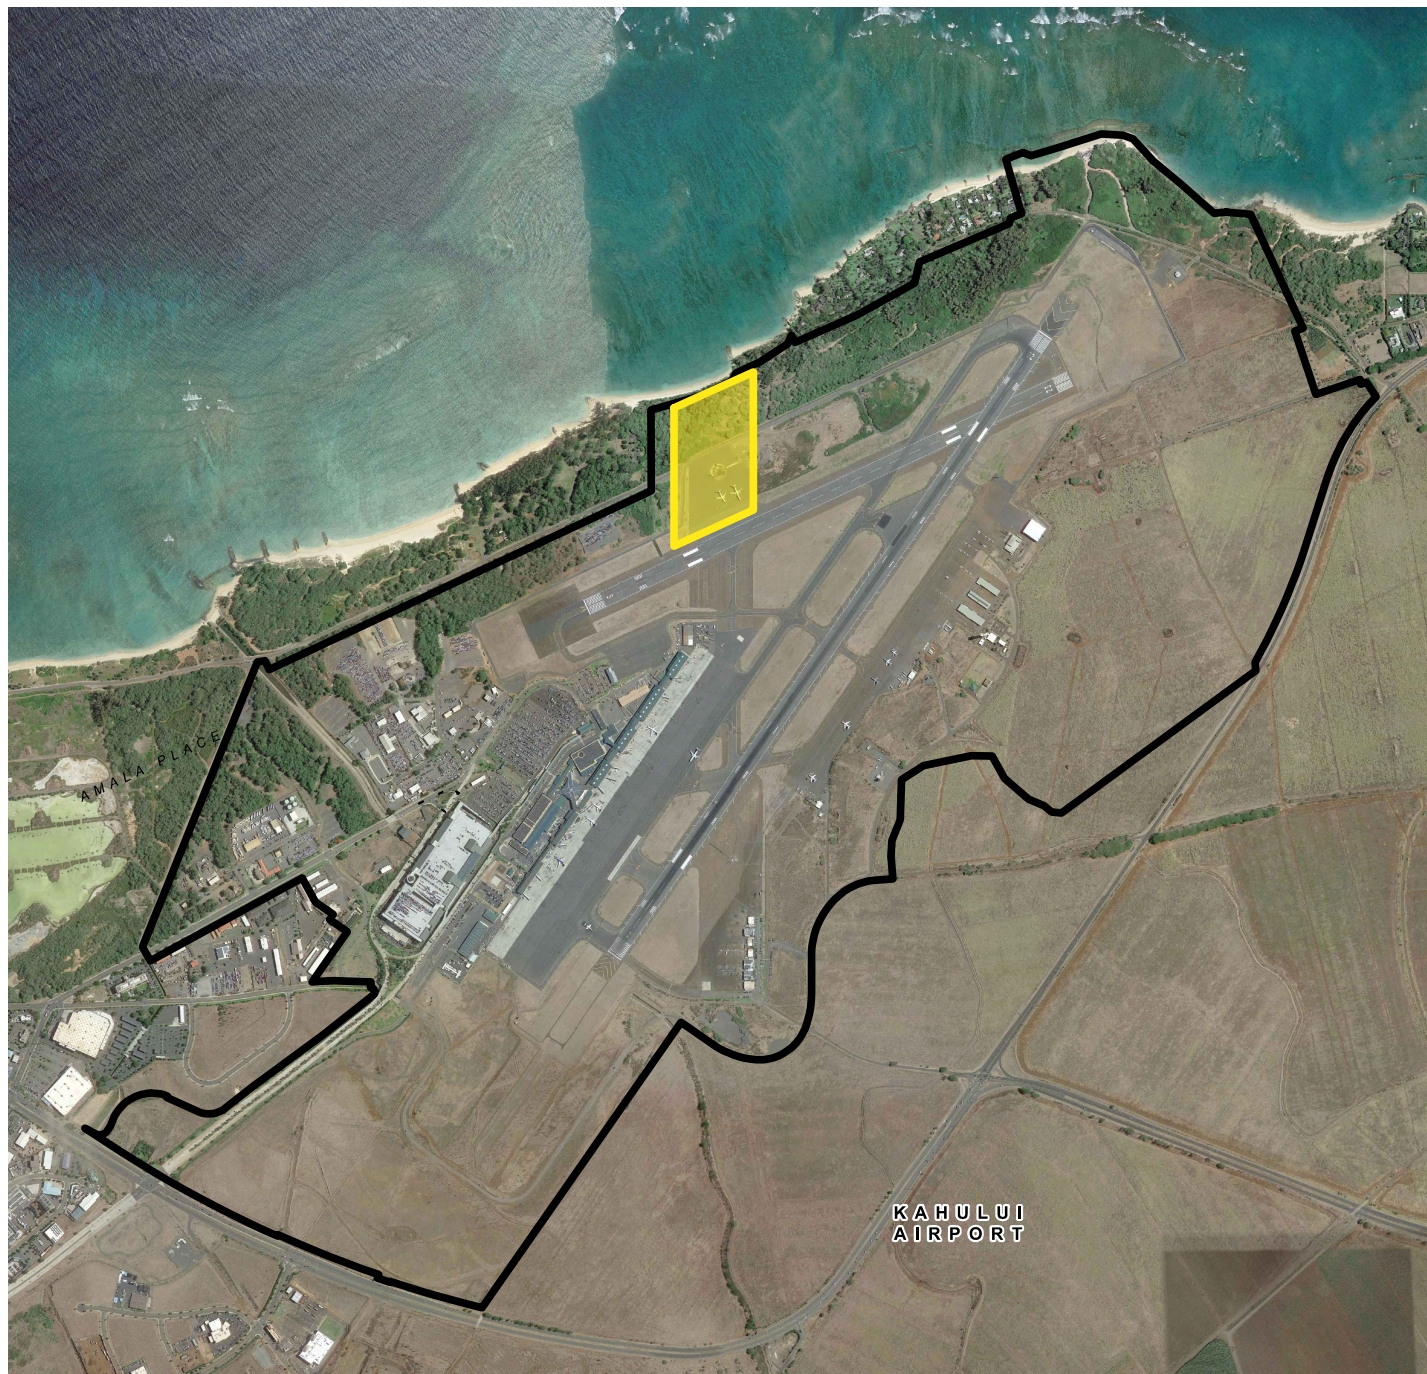
GENERAL AREAS OF KNOWN PFAS CONTAMINATION

Soil and groundwater samples have been collected around the burn pit and north to north west of the burn pit, towards Kahului Bay. A total of twelve groundwater monitoring wells have been installed. PFAS has been detected at concentrations exceeding the HDOH HEER Office Environmental Action Levels [EALs] in soil and groundwater surrounding the burn pit and in areas between the Training Area and Kahului Bay. A map showing the areas where PFAS has been detected at

concentrations above the HDOH HEER Office EALs is attached.

Short-term remedial actions that have been implemented include installing fencing and warning signs to prevent exposure of the public. Additionally, removal of PFAS impacted soil at the surface and near surface outside of the AOA secured area that poses a potential direct exposure hazard is planned for the Spring of 2025. Studies are currently being performed to assess potential long-term remedial options.
