# **SECTION C**

CULVERTS

## HAER CULVERTS OVERVIEW

## Hana Highway, Route 360

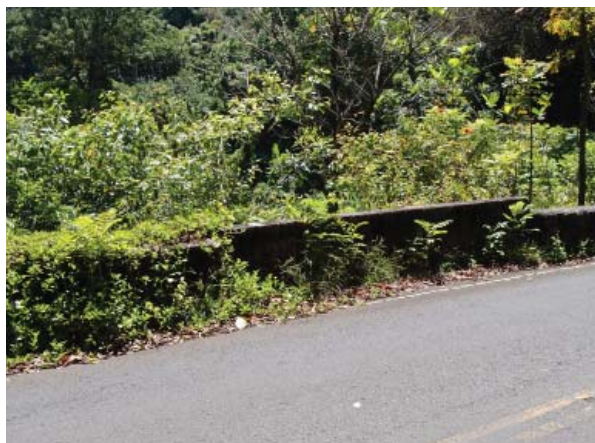
*Solid concrete parapet, downstream side  
Courtesy of NOEI*

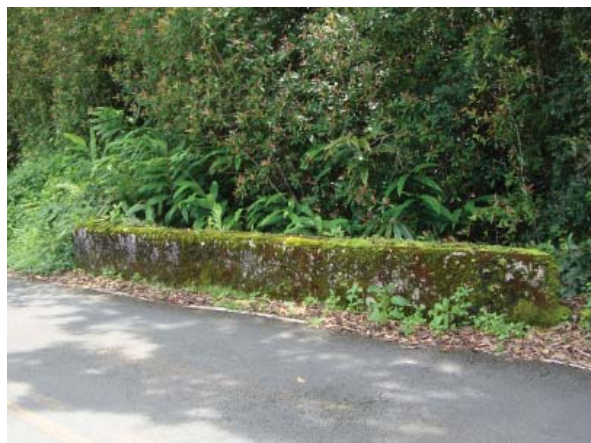
*Solid concrete parapet, upstream side  
Courtesy of NOEI*

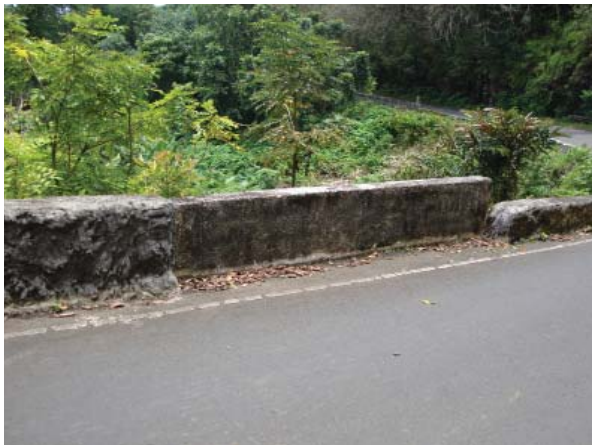
*Solid concrete parapet, downstream side*  
Courtesy of FAI

Of the three historic culverts along this stretch of Hana Highway, Culvert #4 is the only culvert with a reinforced concrete upstream and downstream parapet. The concrete parapets do not meet TL-2 crash requirements. To keep with the historic character of the adjacent culverts, it is recommended to replace the upstream parapet with a similar recommended design as Culverts #2 and #3. Therefore, the upstream parapet will be replaced with a stone masonry guardwall, which will be constructed monolithic with the approach walls (refer to Section G, Appendix 5. *Proposed Crash-Tested Railing Options*). The downstream parapet will be replaced with a similarly designed reinforced concrete

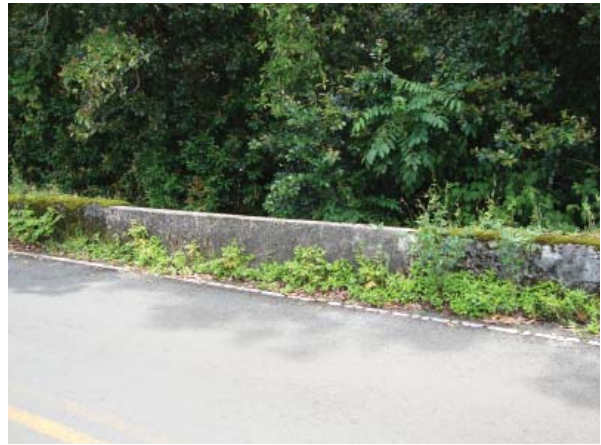
*Solid concrete parapet, upstream side*  
Courtesy of FAI

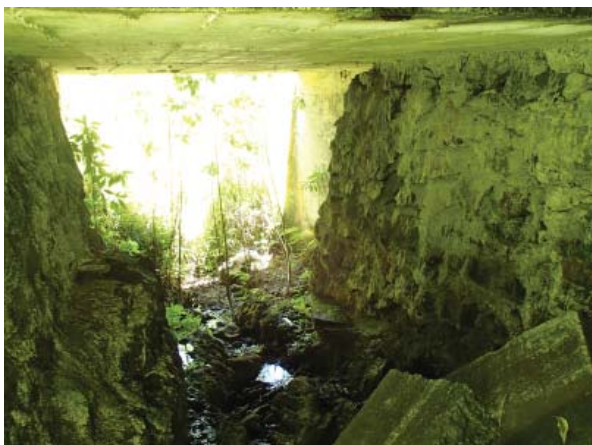
*CRM abutment, Kahului and Hana sides*  
Courtesy of FAI

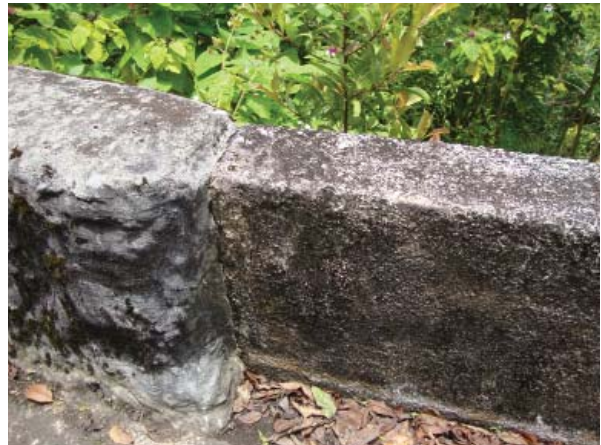
*Downstream approach wall, Kahului side*  
Courtesy of FAI

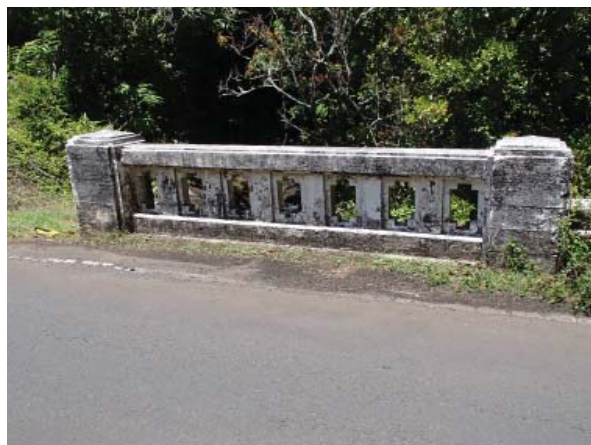
*Greek cross parapet, upstream side  
Courtesy of NOEI*

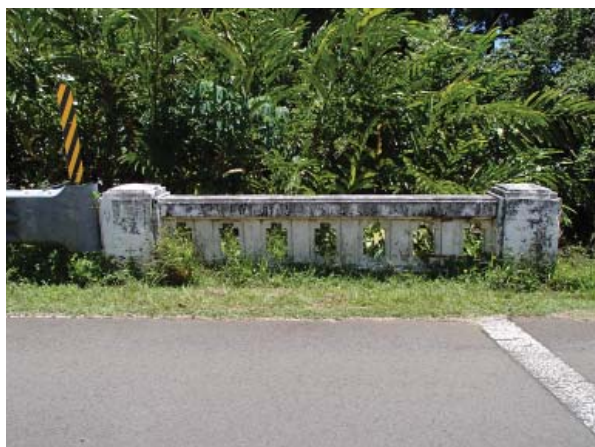
*Greek cross parapet, downstream side  
Courtesy of NOEI*

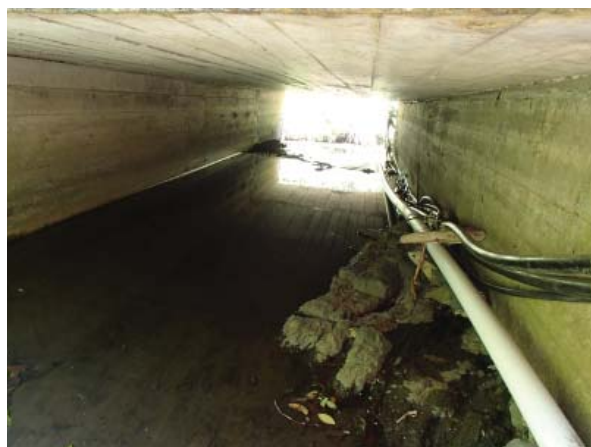
*Concrete abutment  
Courtesy of NOEI*

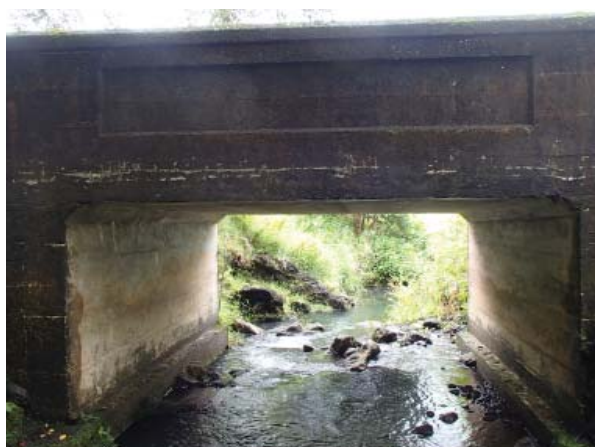
*Culvert elevation, upstream side  
Courtesy of NOEI*

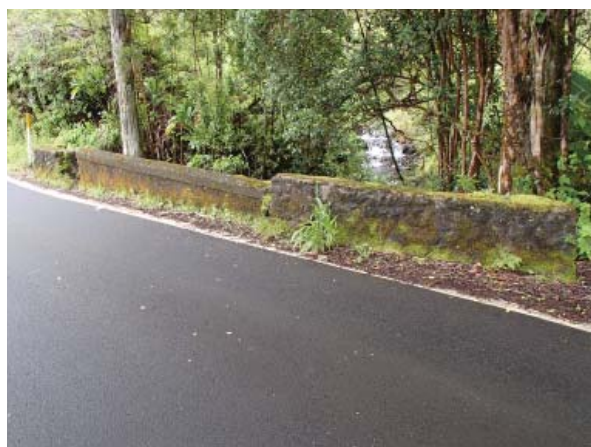
*Solid concrete parapet with saddle coping, upstream side  
Courtesy of NOEI*

The concrete culvert parapets do not meet TL-2 crash requirements. It is recommended to preserve, relocate, and connect the existing downstream parapet to the new widened portion of the deck. A crash-tested railing will be constructed in front of the existing parapets. For this purpose, it is recommended to use a Wyoming 740 railing which will be attached to the deck of the culvert (refer to Section G, Appendix 5. *Proposed Crash-Tested Railing Options*). Since record drawings are not available, additional investigation of the deck is recommended (refer to "Deck" section). Also, drainage should be provided through the base of each parapet.

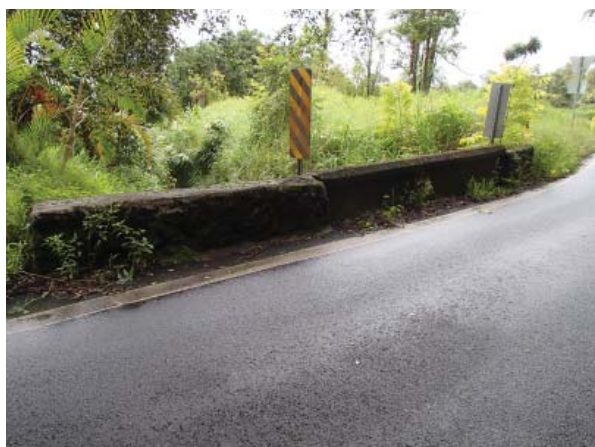
*Solid concrete parapet with saddle coping, downstream side  
Courtesy of NOEI*

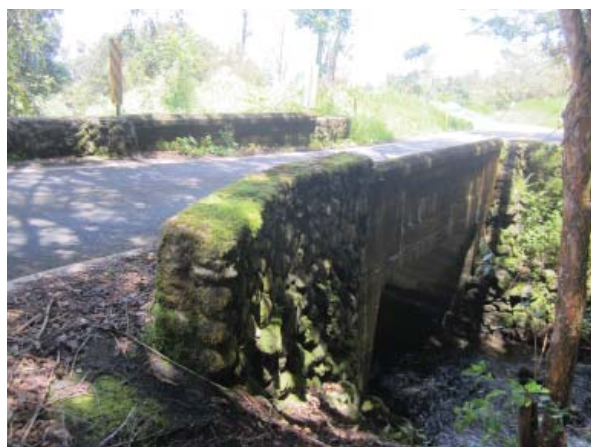
*Upstream CRM approach wall, Kahului side  
Courtesy of FAI*

The existing CRM walls at the approaches to the culvert do not meet the TL-2 crash requirements and cannot act as the culvert's traffic features. The existing CRM approach walls are recommended to be replaced with a reinforced concrete wall with a reconstructed rock façade. For this purpose, a stone masonry guardwall is recommended to be used (refer to Section G, Appendix 5. *Proposed Crash-Tested Railing Options*). The approach walls shall also contain a concrete bridge name panel, pending confirmation of the Hawaiian place name by community and scholarly experts. Refer to Section A, Chapter 5. iii. a. *Approach Walls & Safety Features at the Approaches* for an example of the stone masonry guardwall with bridge name detail.

To achieve the reconstructed rock façade appearance, the existing CRM façades of the CRM approach walls are to have their rock configurations documented and recorded. Once documentation has been completed, the CRM approach walls are to be carefully disassembled. Thorough documentation of the disassembling rock process is

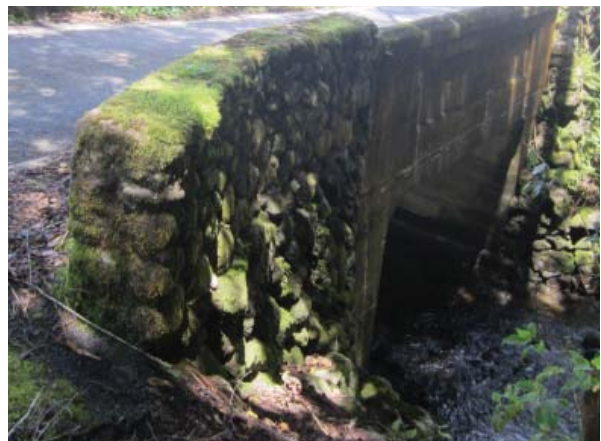
This culvert has a CRM approach wall of exemplary historic craftsmanship, with tight joints, minimal exposed mortar, and varied rock sizes for a natural, rustic appearance. Approach walls of similar quality are shown in the following bridges and may be used for reference: #19 Kopiliula Stream Bridge, #38 Heleleikeoha Stream Bridge, #39 Ulaino Stream Bridge, and #40 Mokulehua Stream Bridge. The rock wall portions of the EMI system at #06 Kaaiea Stream Bridge and #19 Kopiliula Stream Bridge are also excellent examples of historic rock walls showing original craftsmanship.

*Exemplary CRM approach wall, East Hanawi Culvert  
Courtesy of FAI*

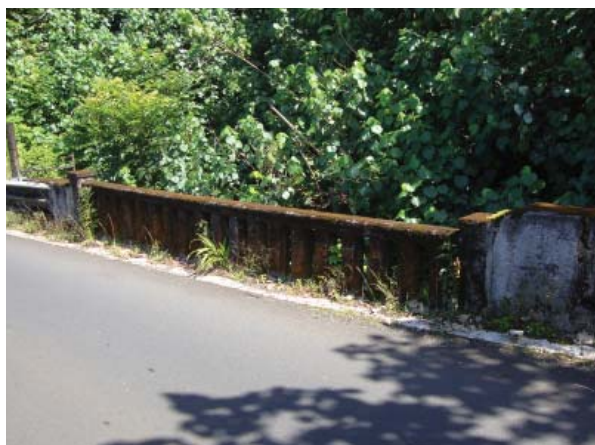
*Concrete open vertical railing, upstream side  
Courtesy of FAI*

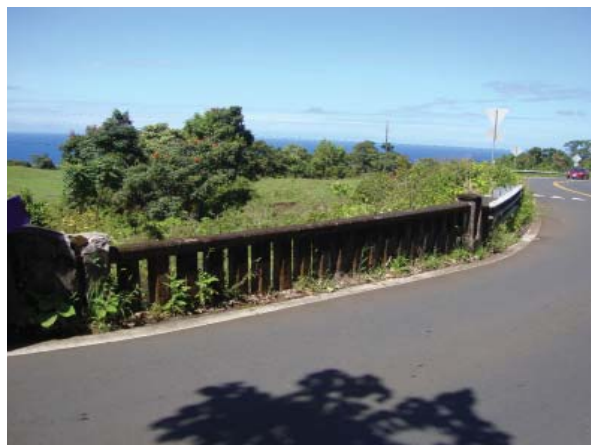
*Concrete open vertical railing, downstream side  
Courtesy of FAI*

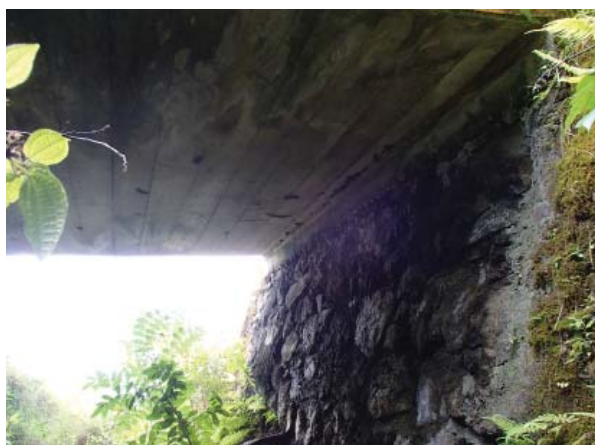
*CRM abutment, Hana side  
Courtesy of NOEI*

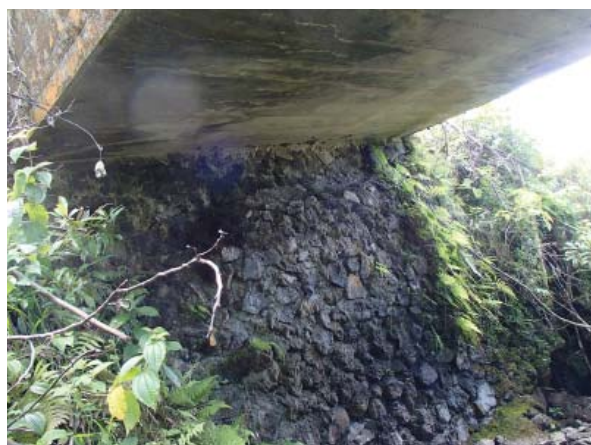
*CRM abutment, Kahului side  
Courtesy of NOEI*

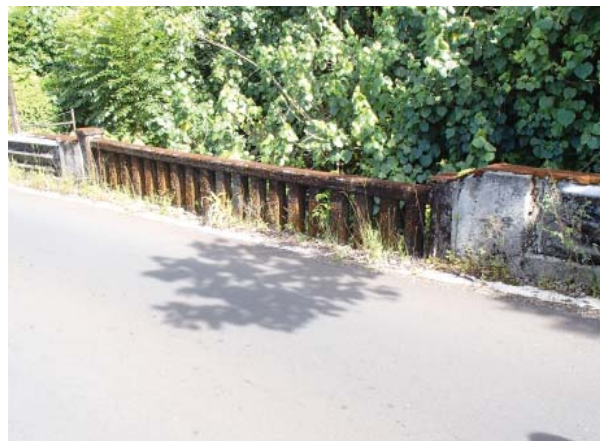
Culvert #5 currently does not meet the minimum curb-to-curb width of 16 feet for a one-lane culvert; therefore, it is recommended to widen the upstream side of the culvert. Special attention should be paid to removing excess asphalt overlay on the deck because it obscures the base of the existing railings and lowers the height below code minimum.

*Existing guardrails  
Courtesy of NOEI*

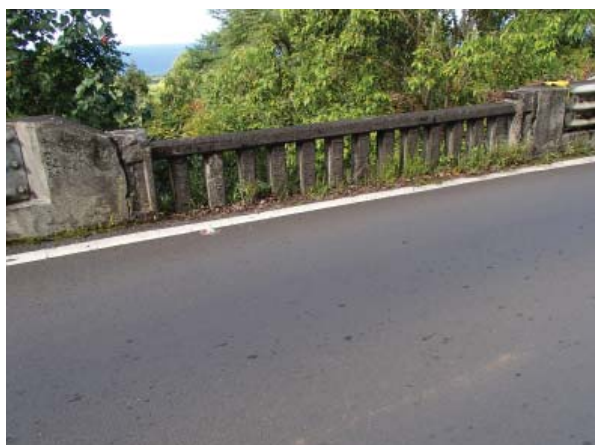
*Concrete open vertical railing, downstream side  
Courtesy of NOEI*

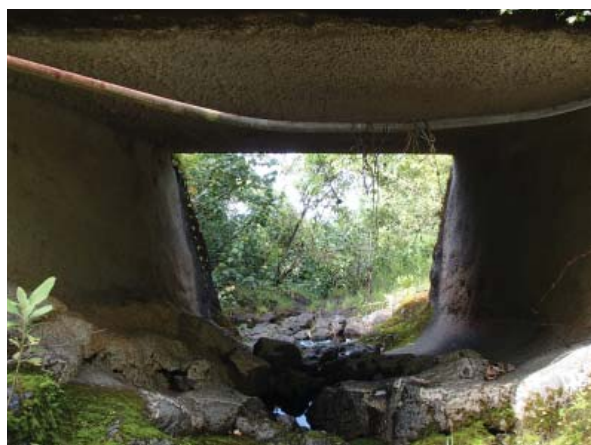
*View of Culvert #6 substructure  
Courtesy of NOEI*

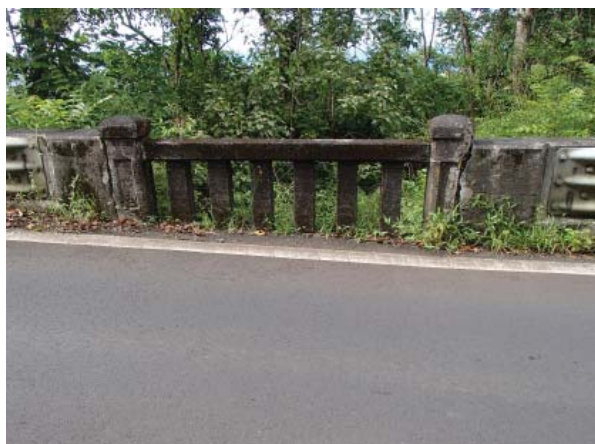
*Concrete open railings with inset panels at end caps, downstream side  
Courtesy of NOEI*

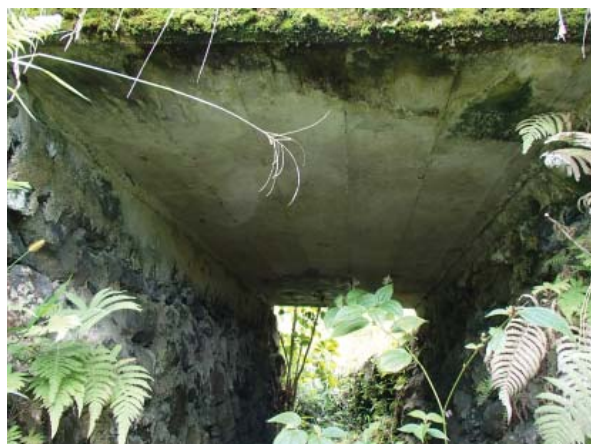
*CRM abutments  
Courtesy of NOEI*

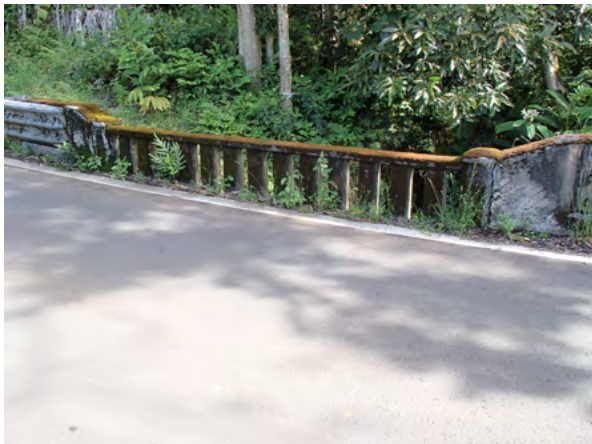
*Concrete open vertical railing, upstream side  
Courtesy of NOEI*

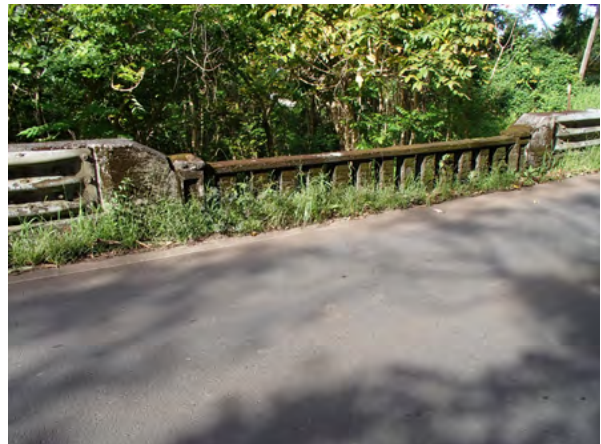
*Concrete open vertical railing, downstream side  
Courtesy of NOEI*

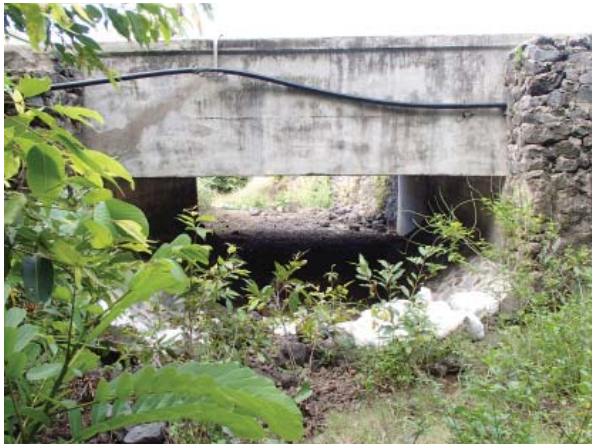
*Culvert #9 downstream elevation  
Courtesy of NOEI*

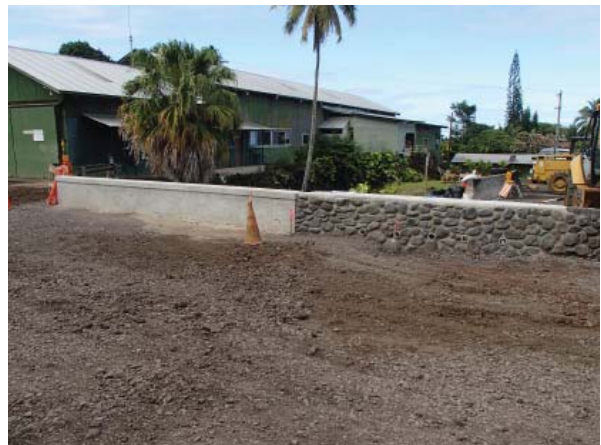
*Solid concrete parapet, downstream side, and approach wall  
Courtesy of NOEI*

The upstream approach walls and parapet are original over the culvert. The downstream parapet and approach guardrails were demolished. The downstream Hana approach wall was constructed with a CRM facade and metal guardrails were placed at the downstream Kahului approach corner. The downstream parapet was replaced with a similarly designed concrete parapet.

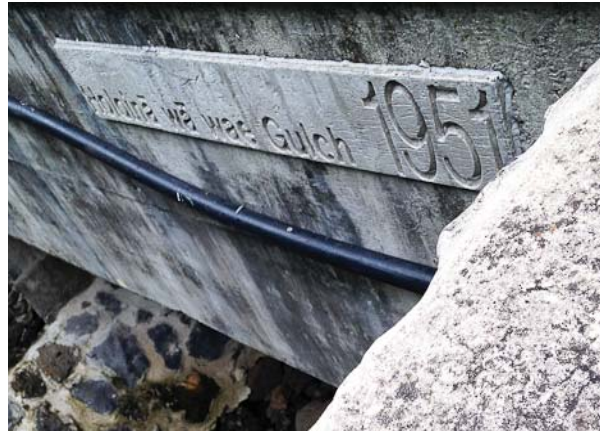
During the 2014 rehabilitation project, the downstream parapet was replaced with a new, solid concrete parapet without an inscription. However, a simple concrete name and date plaque was added to the exterior side of the upstream parapet during this project. The concrete plaque is inscribed "Holoina wa wae 1951" with diacritical marks; the date is incorrectly inscribed. Additionally, a 1934 parcel tax map indicates the feature crossed at this location is "Holoinawae Stream."<sup>13</sup>

*Culvert #9 upstream elevation with incorrect date inscription  
Courtesy of FAI*

It is recommended that the culvert name and feature crossed at this location be confirmed, and that the name and date plaque be changed to reflect the correct date of 1915 original construction. It is also recommended that the plaque be re-located at a more visible portion of Culvert #9 in approach walls (refer to "CRM Approach Walls" section). The name of this culvert shall be verified through a process to be determined during future development of

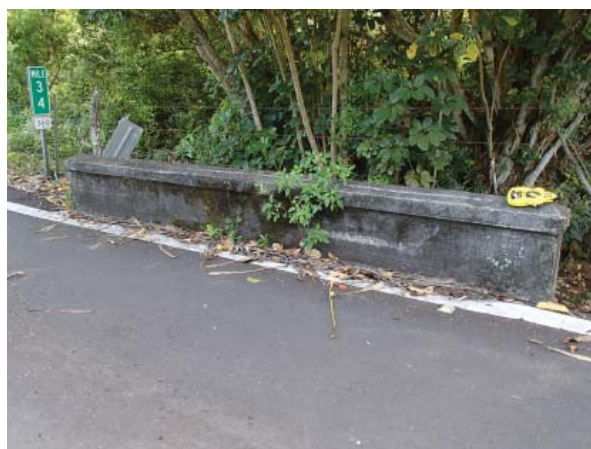
*Solid parapet  
Courtesy of NOEI*

The concrete culvert parapets do not meet TL-2 crash requirements. It is recommended to preserve, relocate, and connect the existing upstream parapet to the new widened portion of the deck. A crash-tested railing will be constructed in front of the existing parapets. For this purpose, it is recommended to use a Wyoming 740 railing which will be attached to the deck of the culvert (refer to Section G, Appendix 5. *Proposed Crash-Tested Railing*

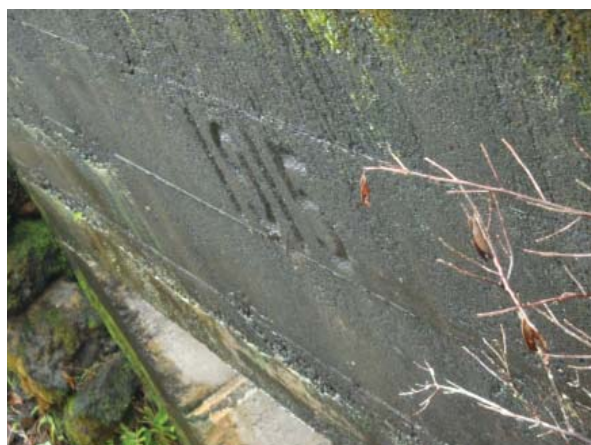
*Culvert #10 downstream elevation with inscription  
Courtesy of NOEI*

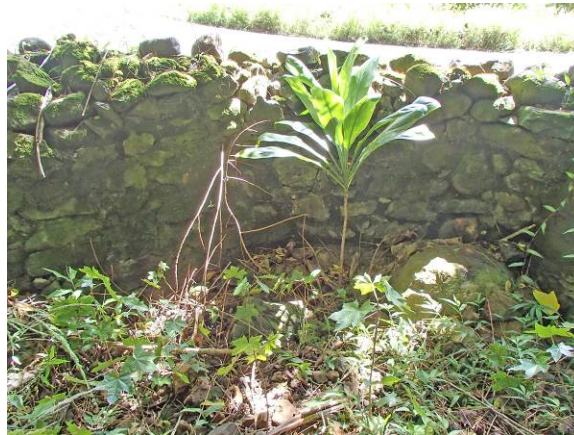
The unknown culvert was found at mile point 14.91 with a CRM headwall, but the upstream inlet did not have any openings (refer to *Figure D – 1*, below).

*Figure D – 1: Backside view of upstream headwall at mile point 14.91  
Courtesy of NOEI*

Record drawings do not exist for these found culverts and it is unknown as to when they were constructed. The HAER report mentions and describes culvert types found along the Hana Highway, Route 360 (refer to *Figure D – 2*). The load carrying capacities of these culverts are unknown since as-built drawings are not available for these structures, nor have condition evaluations for them been performed. At the time of the survey, the found culverts were found to be in good condition. It is recommended that the found culverts be investigated to determine their load carrying capacity and code compliance.

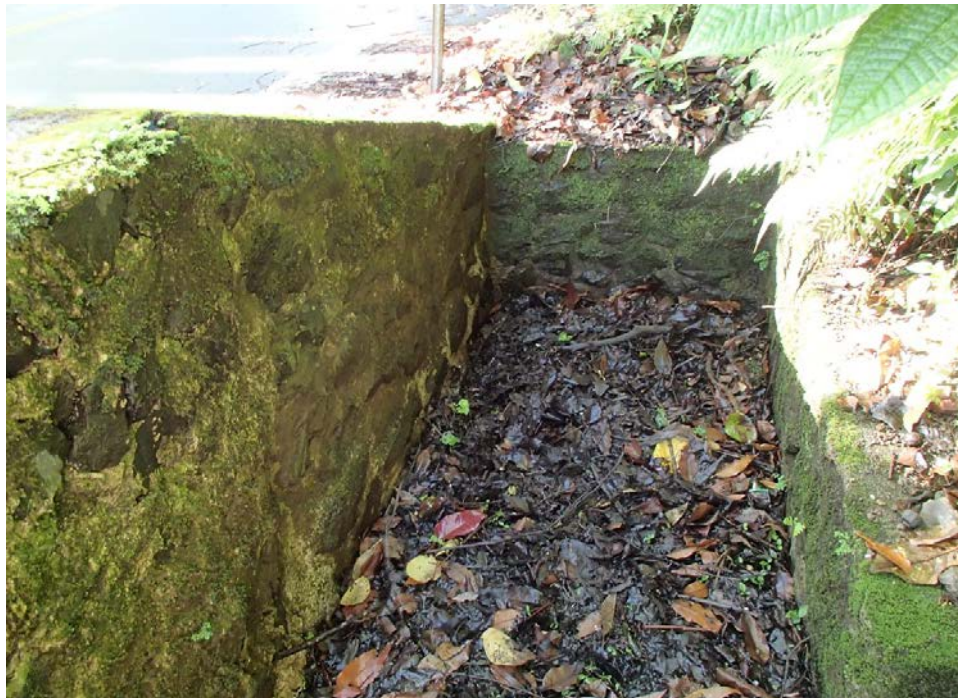
Backside view of upstream / Hana corner of CRM parapet.

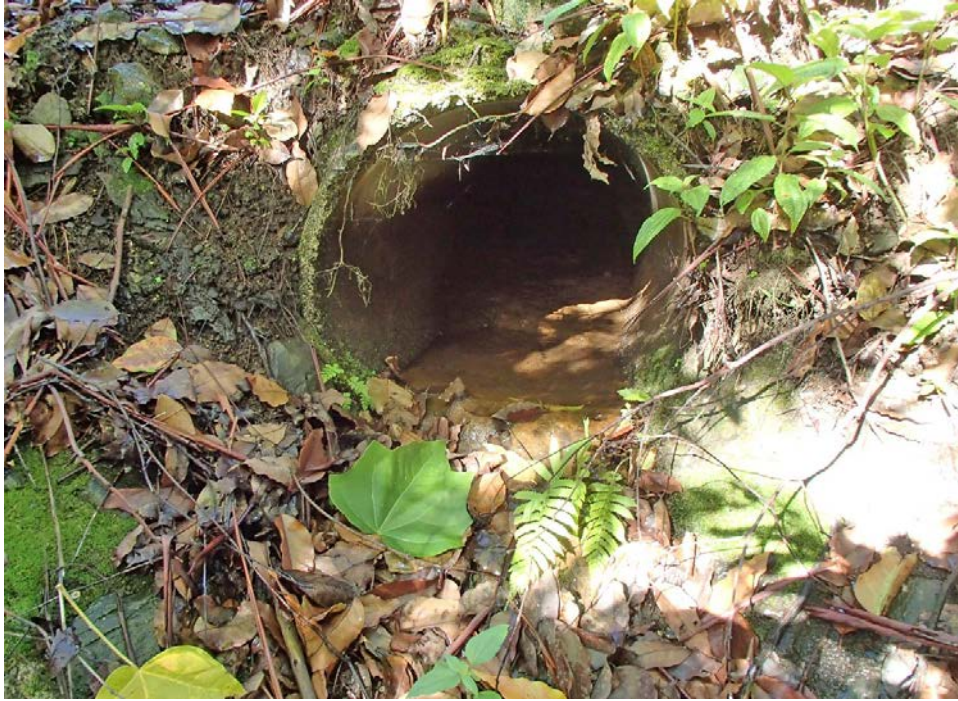
24" diameter RCP outlet at downstream side.

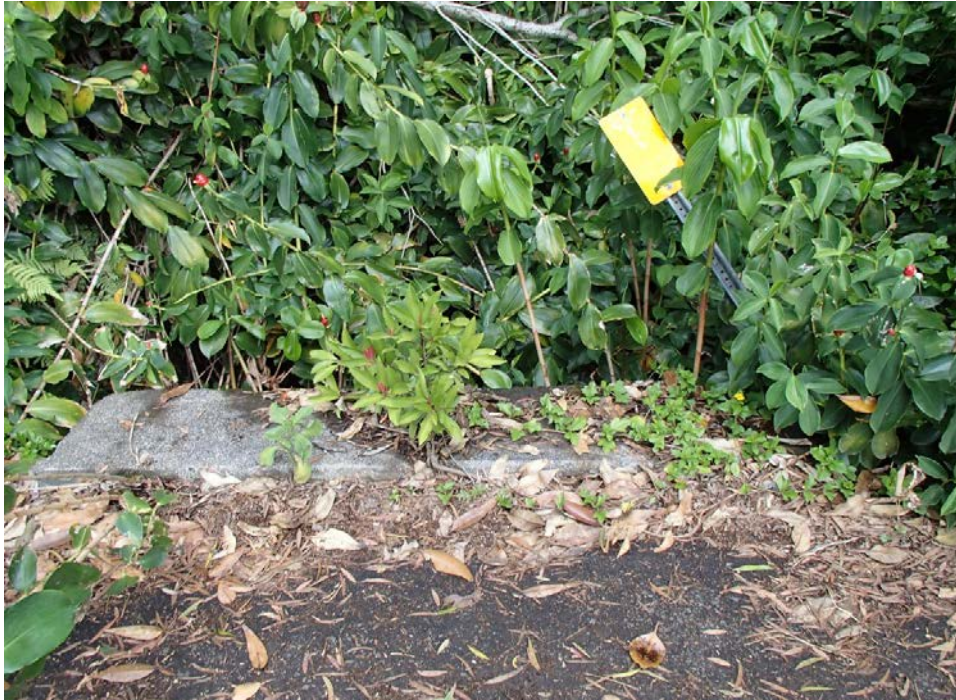
View of upstream CRM parapet looking upstream.

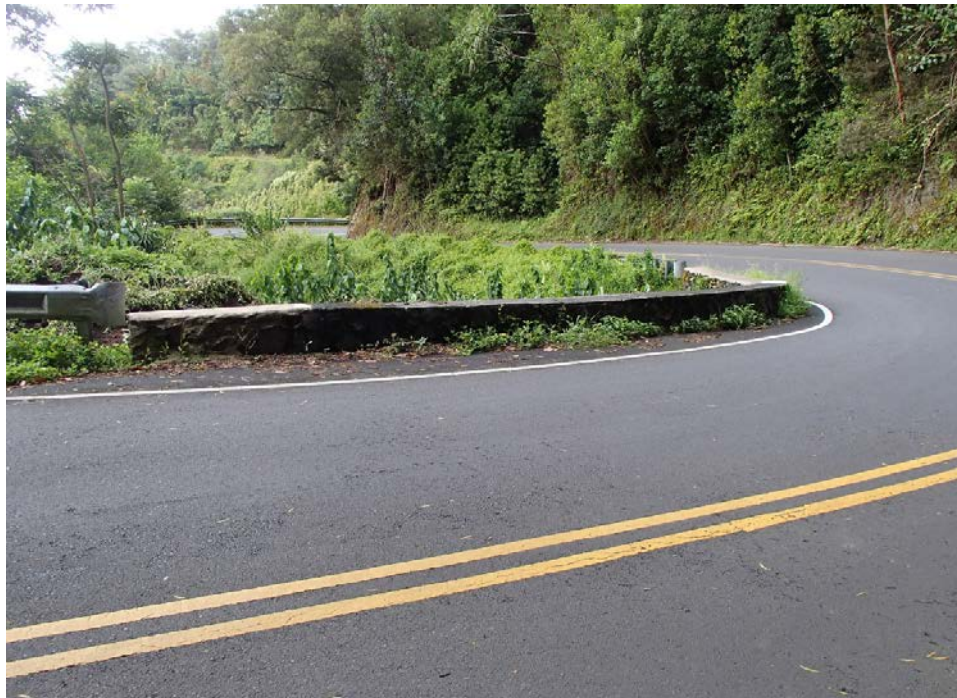
View of downstream CRM parapet looking south-east.

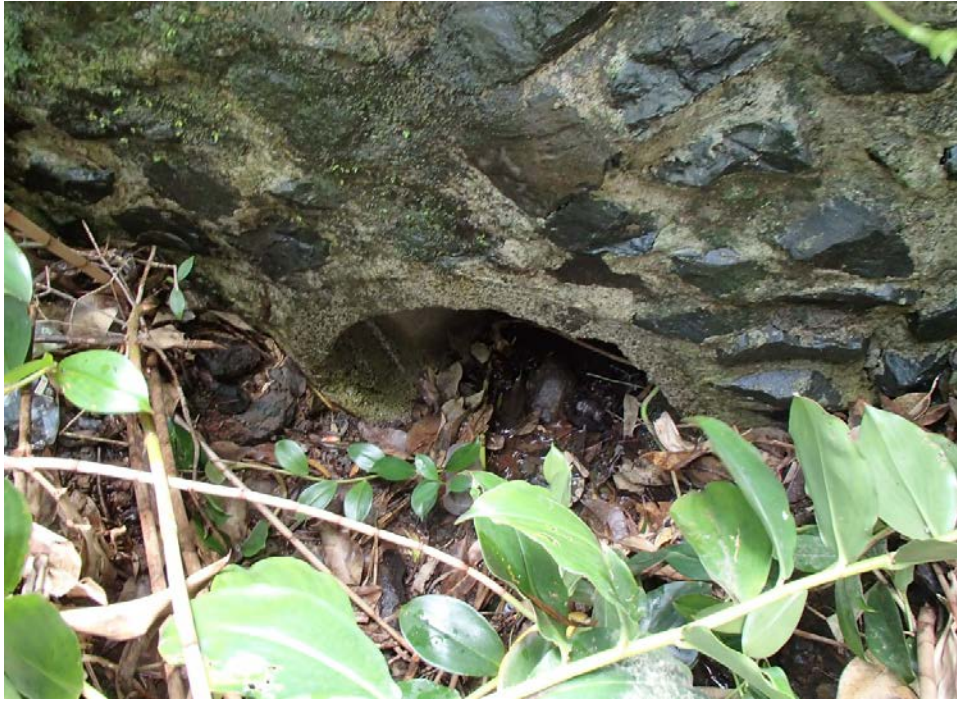
24" diameter RCP inlet at upstream side.

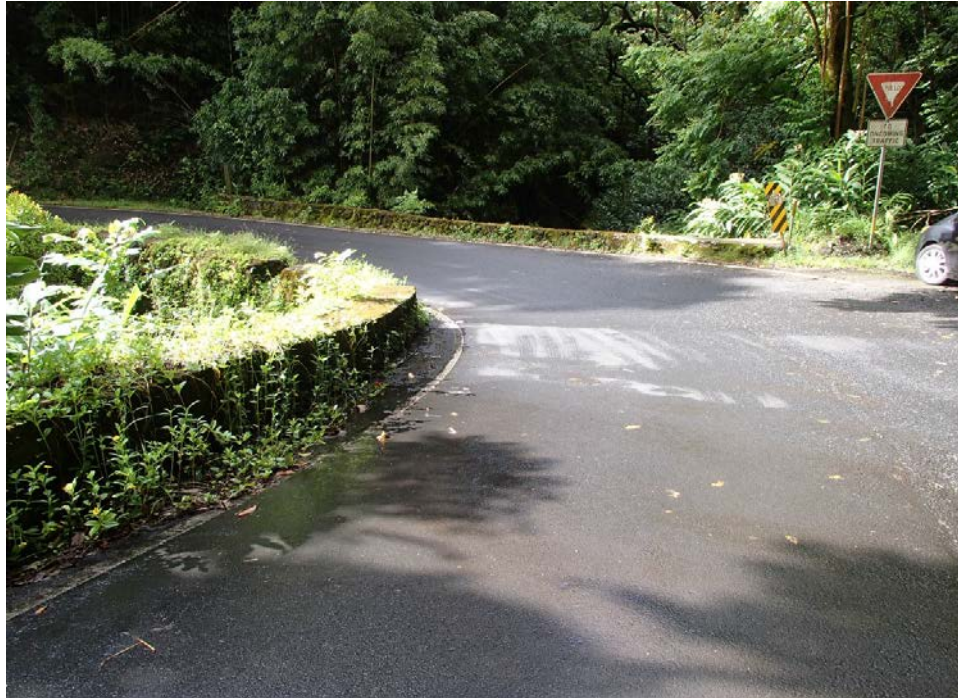
Kahului approach looking toward Hana.

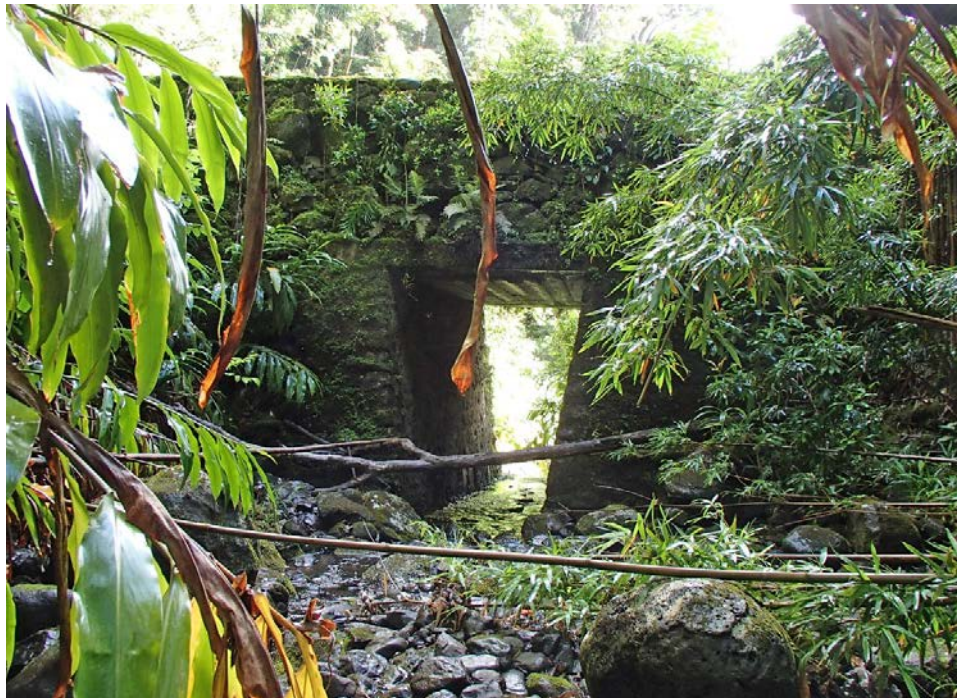
Upstream elevation view of culvert.

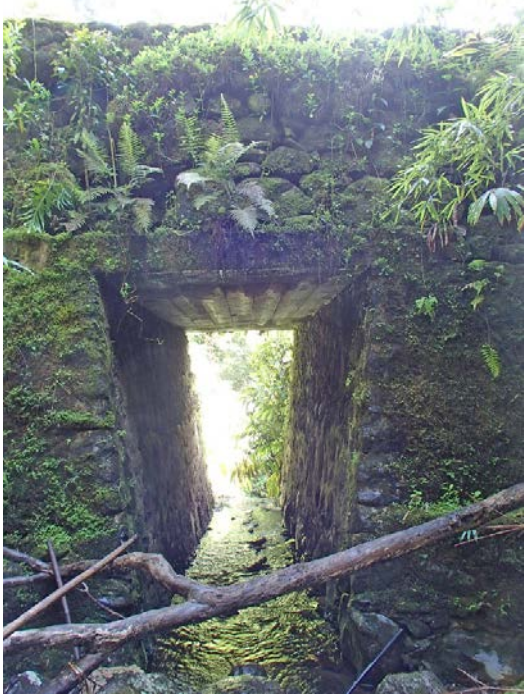
<p>Close-up of culvert opening at upstream side.</p>

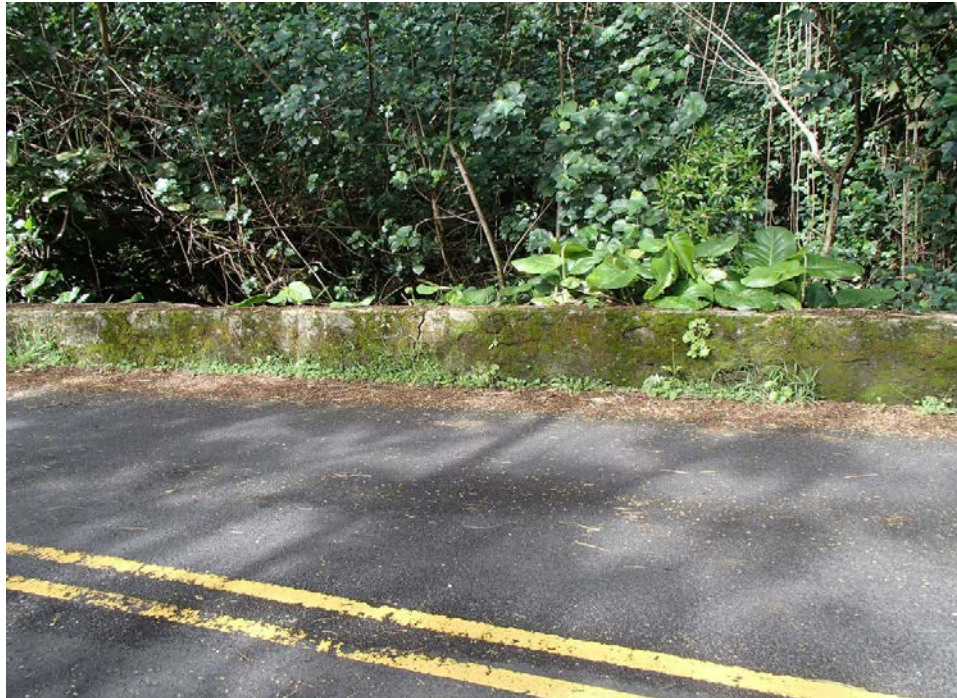
View of upstream CRM parapet.

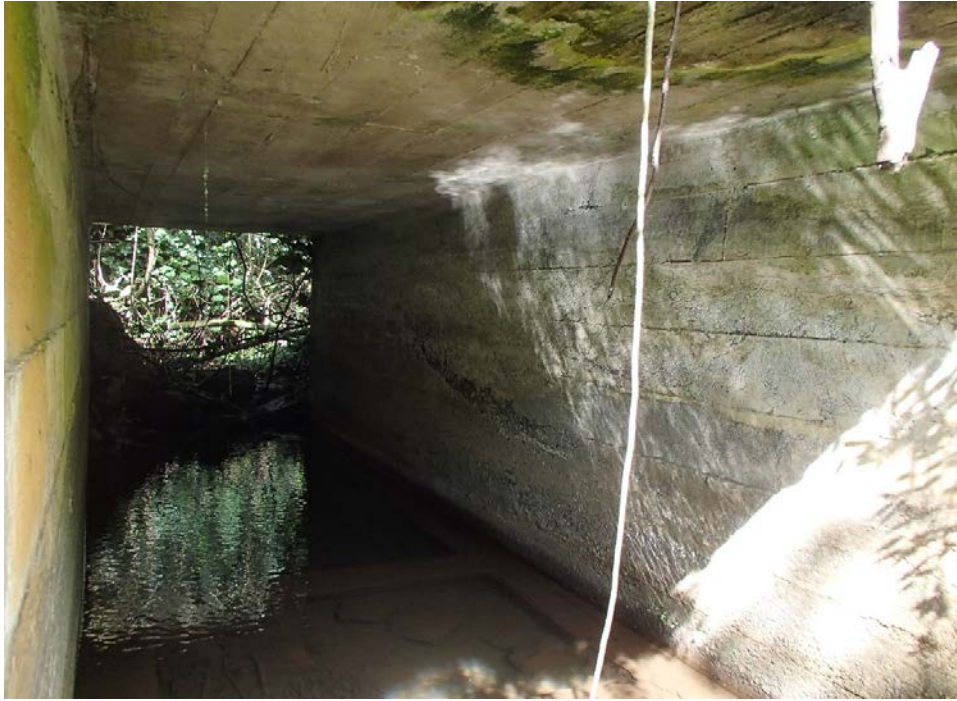
Upstream view through concrete box culvert.

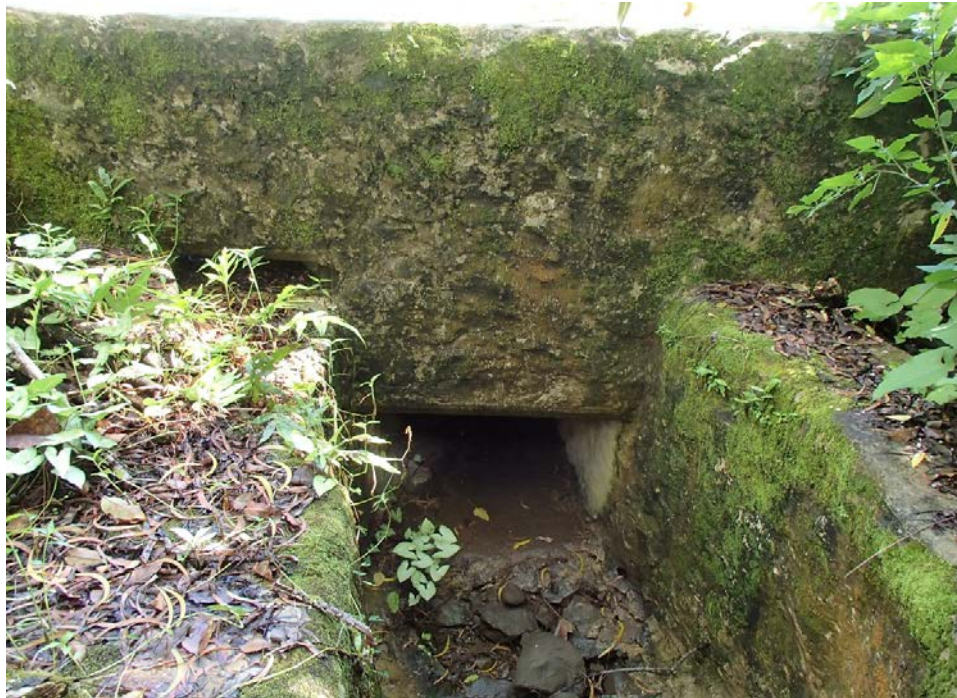
Backside view of upstream CRM headwall / parapet.

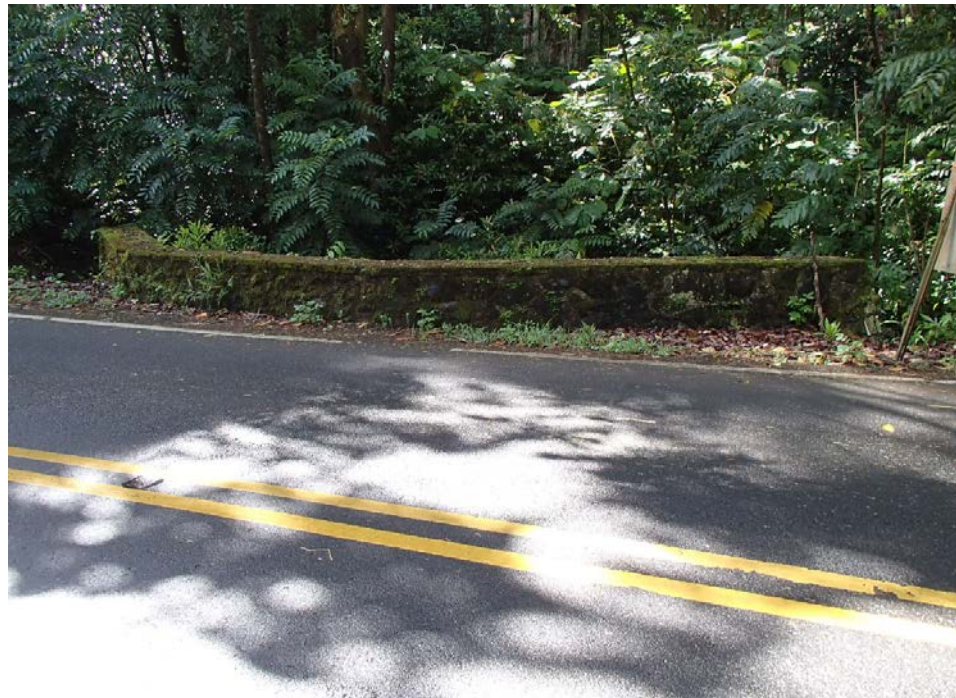
View of upstream CRM parapet.

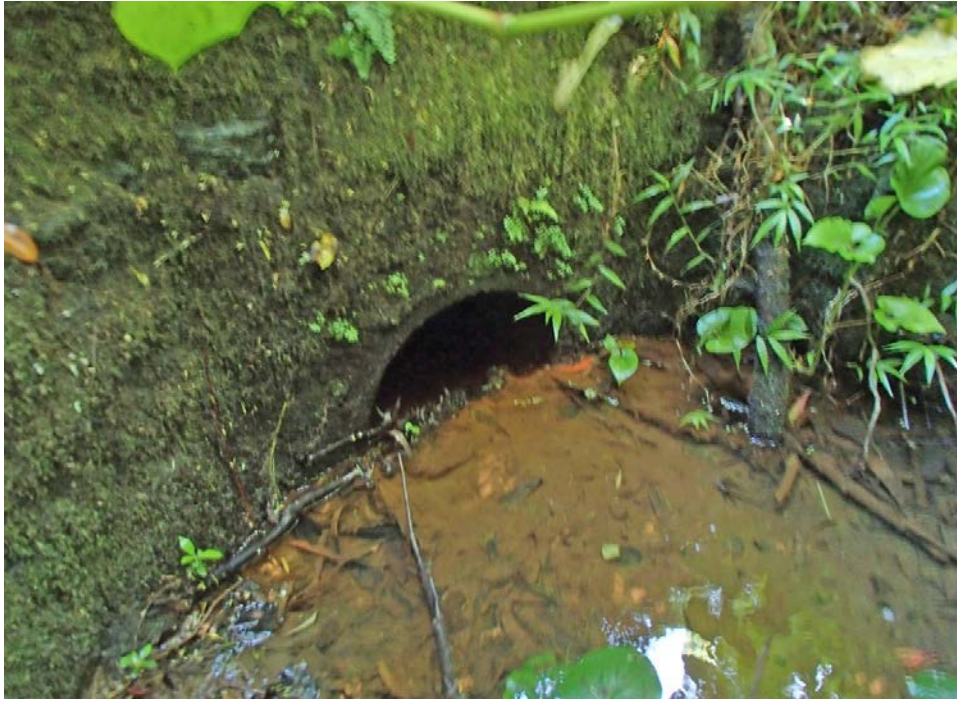
24" diameter RCP inlet at upstream side.

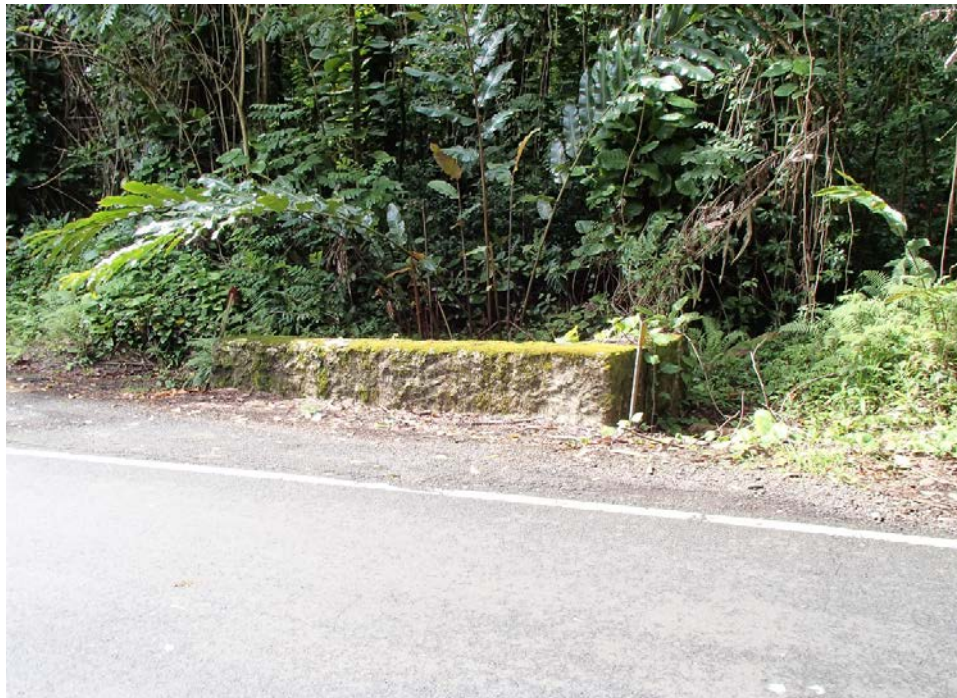
View of upstream CRM parapet.

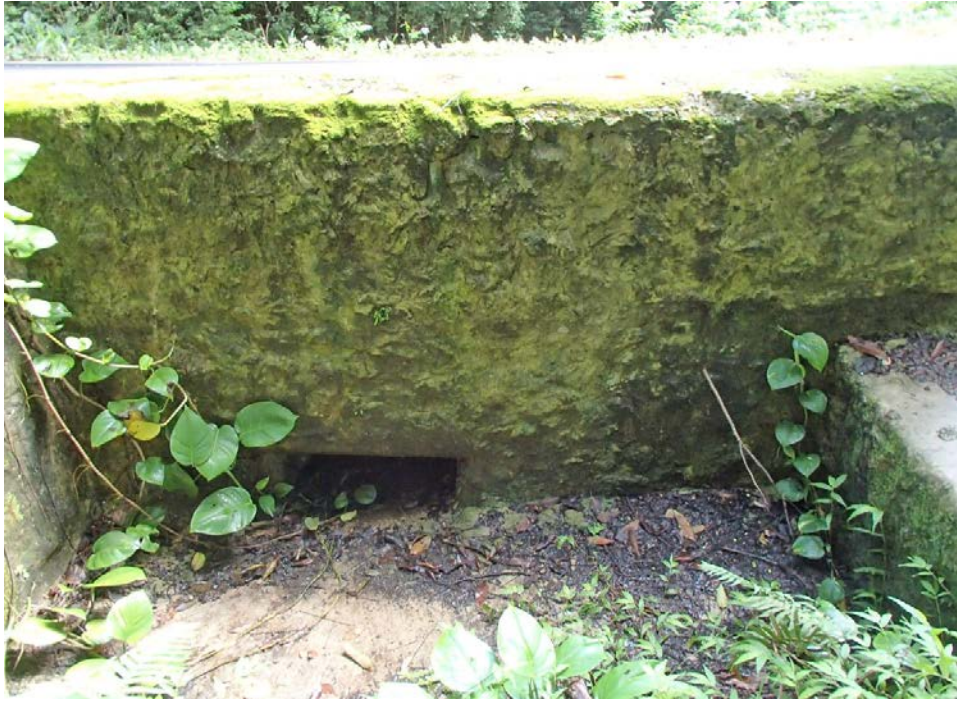
View of upstream CRM headwall / parapet and culvert inlet.

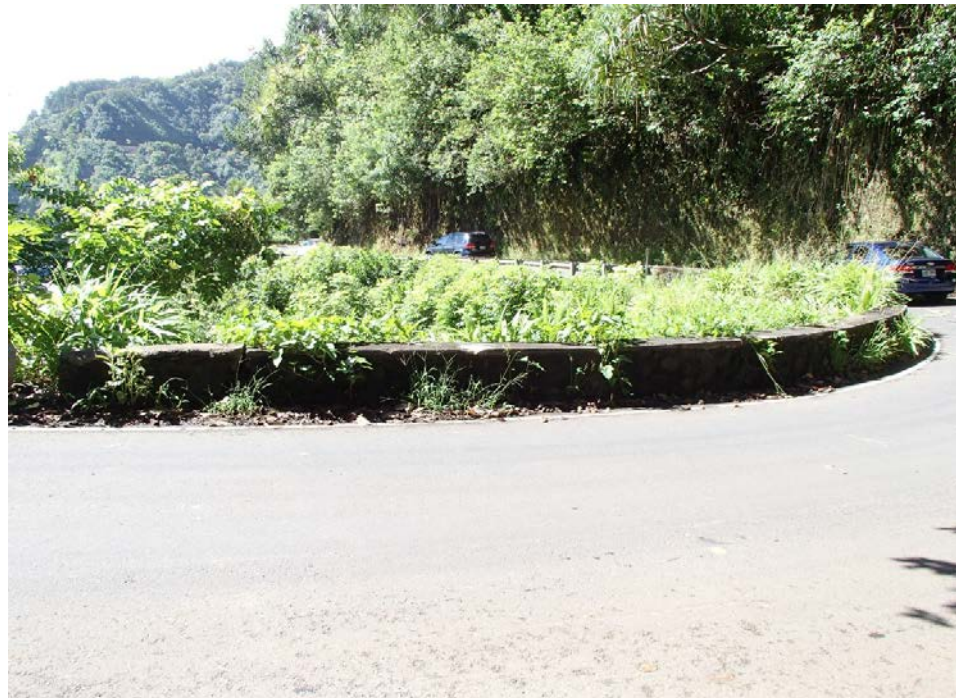
View of downstream CRM parapet looking south-east.

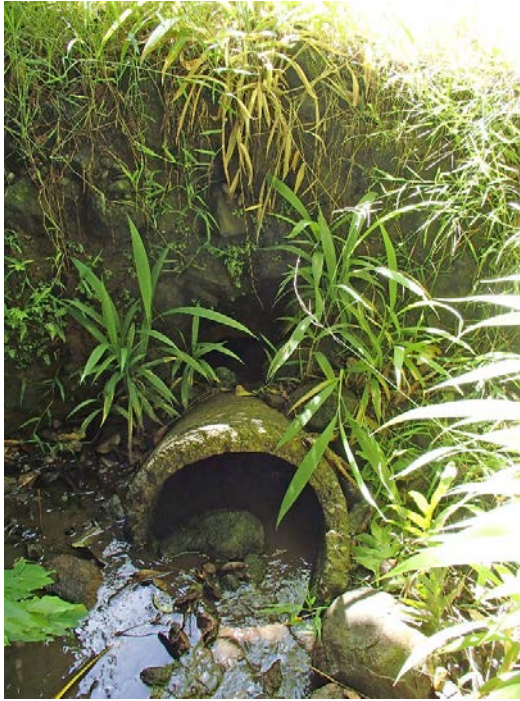
24" diameter RCP inlet at upstream side.

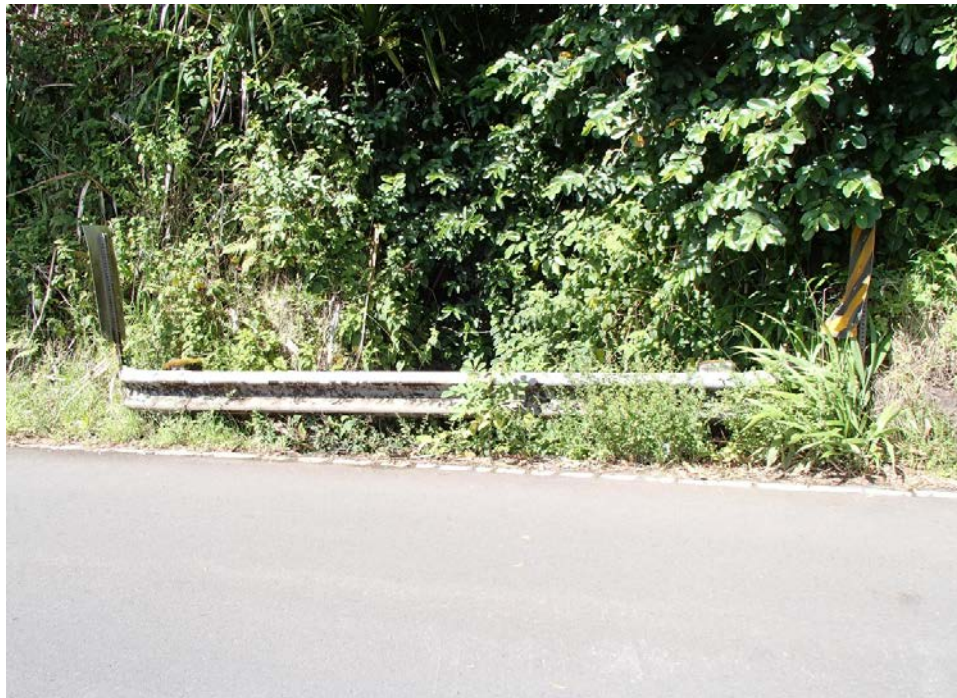
View of upstream metal guardrail.

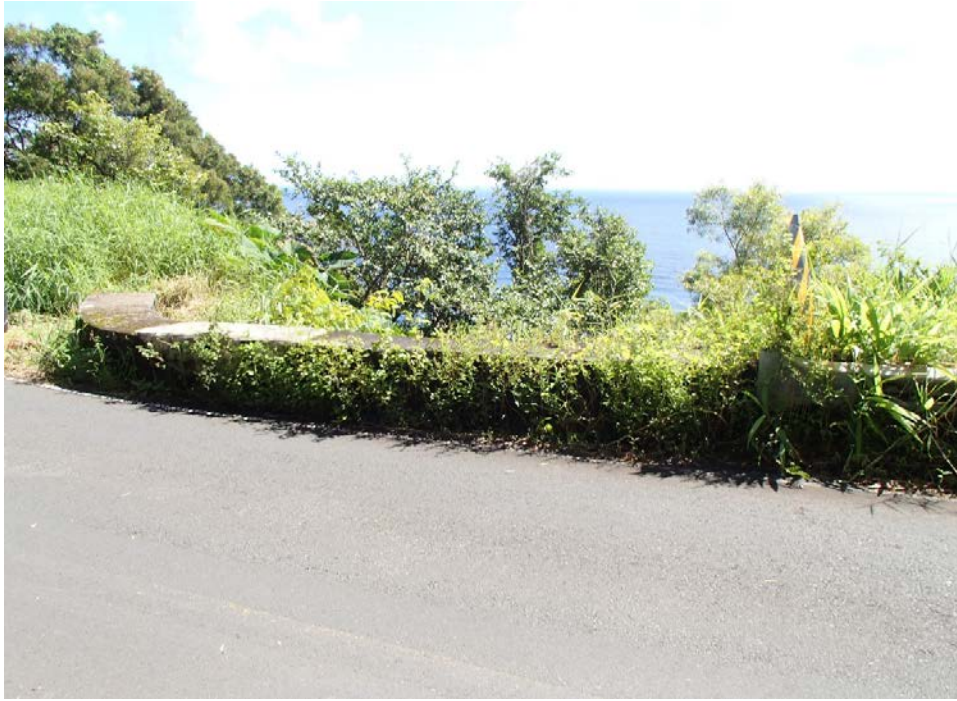
View of downstream CRM parapet.
