# **SECTION C**

CULVERTS

## HAER CULVERTS OVERVIEW

## Hana Highway, Route 360

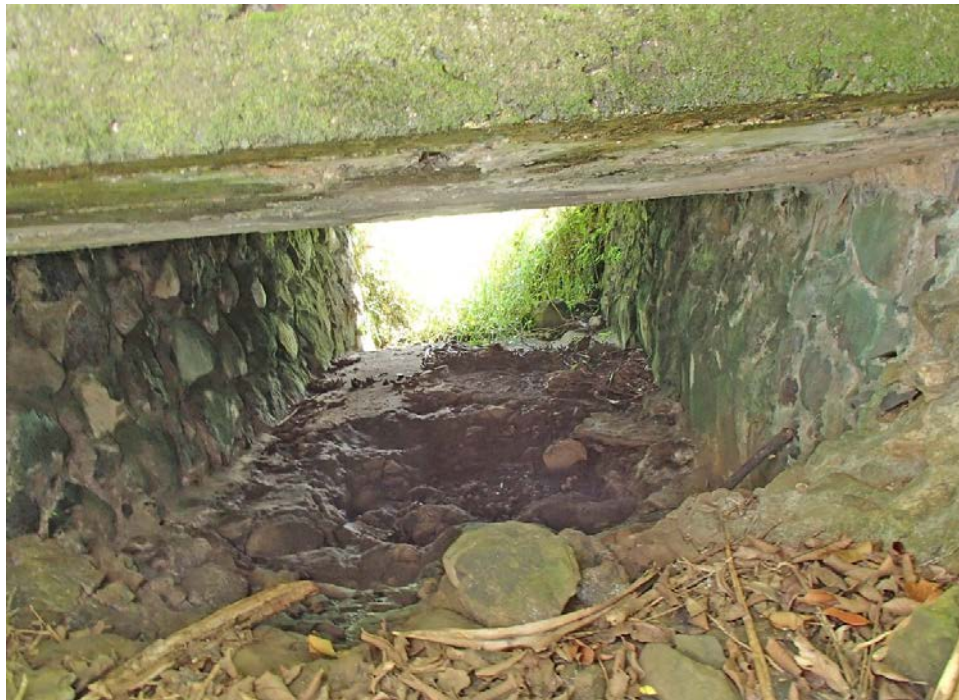
View through culvert from the upstream end.

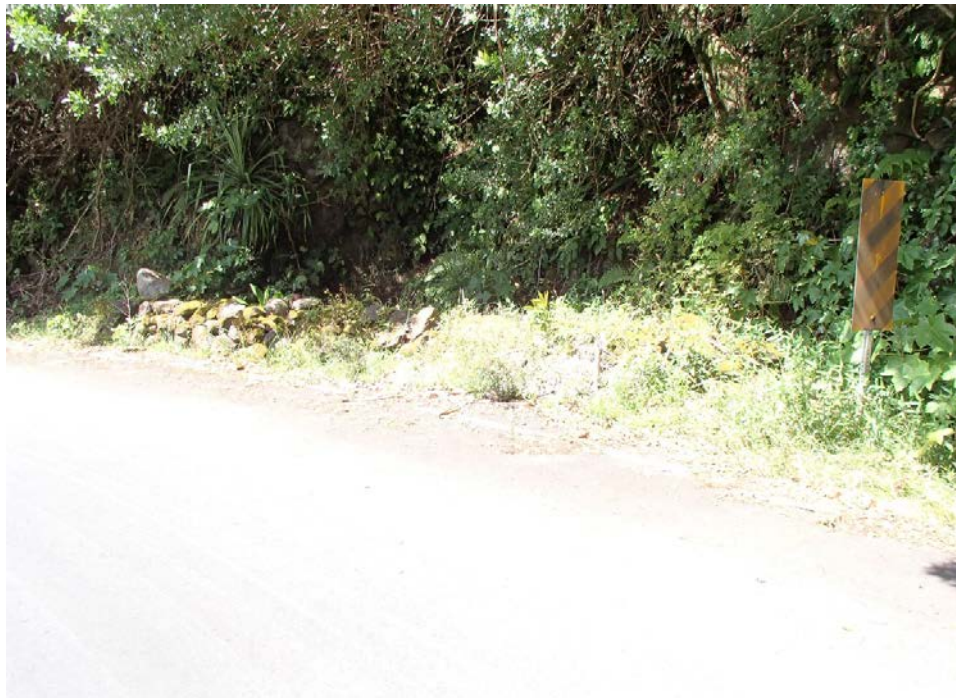
View of upstream CRM parapet.

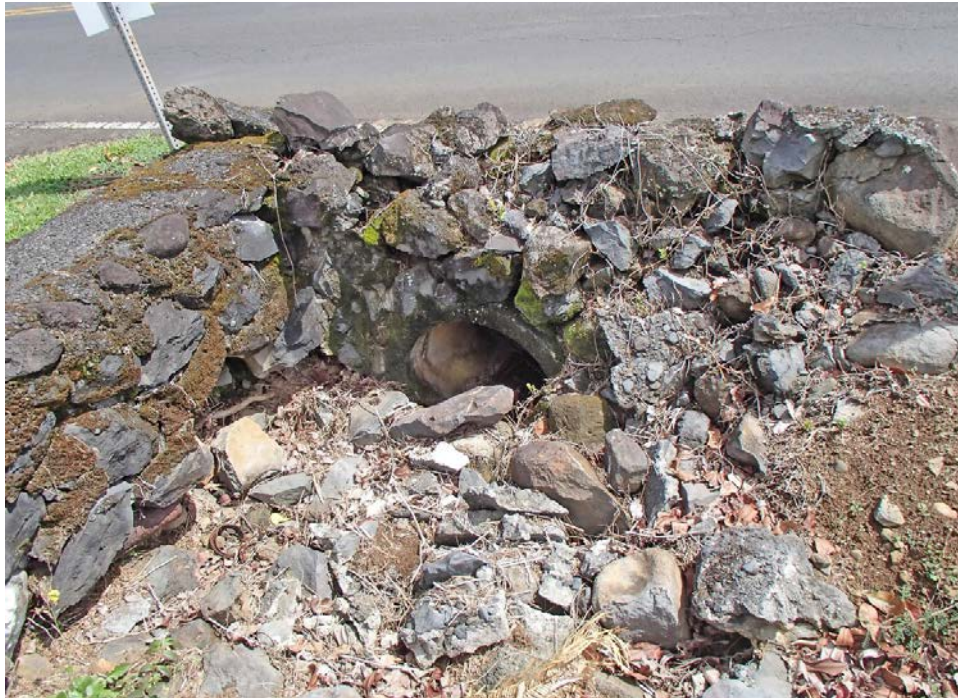
24" diameter RCP inlet at upstream side. Upstream / Hana corner of CRM parapet is damaged.

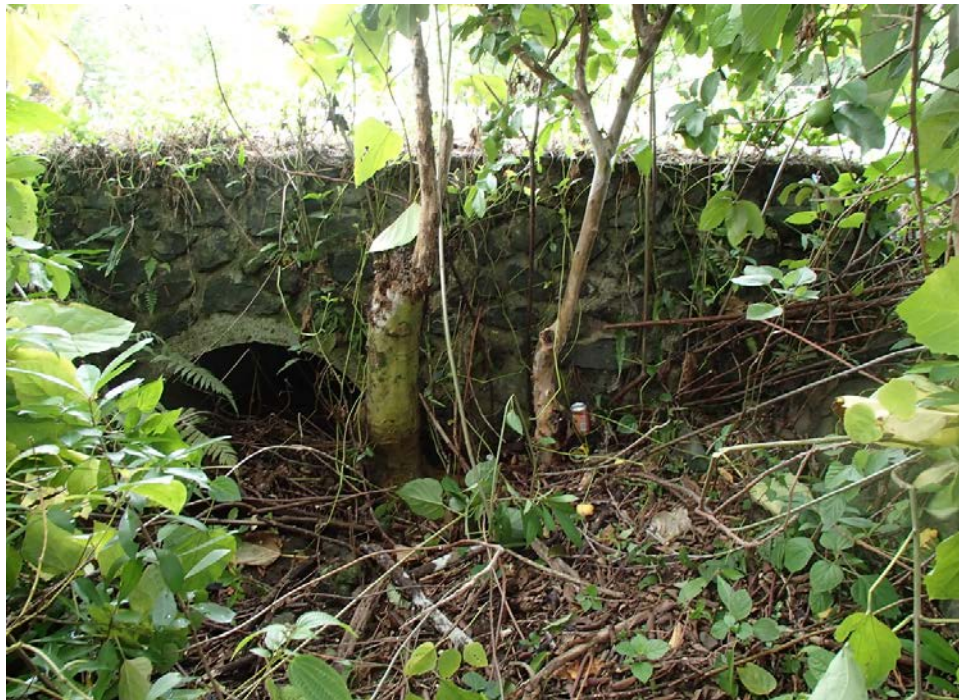
1 - 36" diameter and 1 - 24" diameter RCP outlets in downstream CRM headwall. 24" outlet is filled with debris.

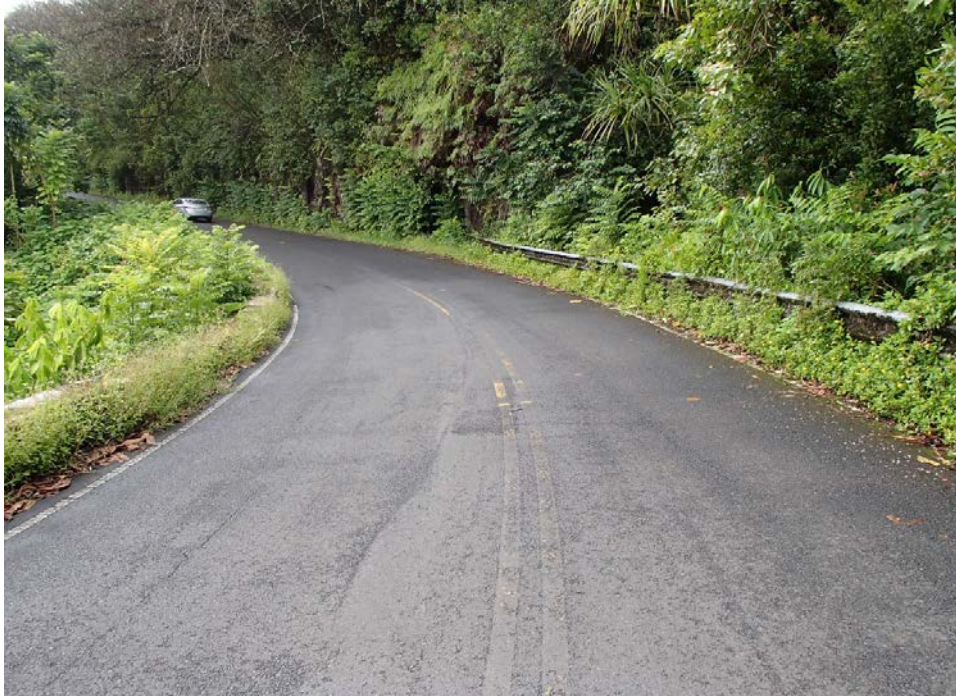
Kahului approach looking toward Hana.

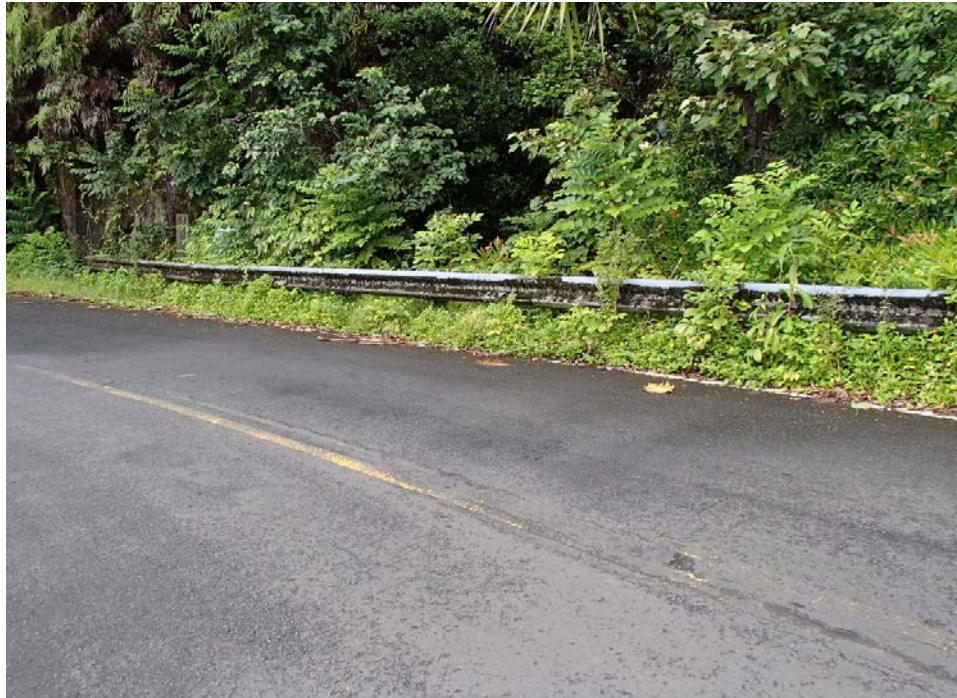
View of upstream metal guardrail.

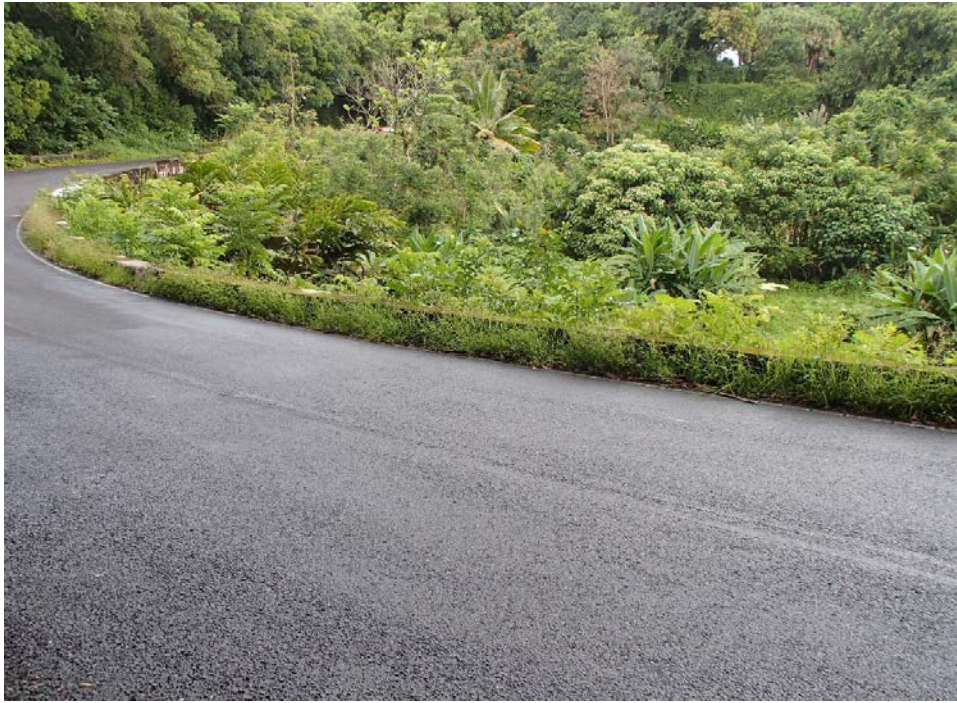
View of downstream CRM parapet.

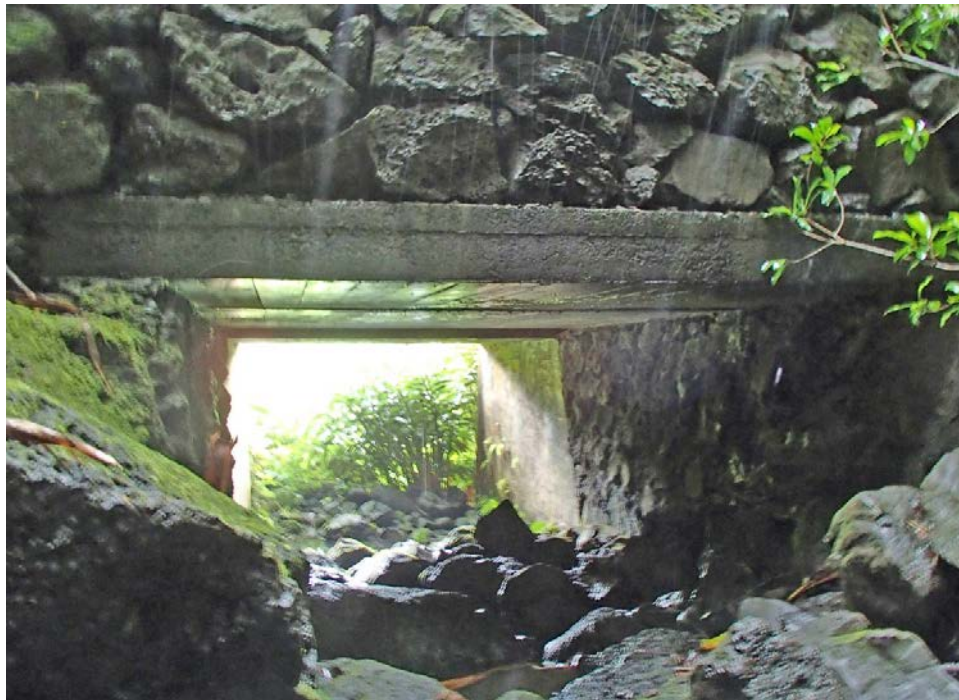
Downstream view through upstream end of bridge.

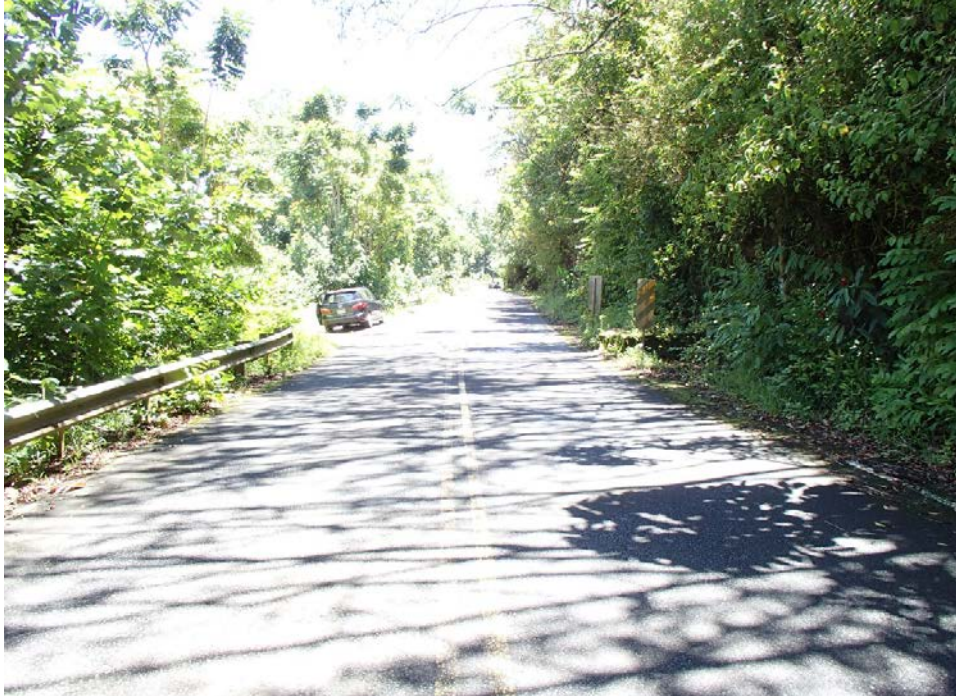
Kahului approach looking toward Hana.

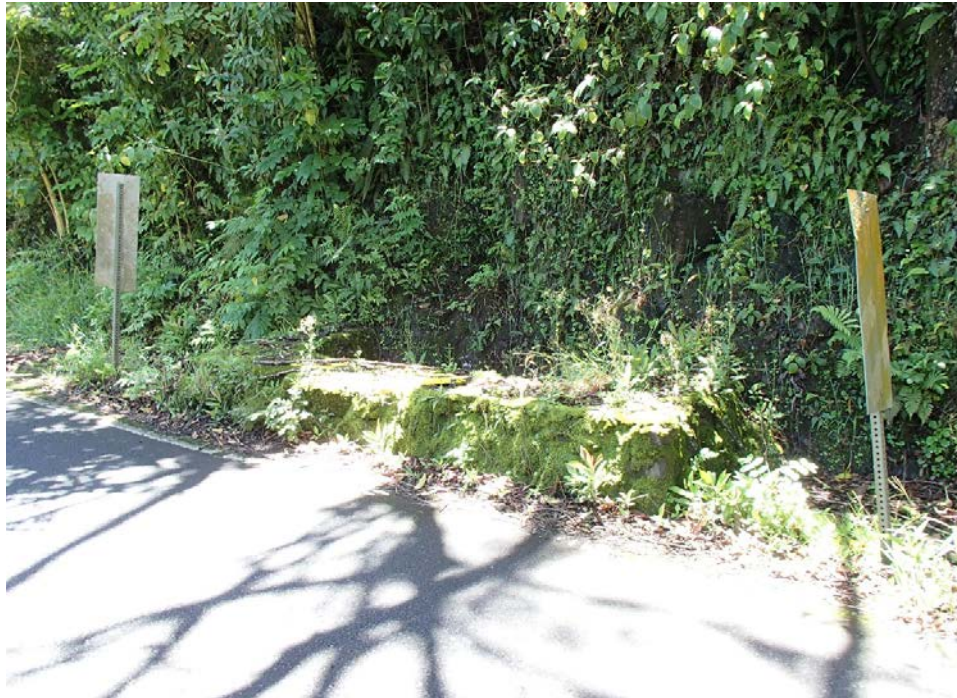
View of upstream CRM parapet.

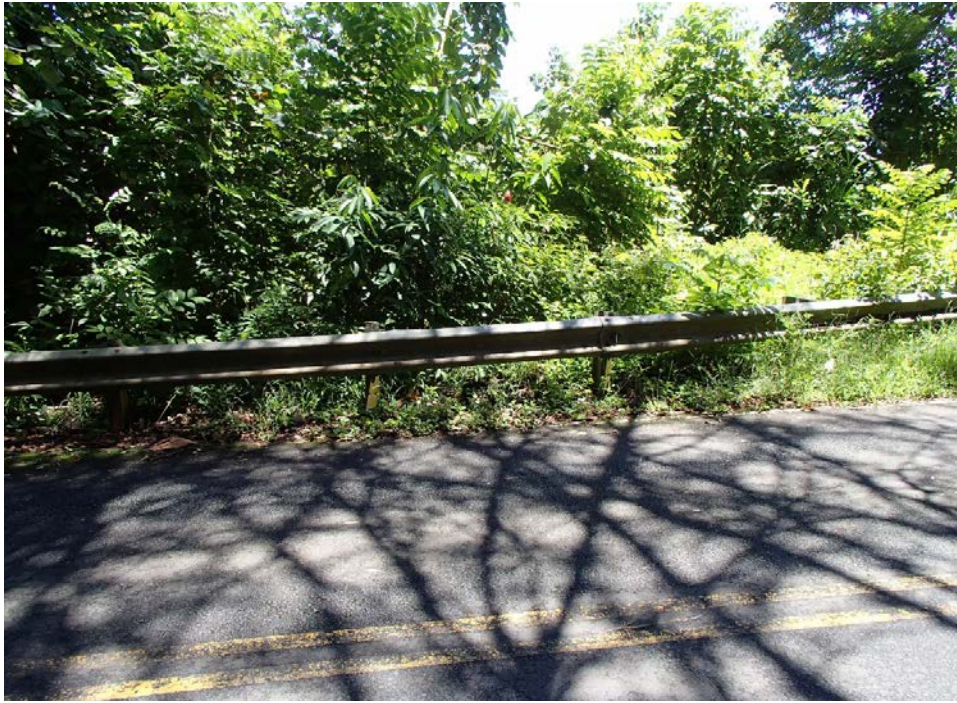
View of downstream metal guardrail.

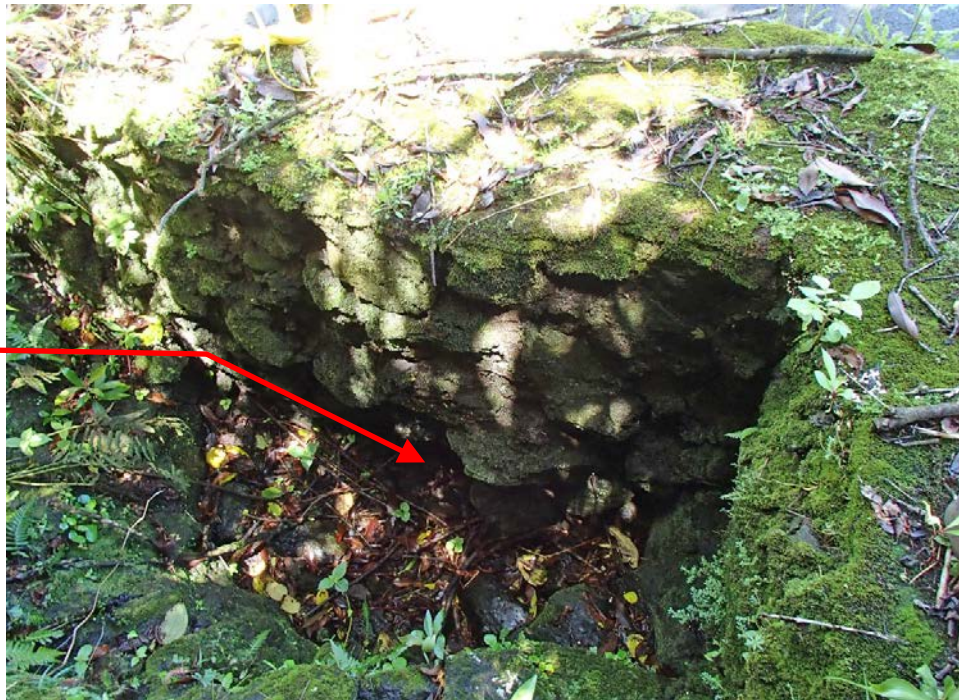
View of upstream CRM headwall / parapet and 24" diameter RCP inlet.

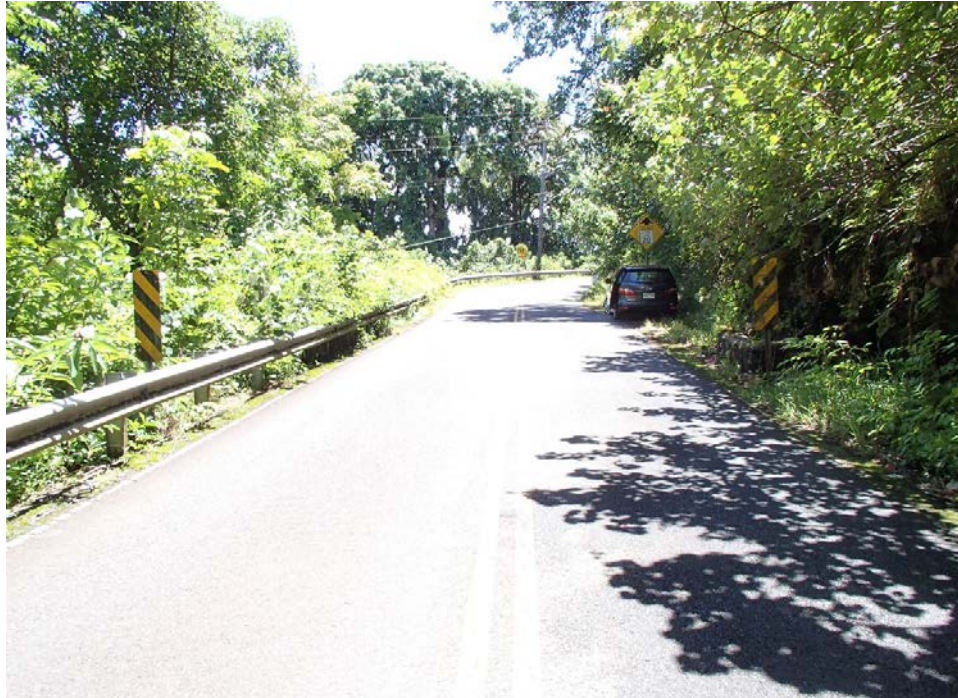
Kahului approach looking toward Hana.

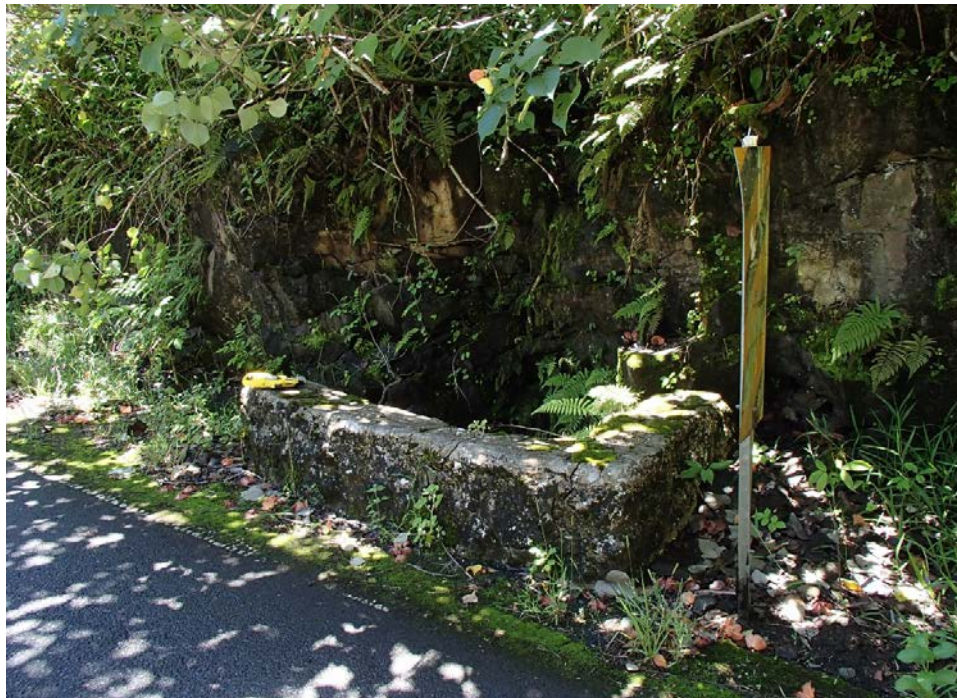
View of upstream CRM parapet.

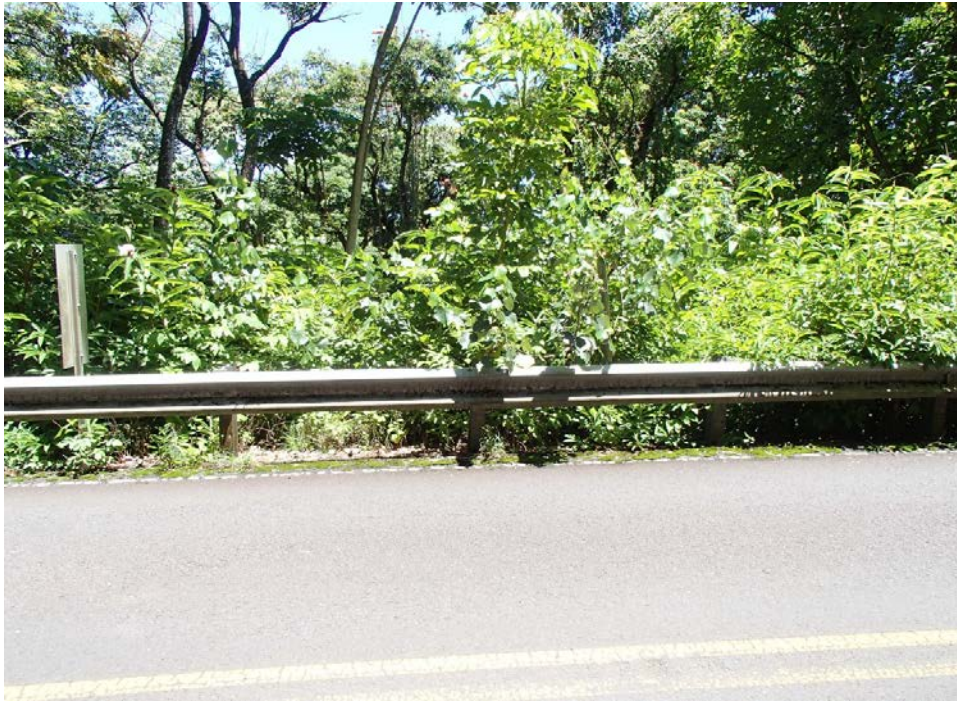
View of downstream metal guardrail.

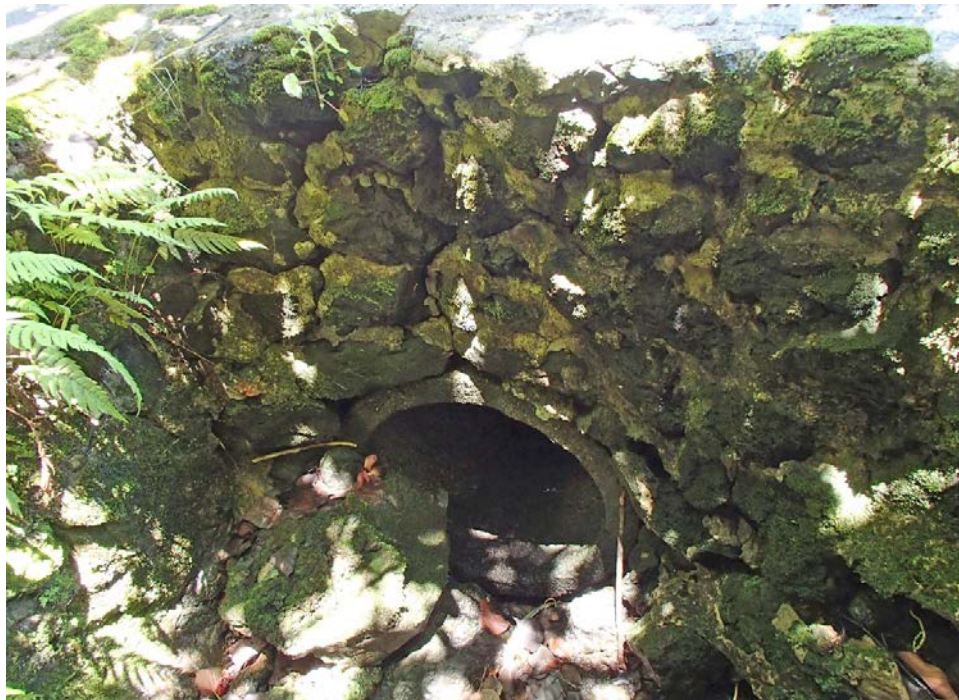
View of upstream CRM headwall / parapet and 24" diameter RCP inlet.

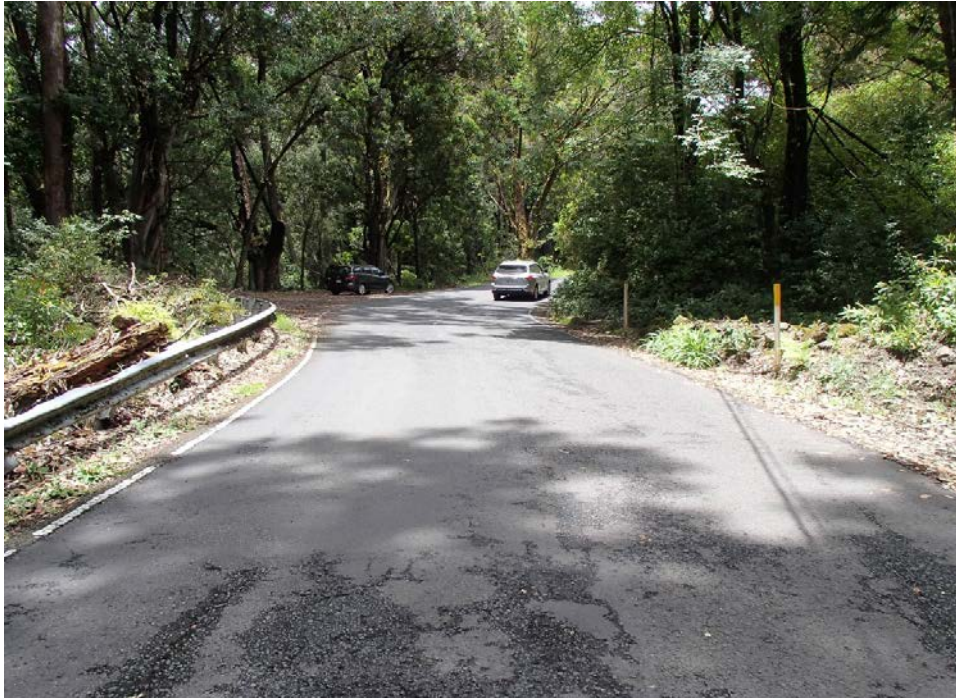
Kahului approach looking toward Hana.

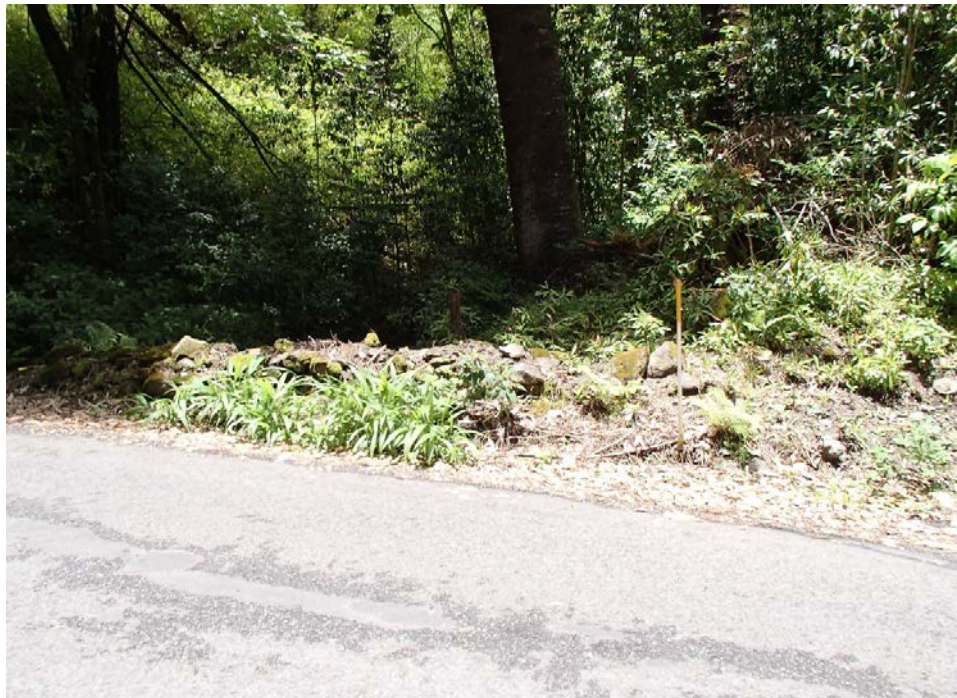
View of upstream CRM parapet.

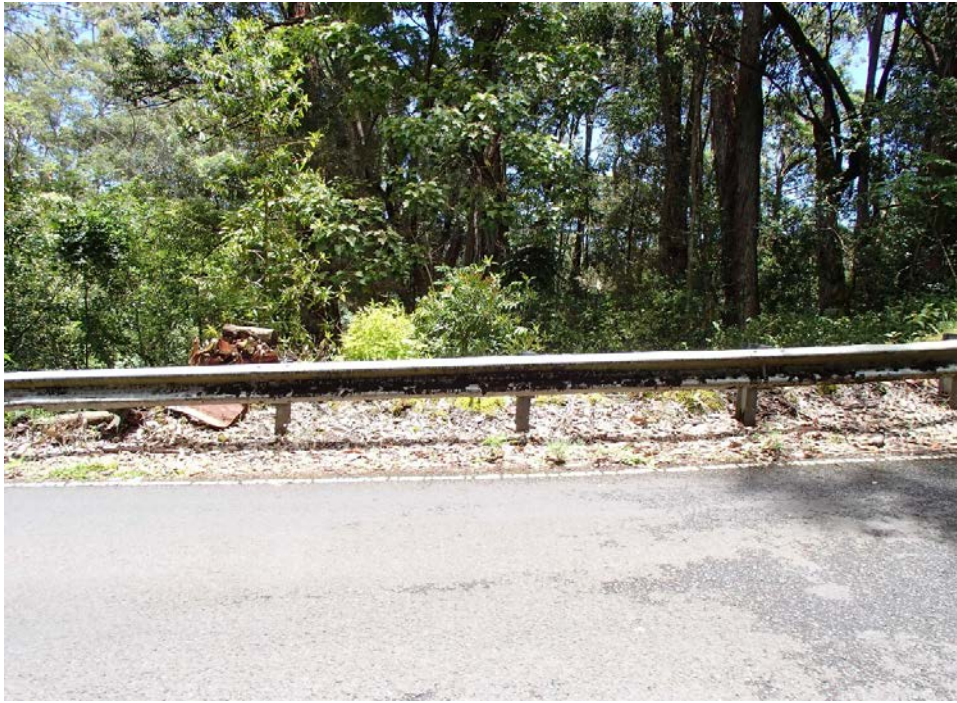
View of downstream metal guardrail.

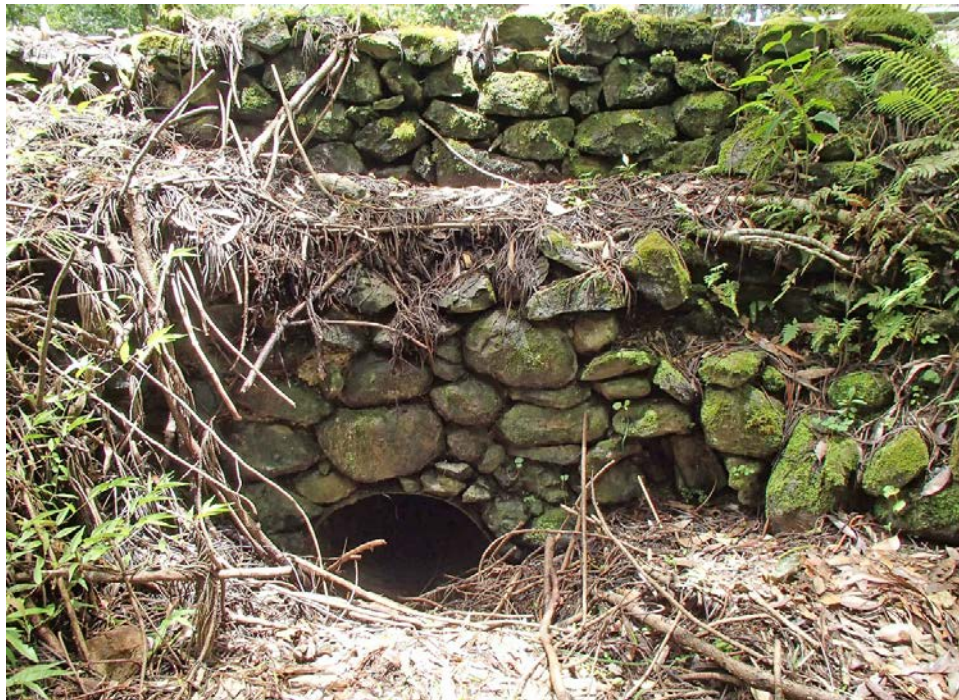
View of upstream CRM headwall / parapet and 30" diameter CMP inlet.

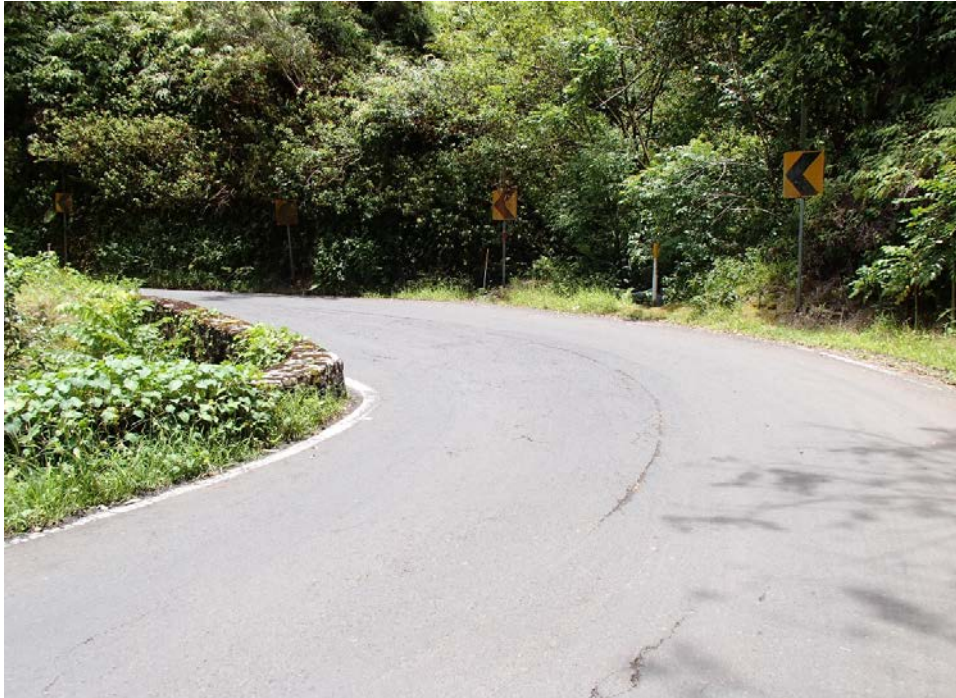
Kahului approach looking toward Hana.

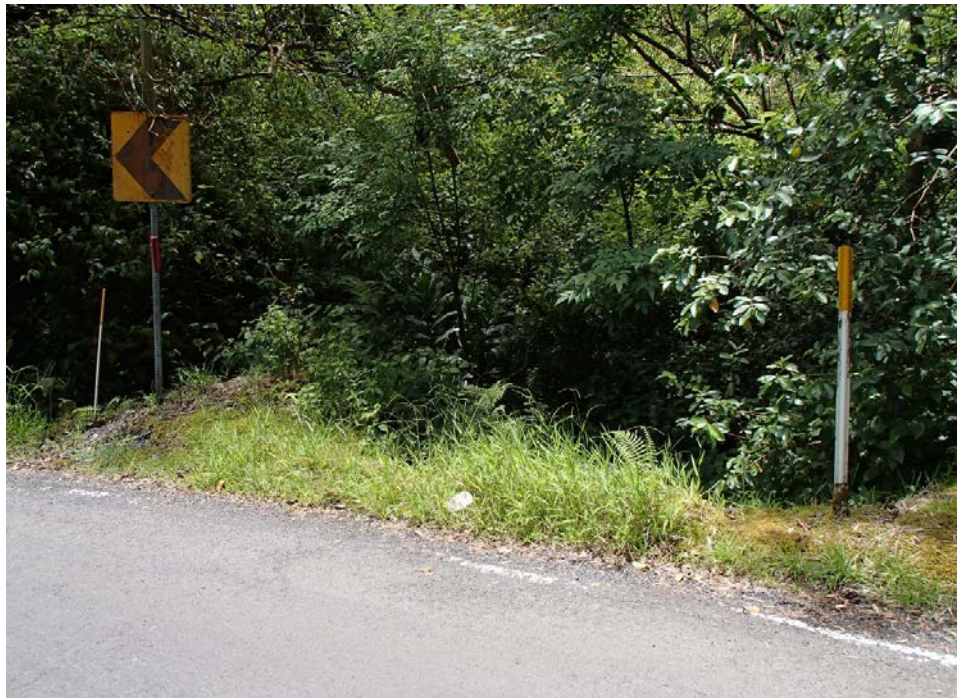
View of upstream CRM parapet.

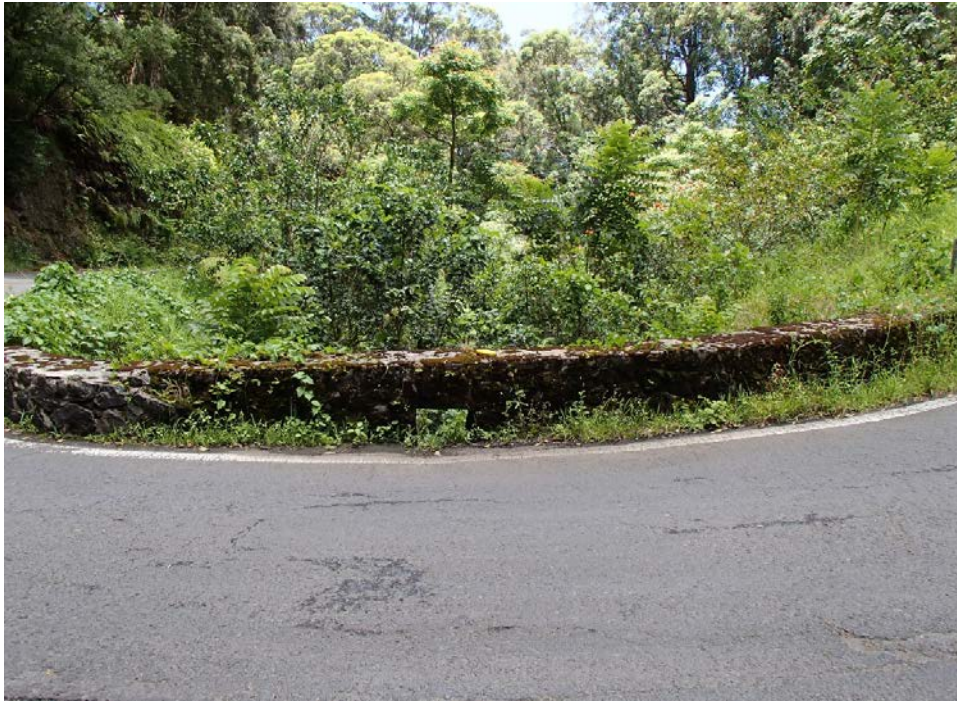
View of downstream CRM parapet.

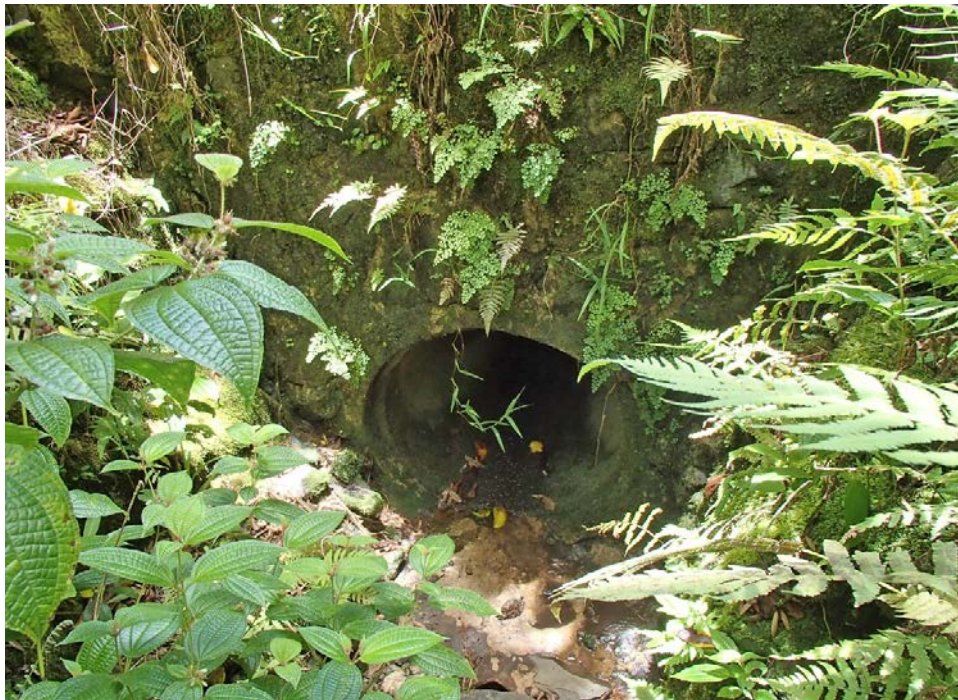
36" diameter CMP inlet at upstream side.

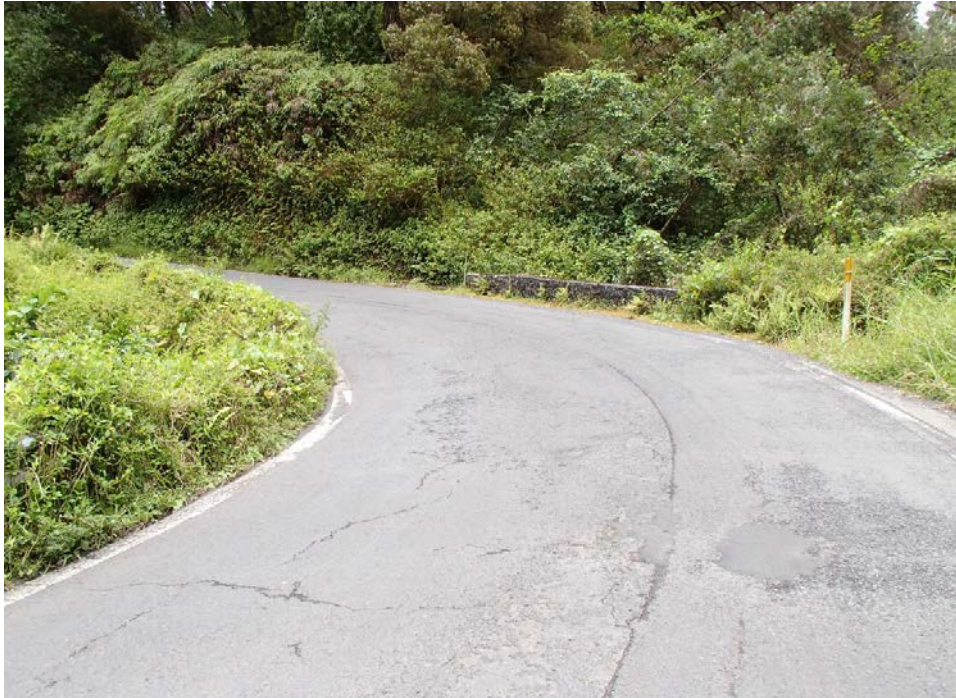
Kahului approach looking toward Hana and upstream CRM parapet.

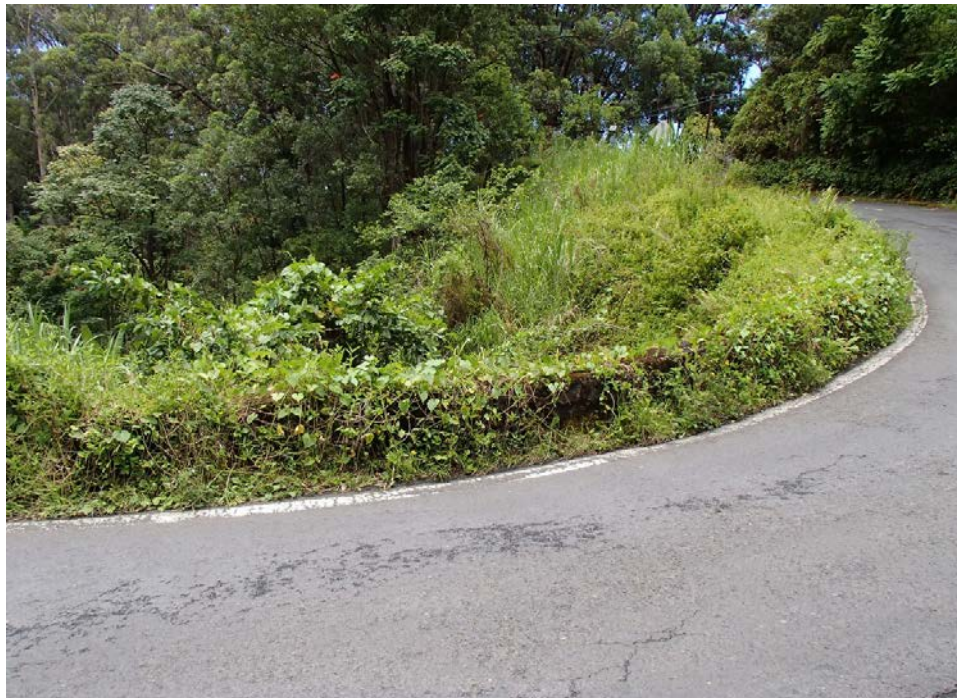
View of downstream CRM parapet.

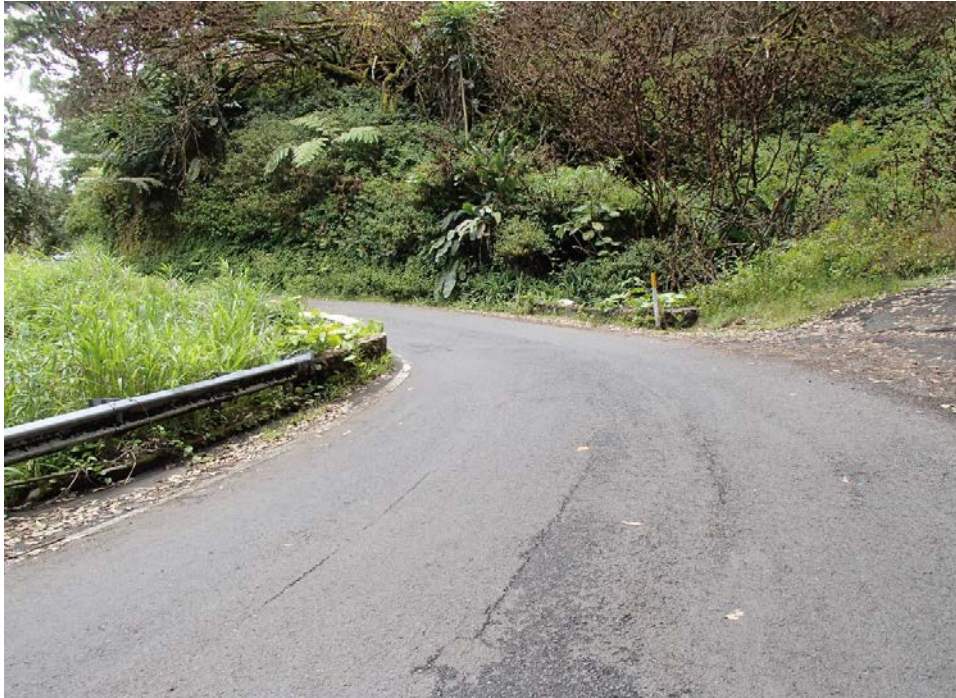
Kahului approach looking toward Hana.

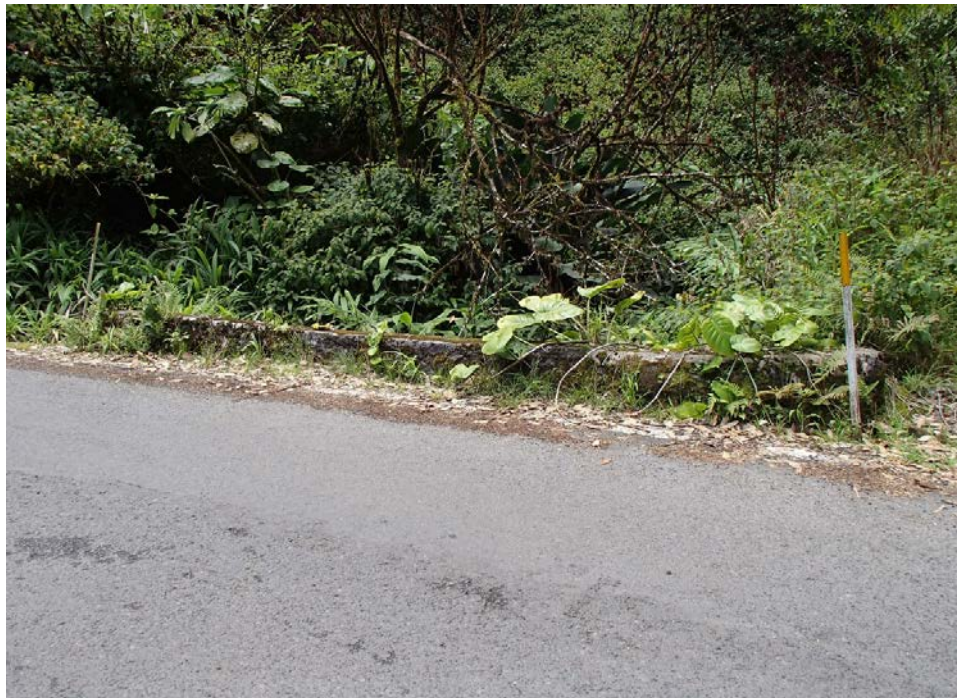
View of upstream CRM parapet.

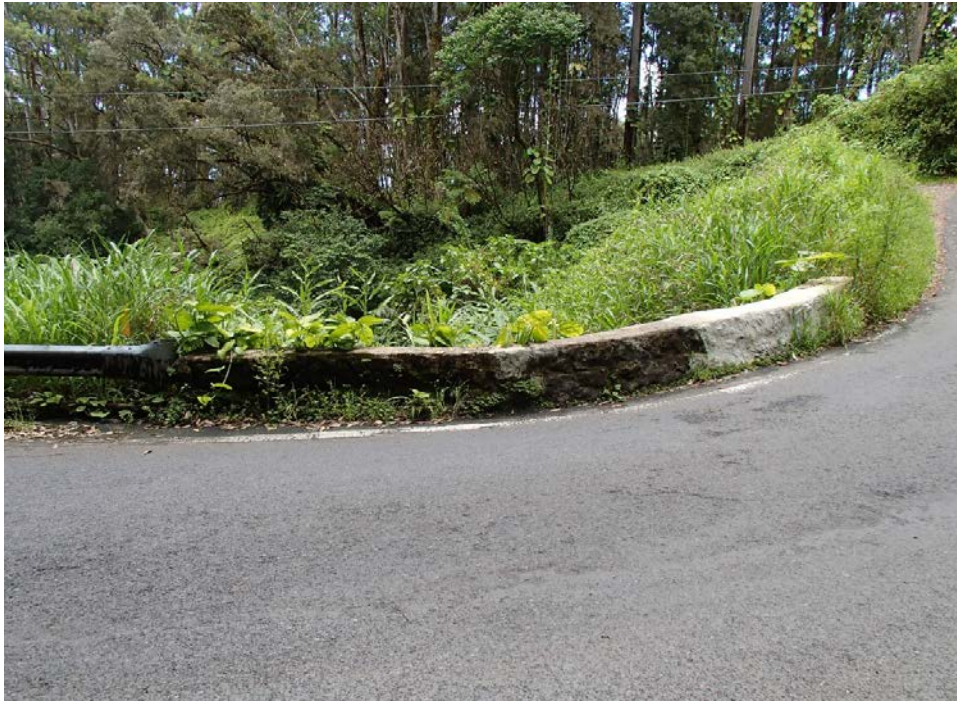
View of downstream CRM parapet.

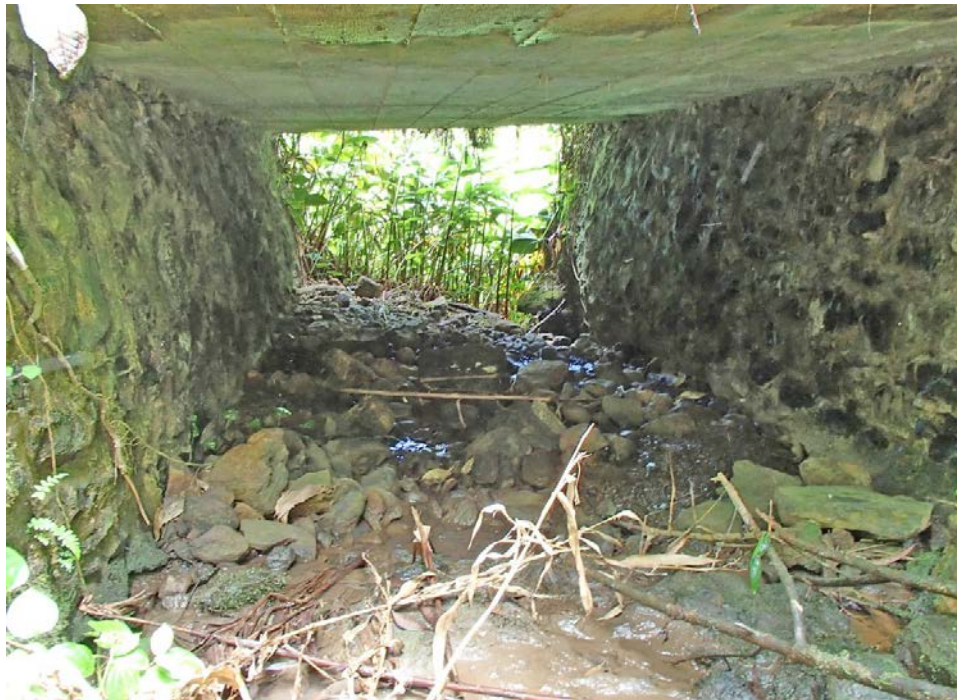
View of downstream through culvert.

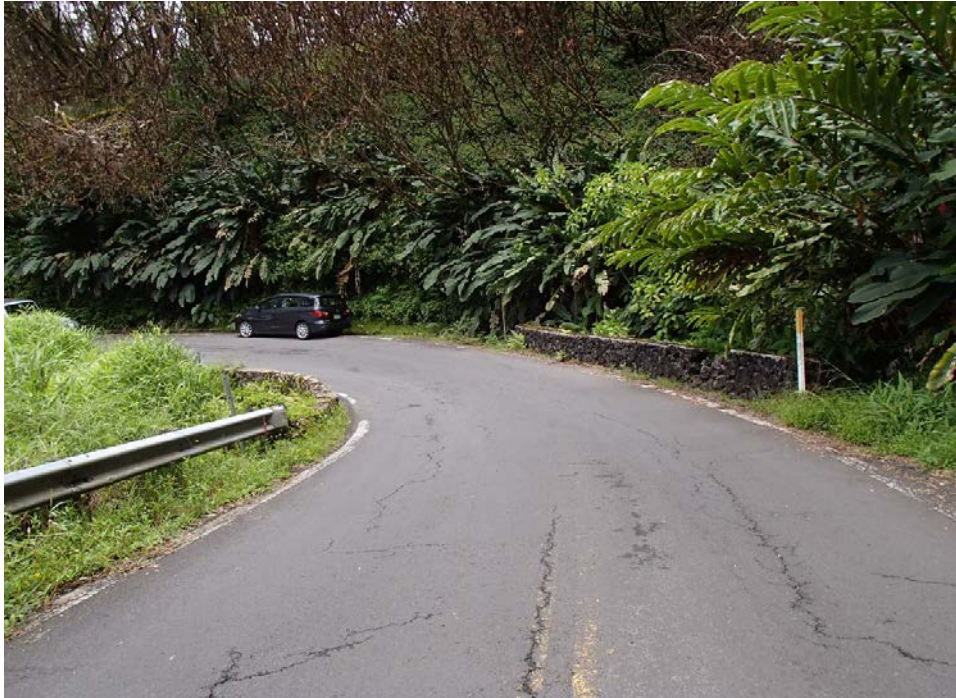
Kahului approach looking toward Hana.

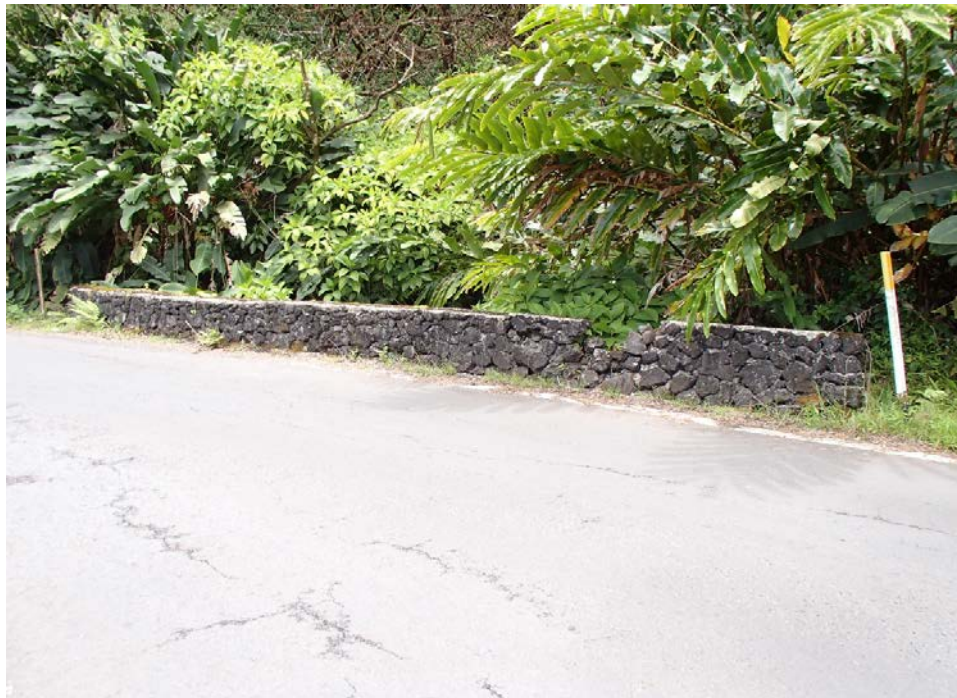
View of upstream CRM parapet.

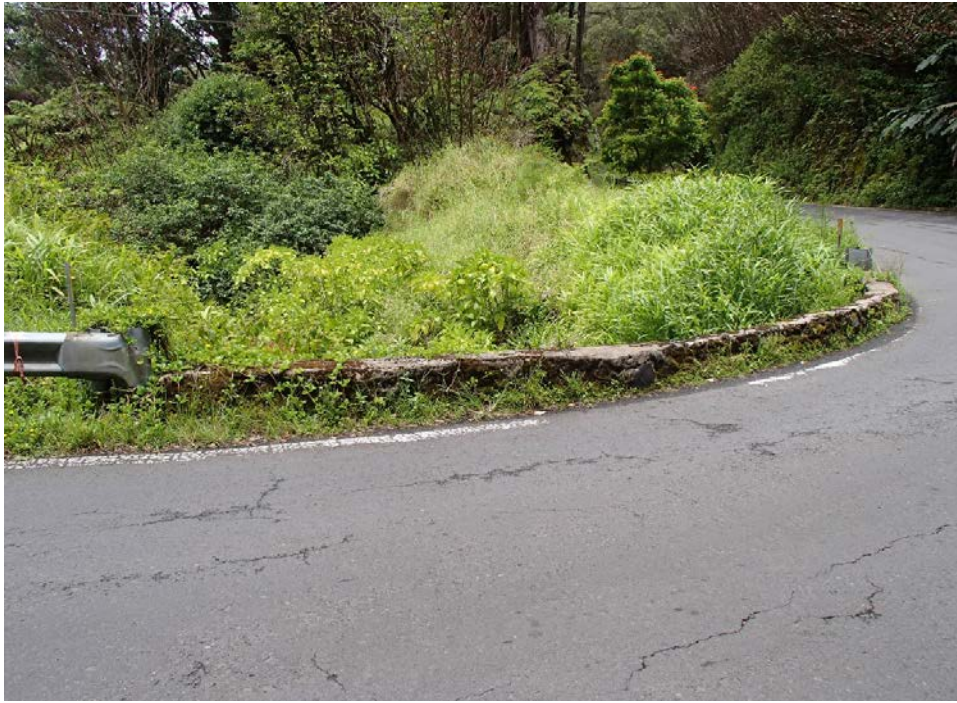
View of downstream CRM parapet.

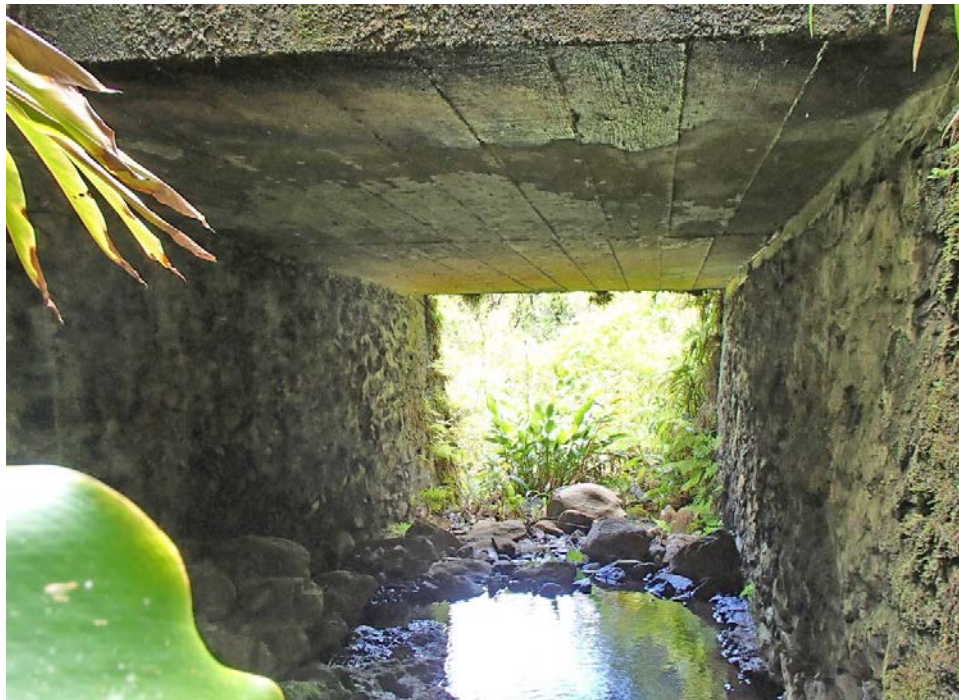
View of downstream through culvert.
