# **SECTION C**

CULVERTS

## HAER CULVERTS OVERVIEW

## Hana Highway, Route 360

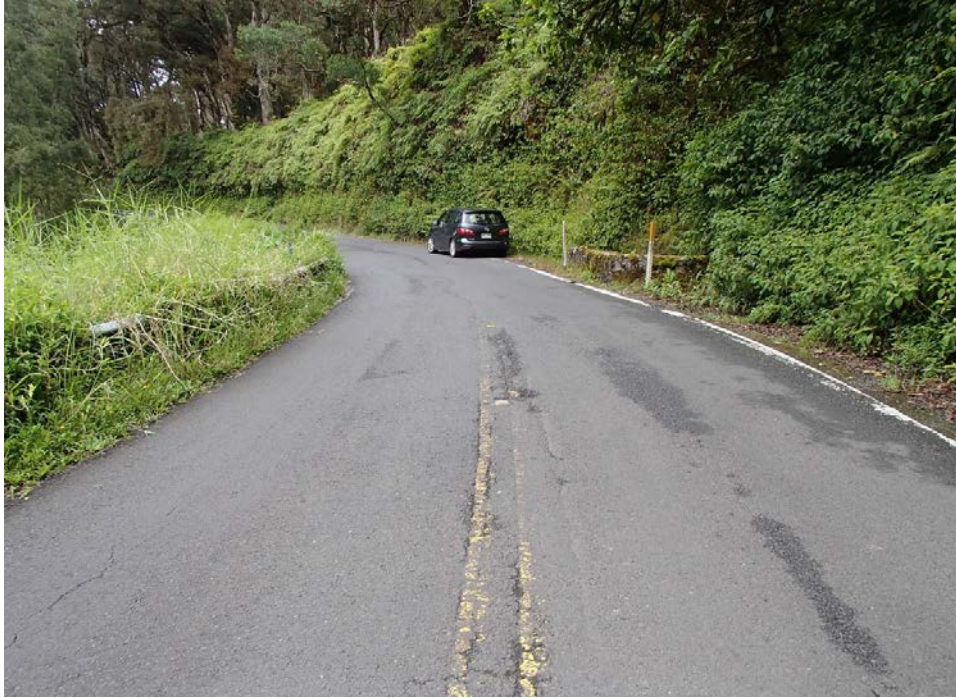
Kahului approach looking toward Hana.

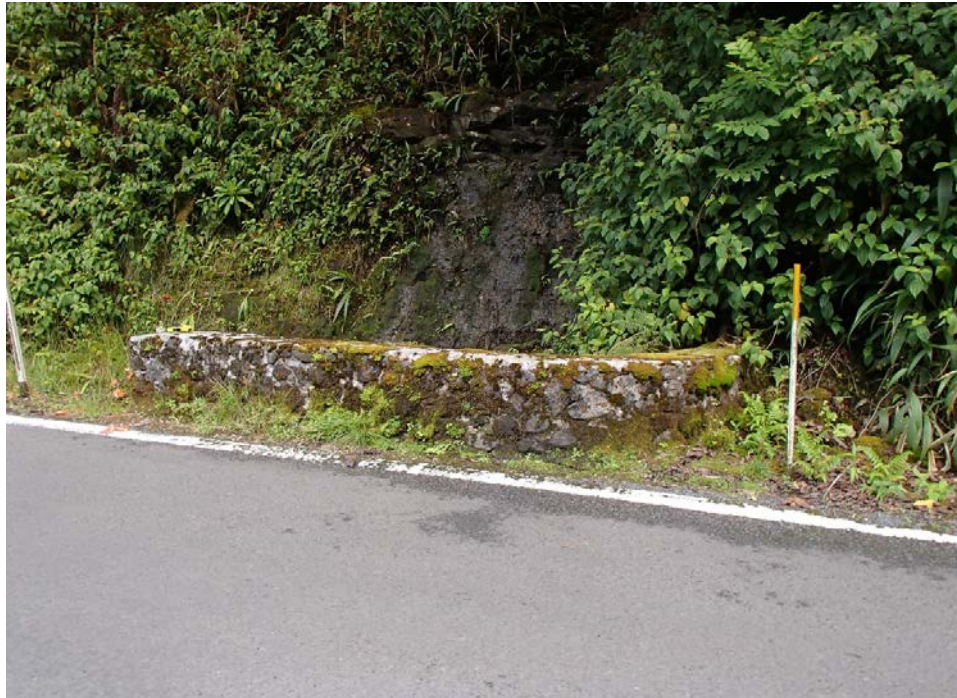
View of upstream CRM parapet.

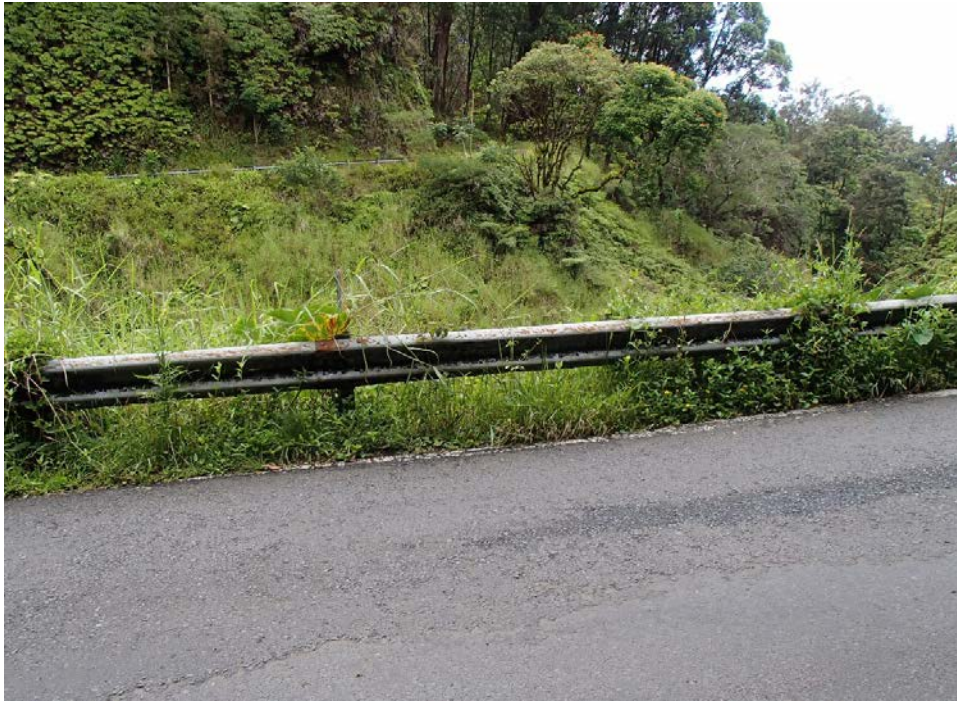
View of downstream metal guardrail.

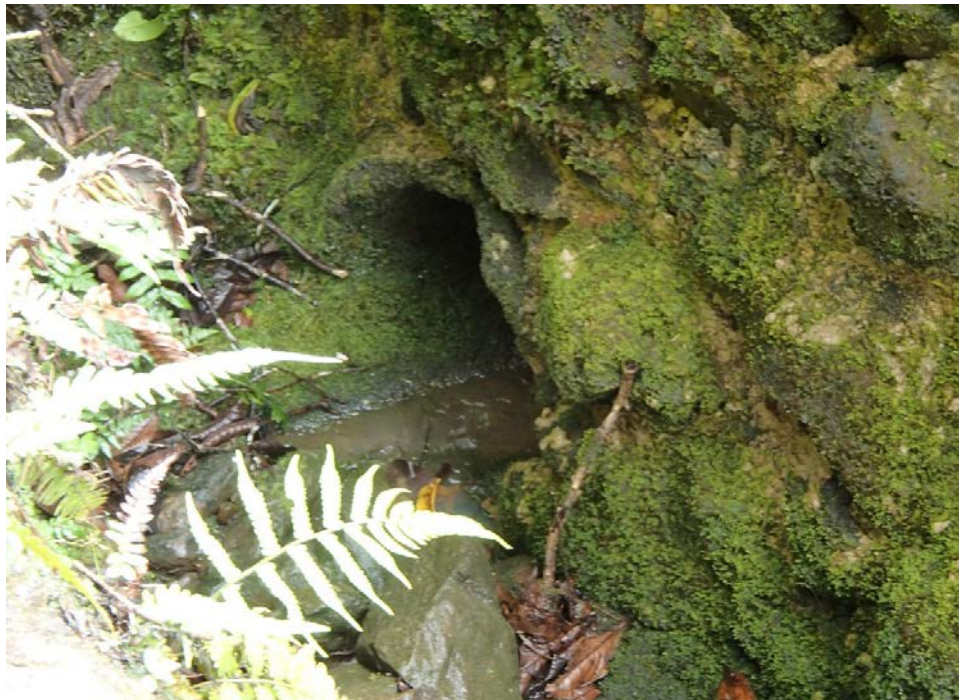
24" diameter RCP inlet at the upstream side.

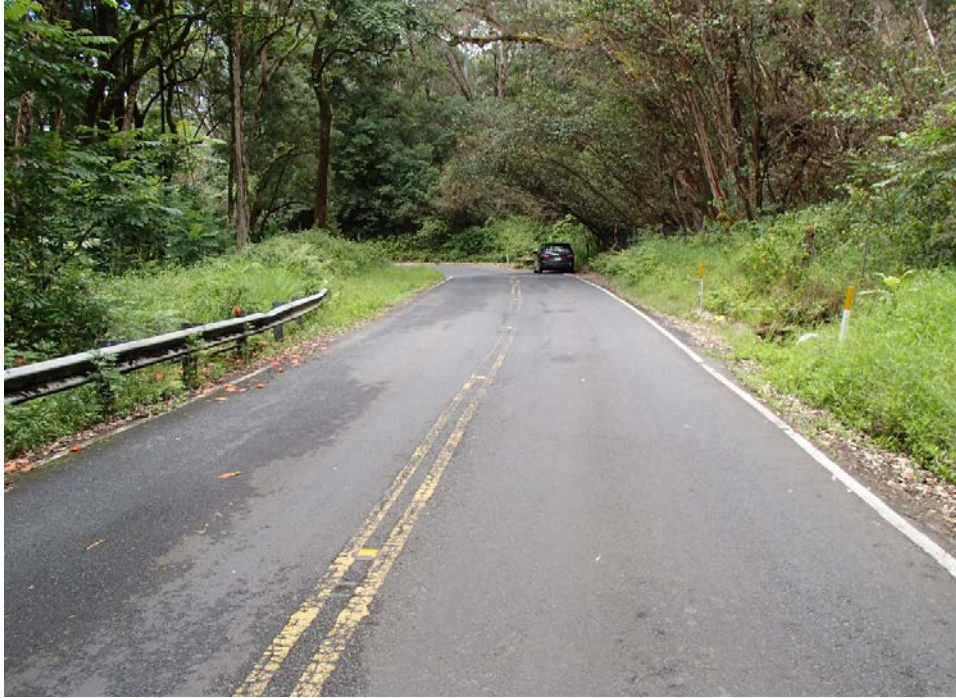
Kahului approach looking toward Hana.

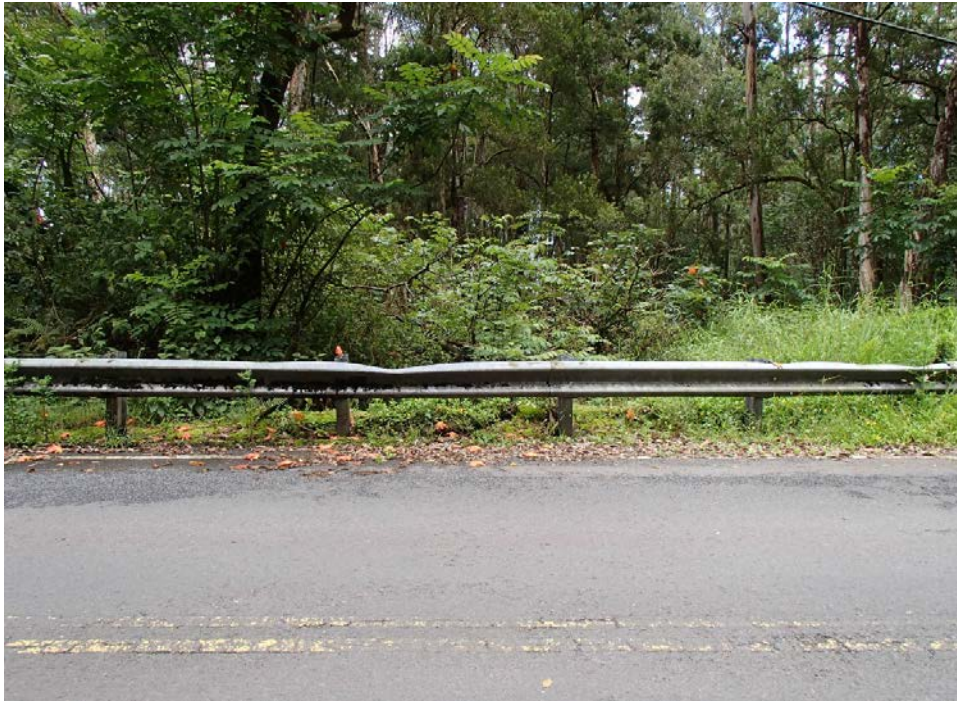
View of downstream metal guardrail.

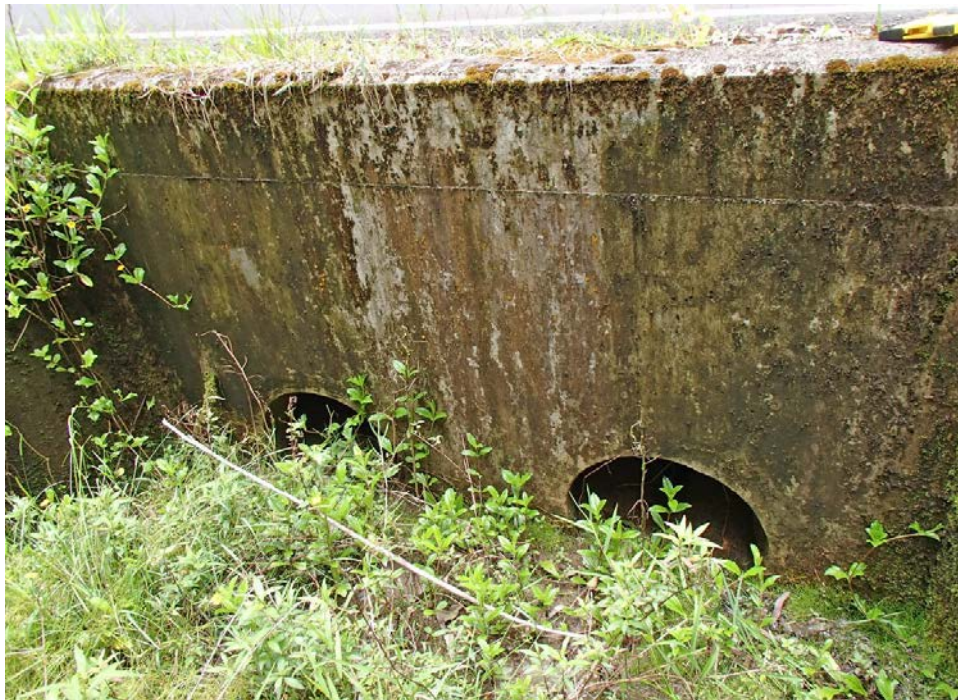
2 - 24" diameter RCP inlets at upstream side.

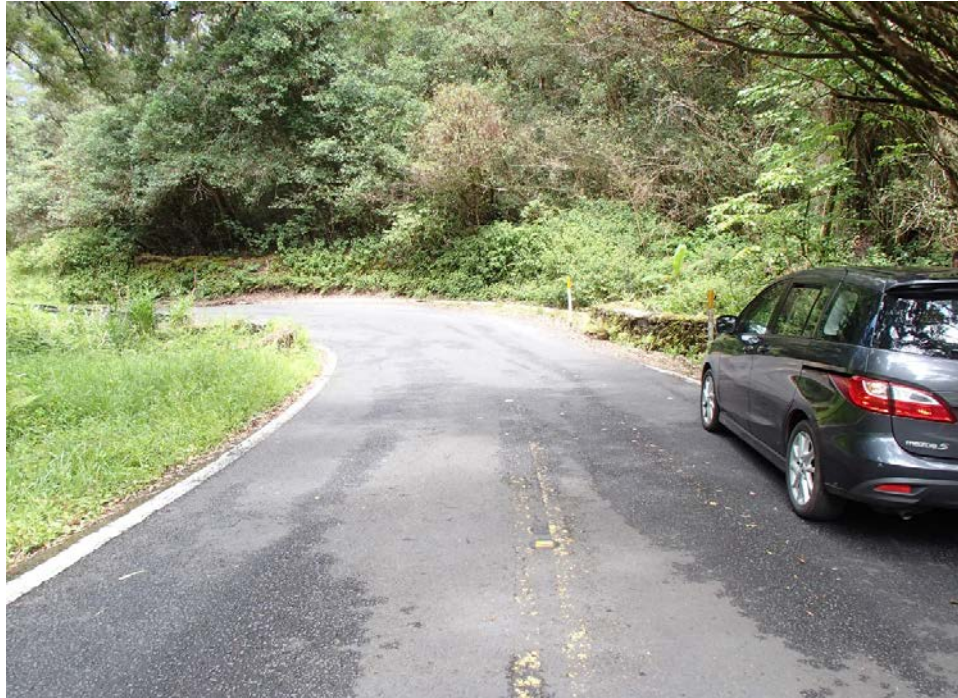
Kahului approach looking toward Hana.

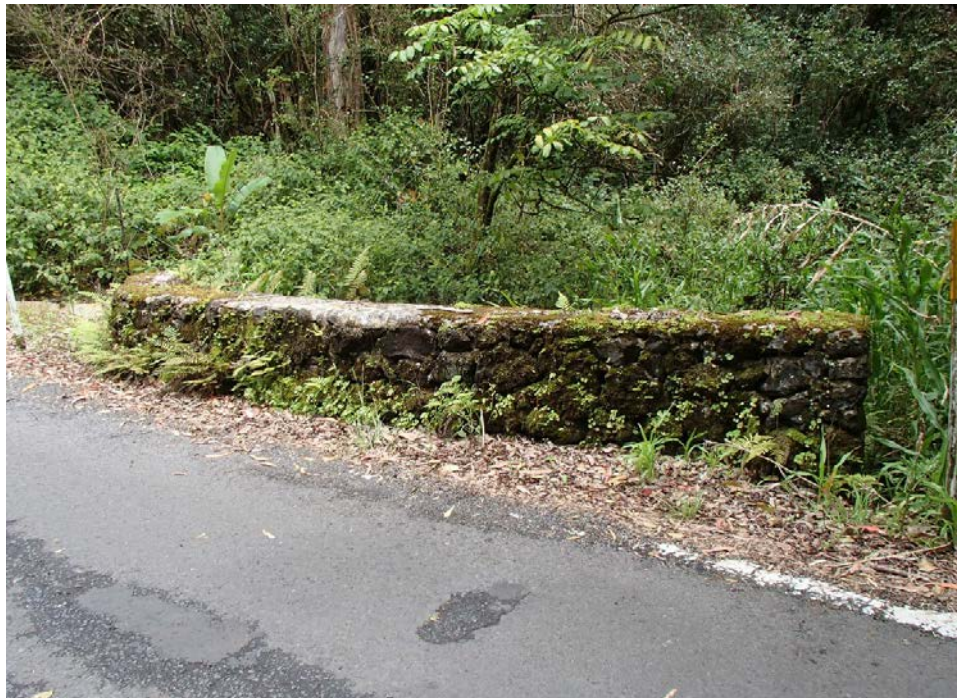
View of upstream CRM parapet.

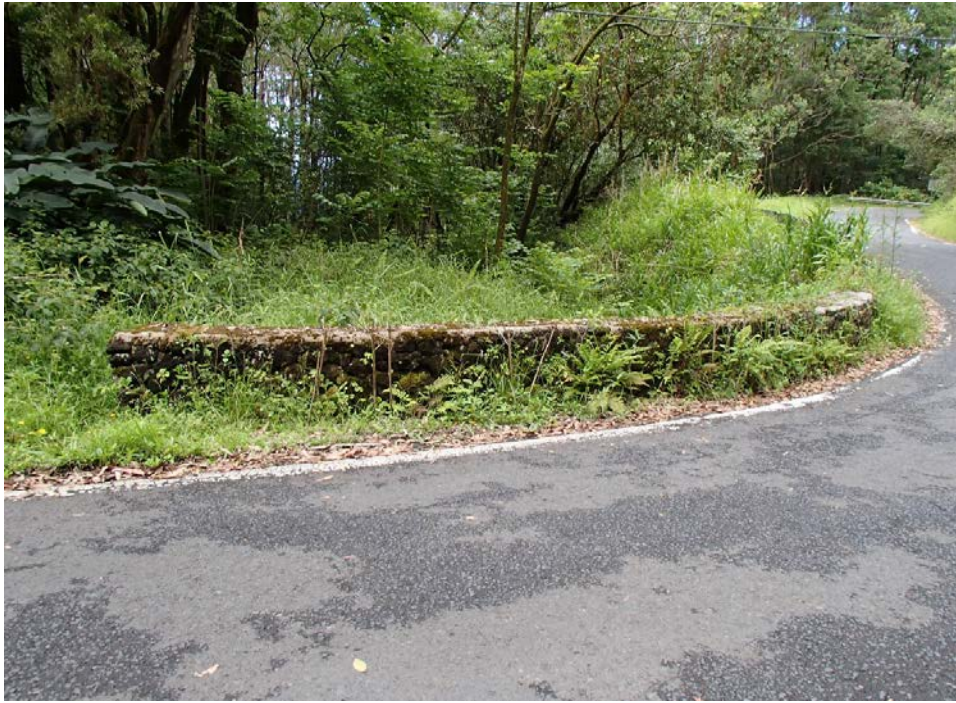
View of downstream CRM parapet.

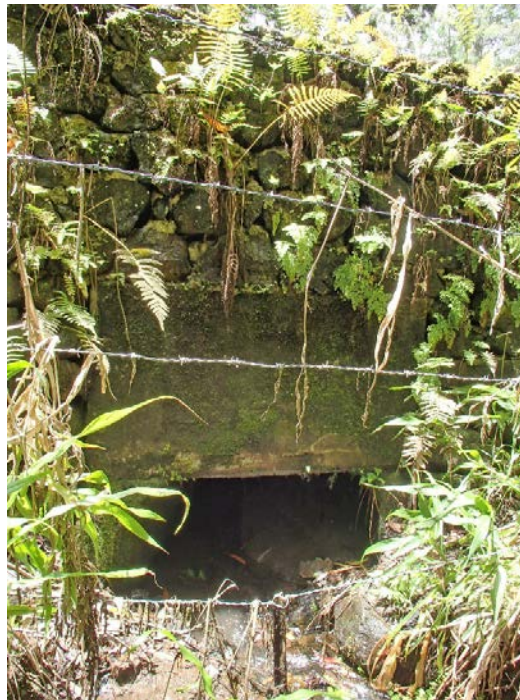
View of CRM parapet and concrete headwall at upstream side.

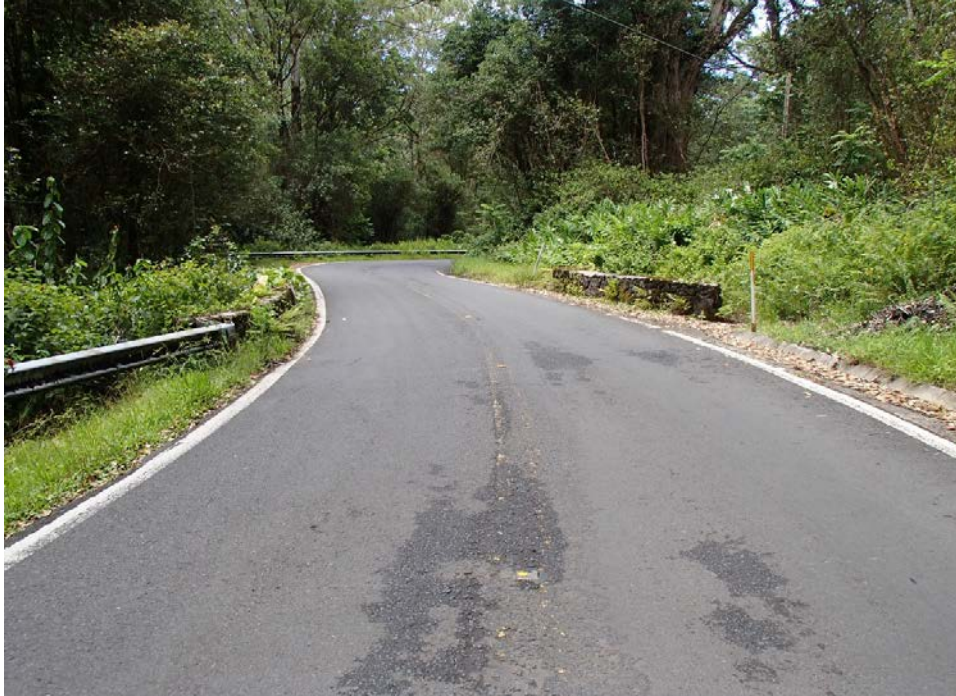
Kahului approach looking toward Hana.

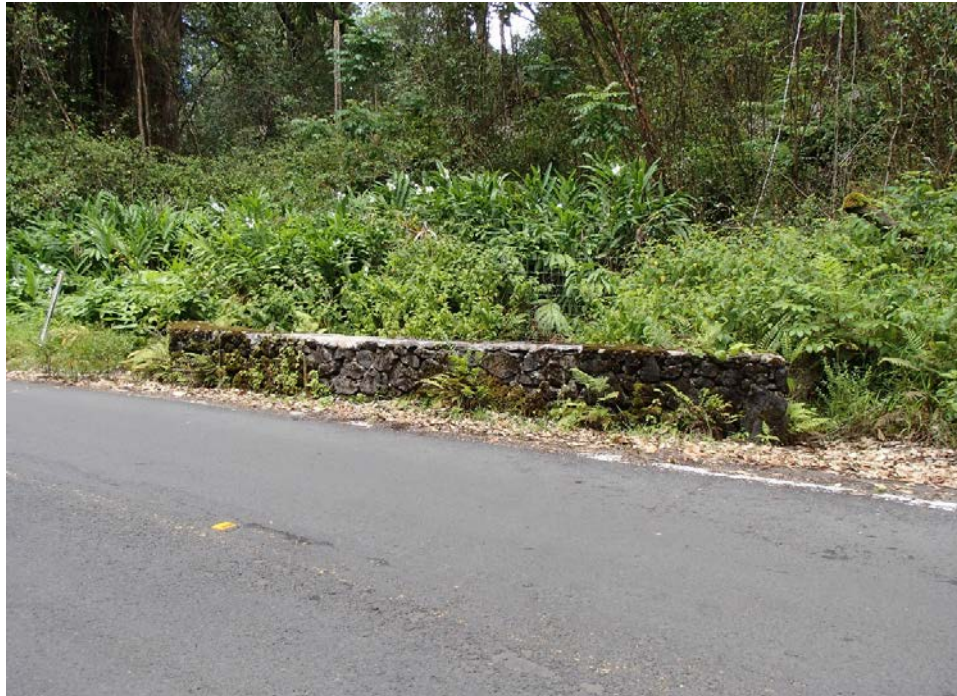
View of upstream CRM parapet.

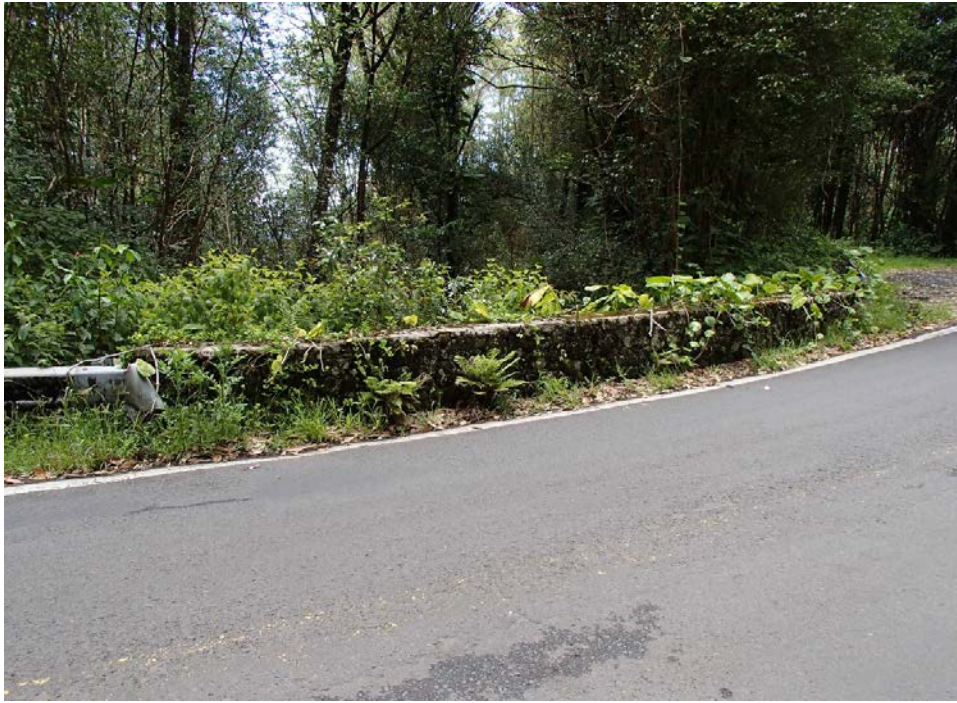
View of downstream CRM parapet.

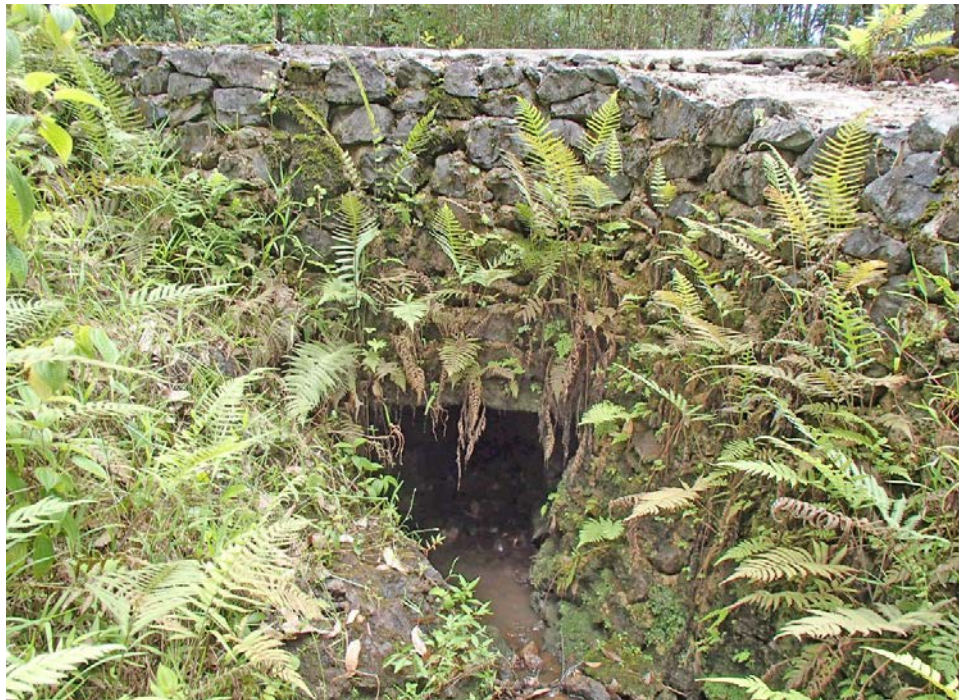
View of upstream CRM headwall / parapet.

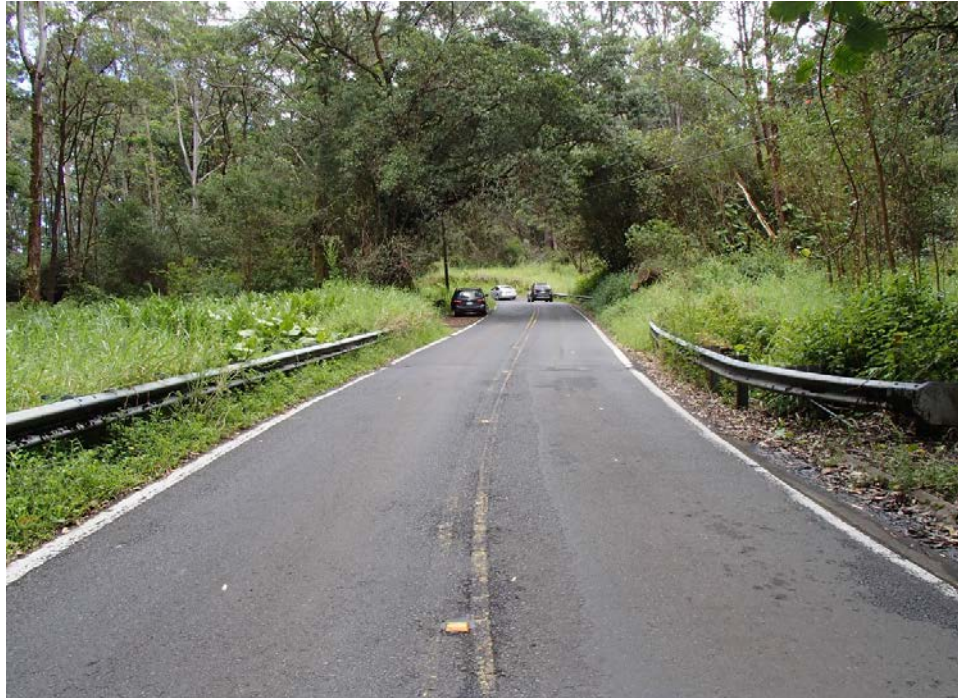
Kahului approach looking toward Hana.

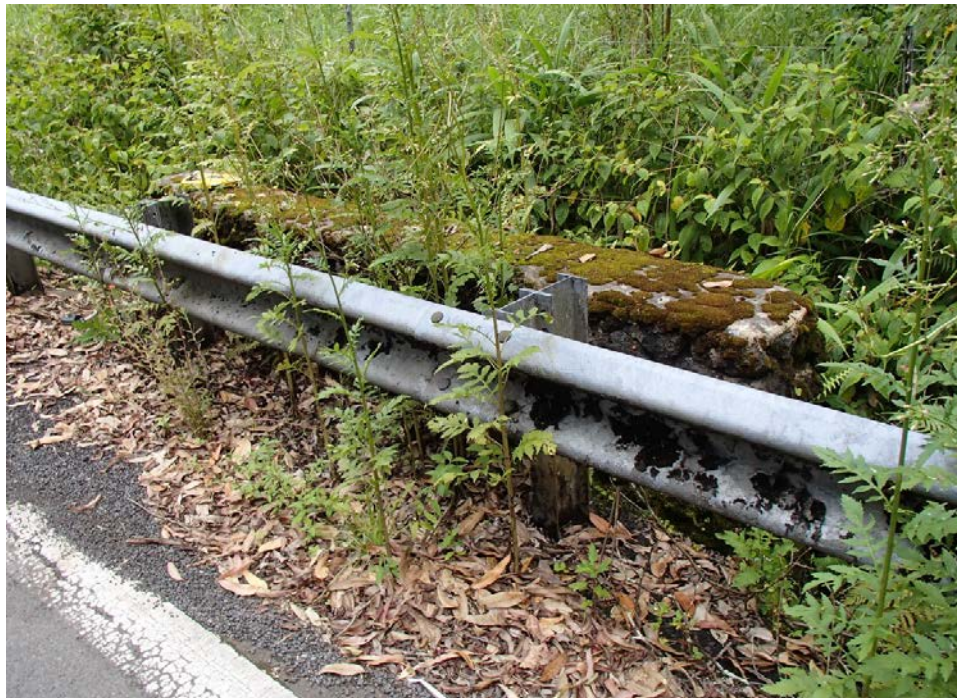
View of upstream CRM parapet with continuous metal guardrail in-front.

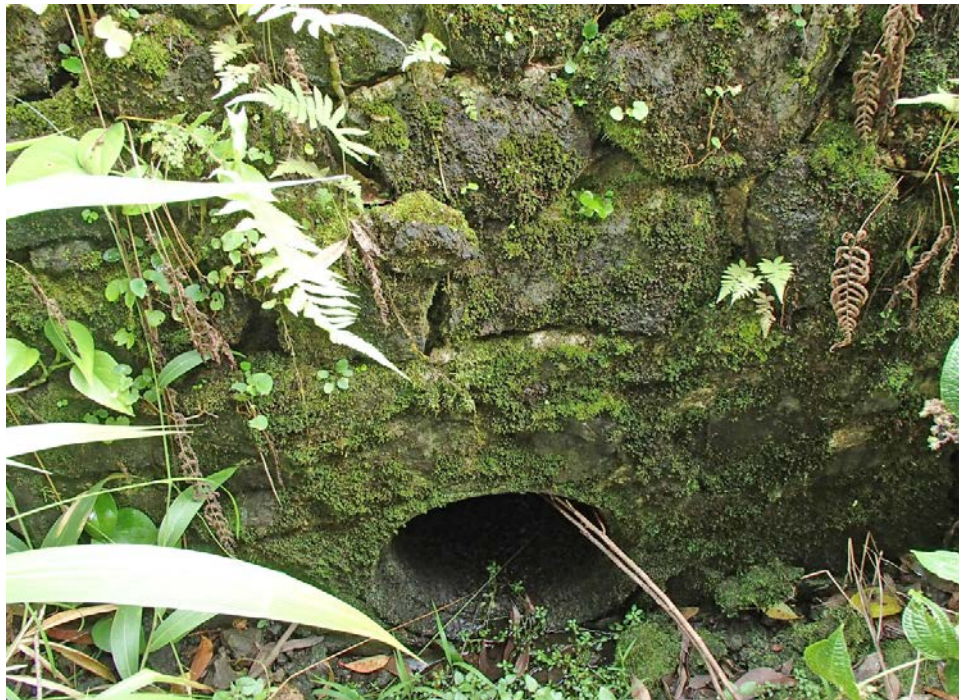
18" diameter RCP inlet at the upstream side.

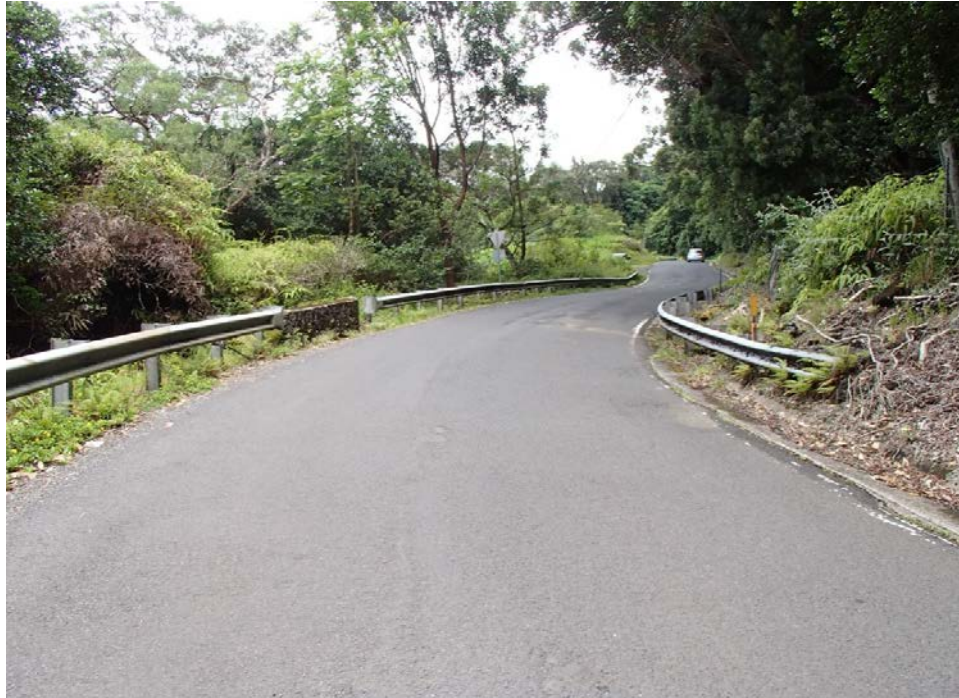
Kahului approach looking toward Hana.

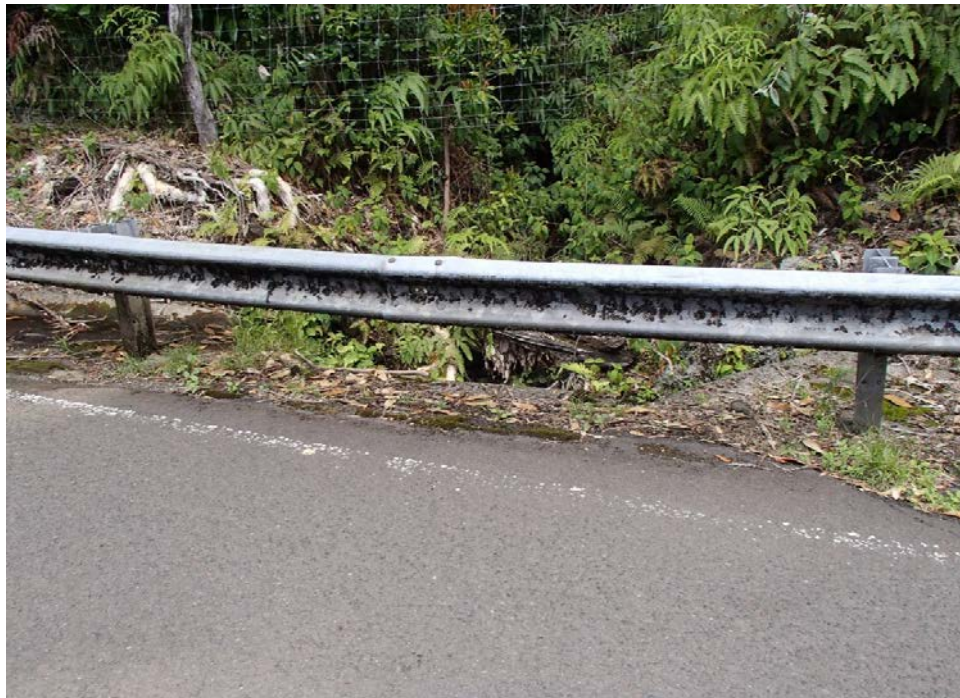
View of upstream metal guardrail.

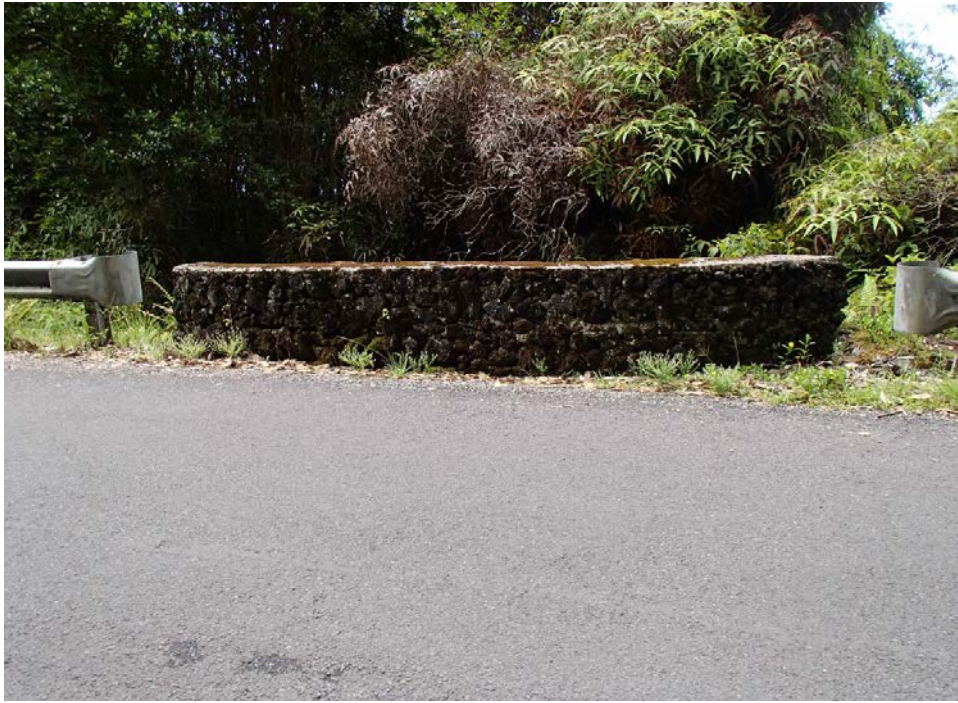
View of downstream CRM parapet.

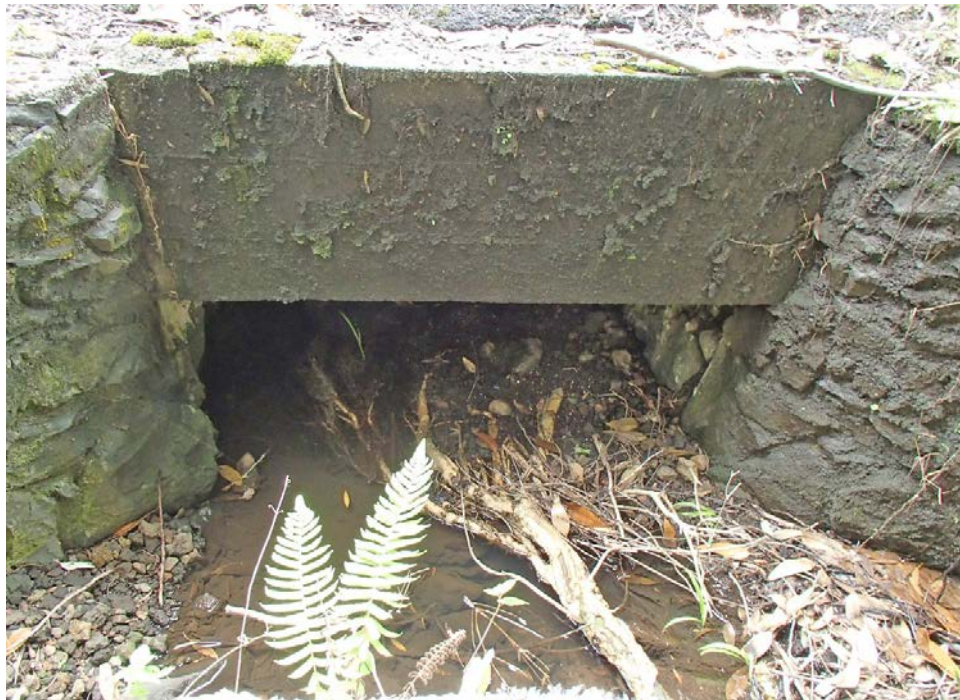
View of upstream concrete culvert headwall and CRM wingwalls.

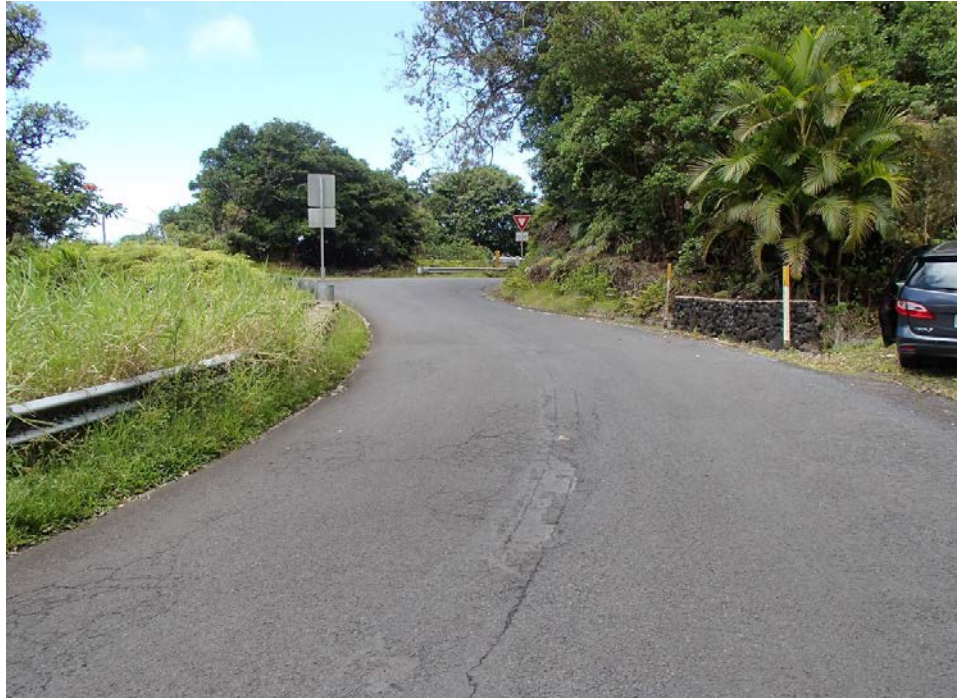
Kahului approach looking toward Hana.

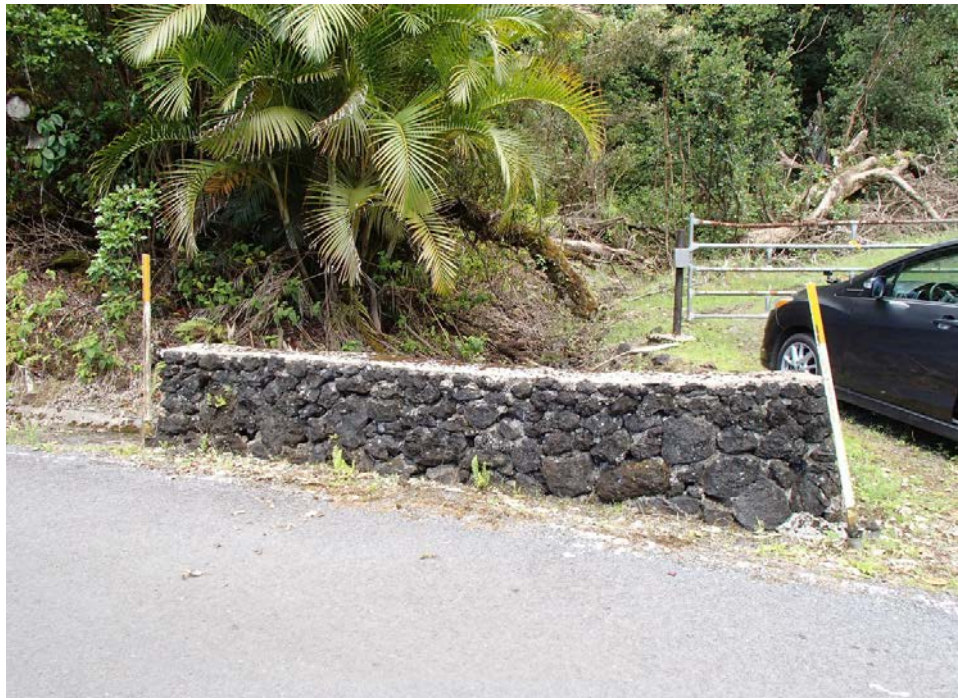
View of upstream CRM parapet.

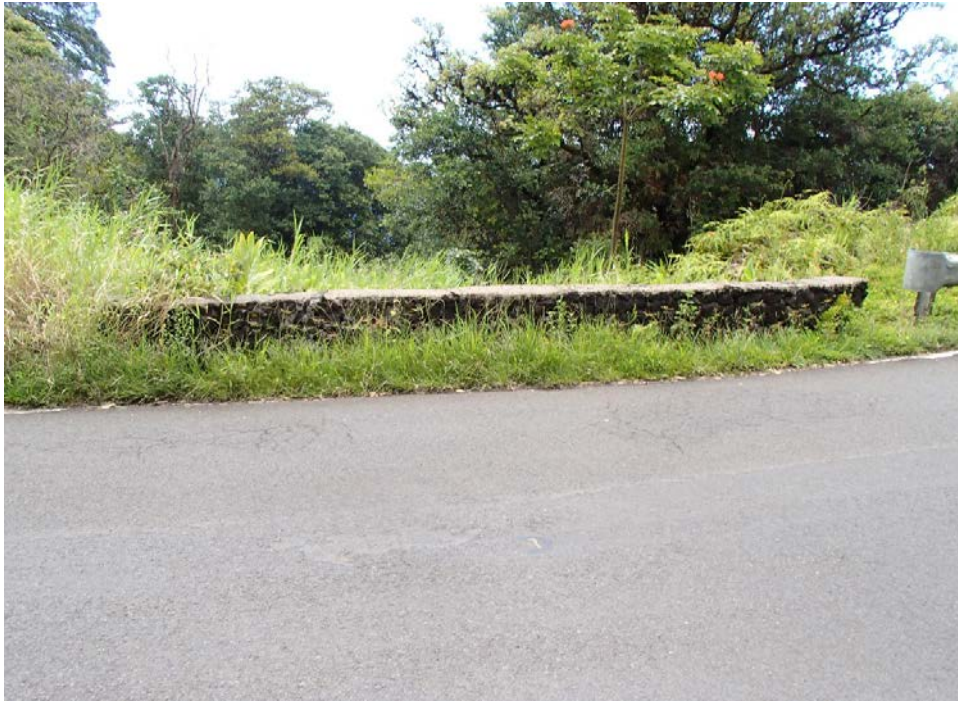
View of downstream CRM parapet.

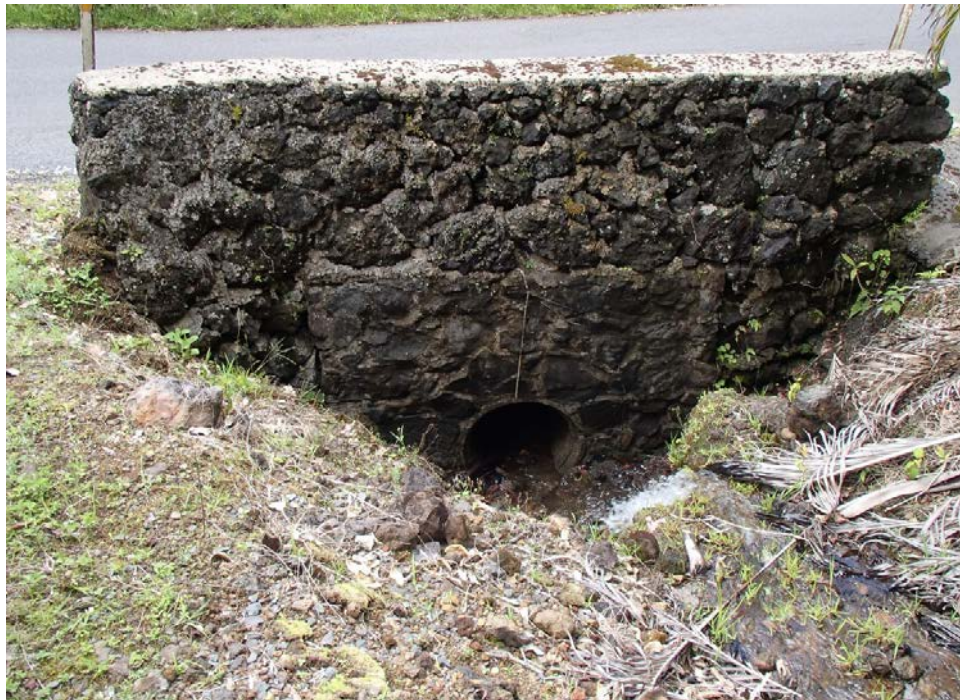
24" diameter RCP inlet at upstream side.

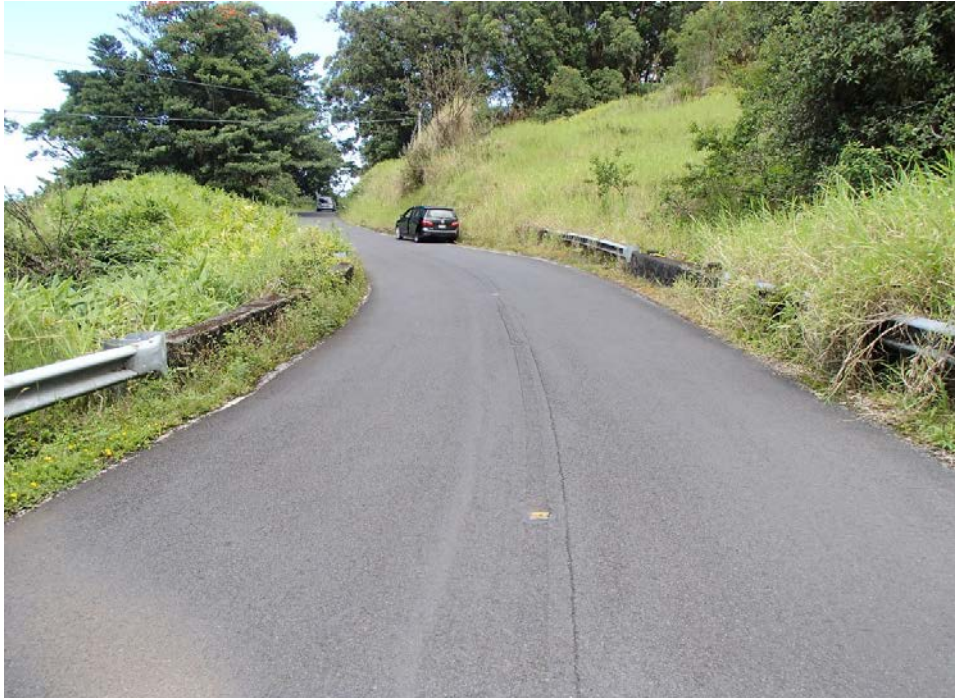
Kahului approach looking toward Hana.

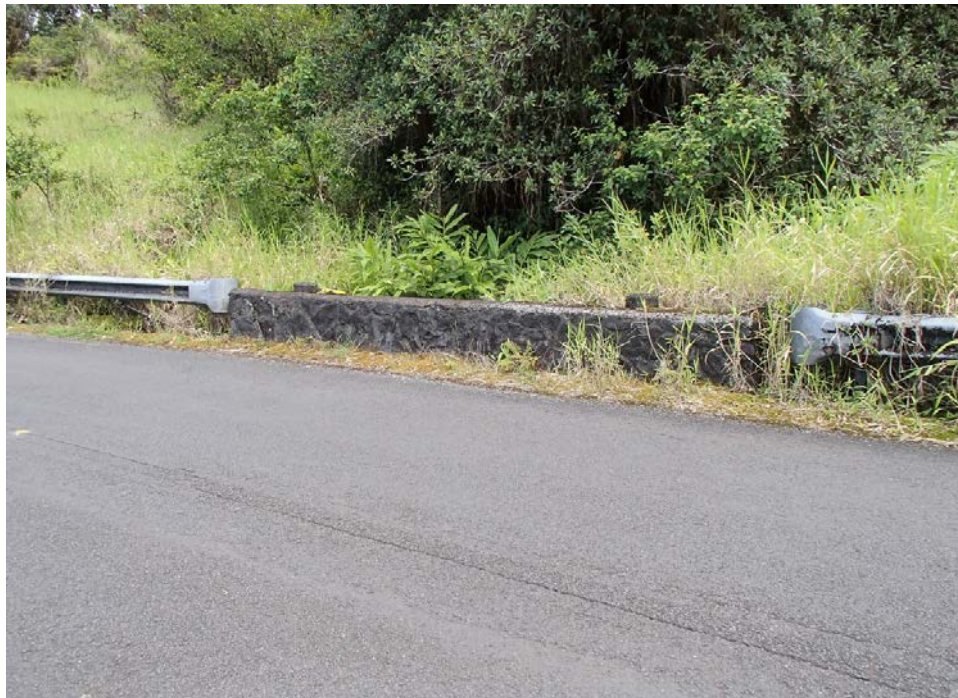
View of upstream CRM parapet.

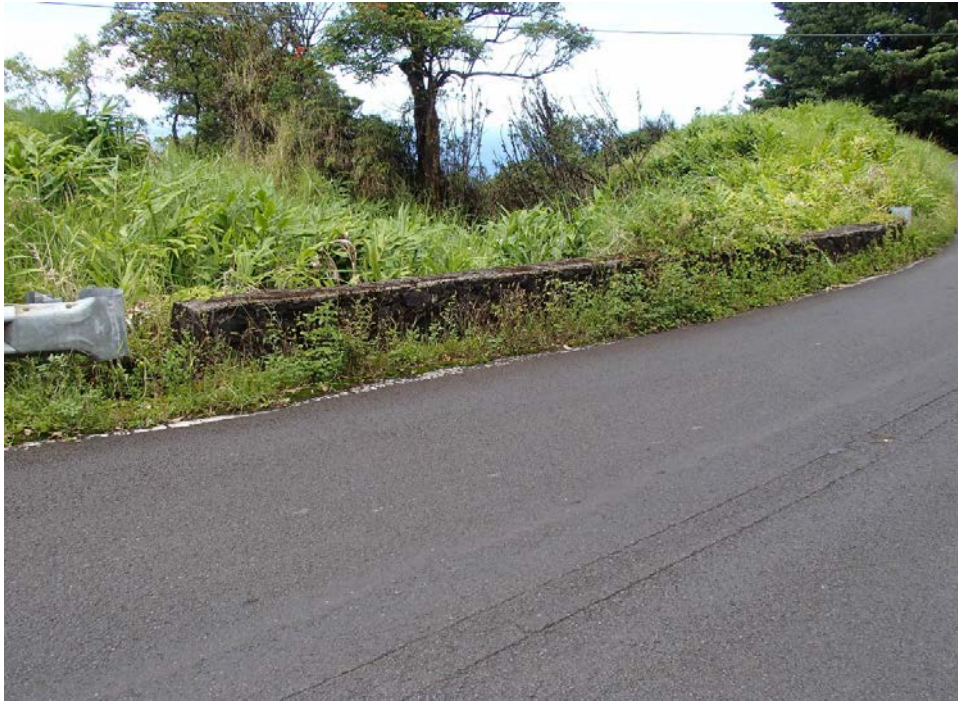
View of downstream CRM parapet.

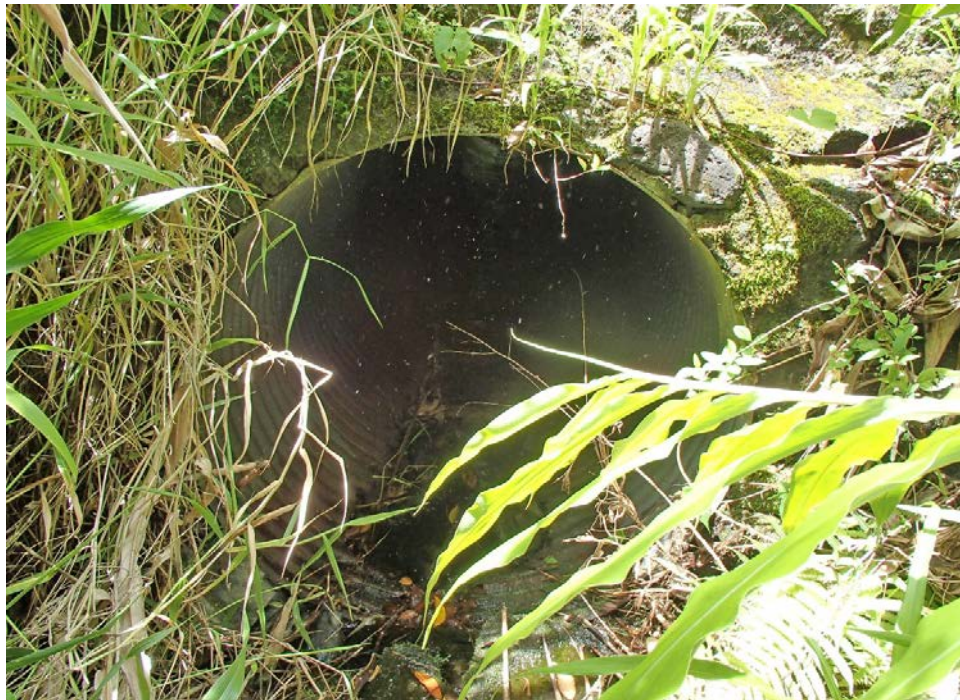
48" diameter CMP inlet at upstream side.

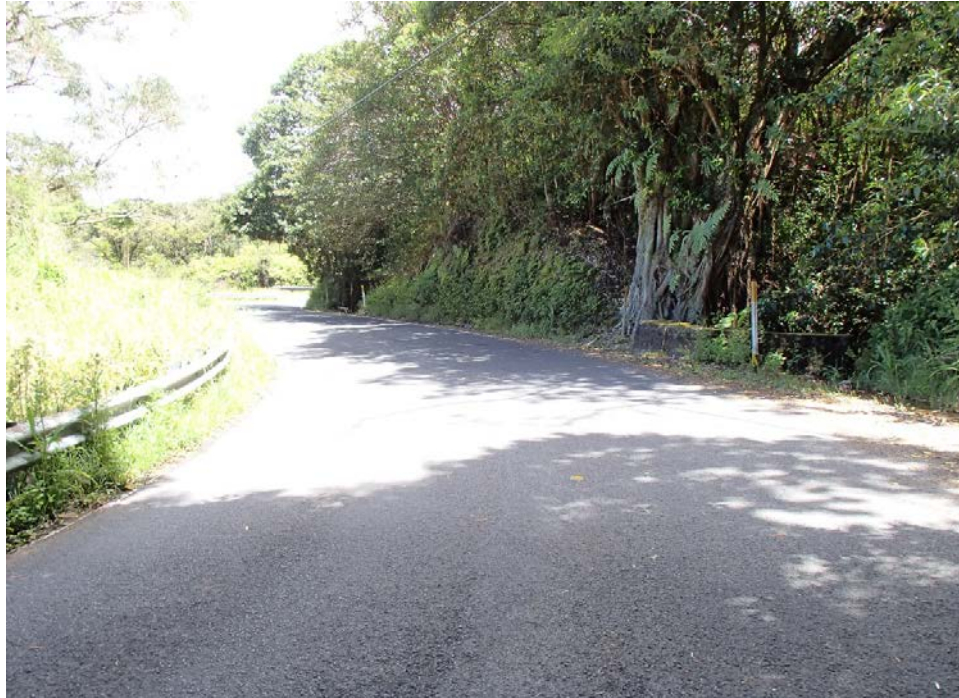
Kahului approach looking toward Hana.

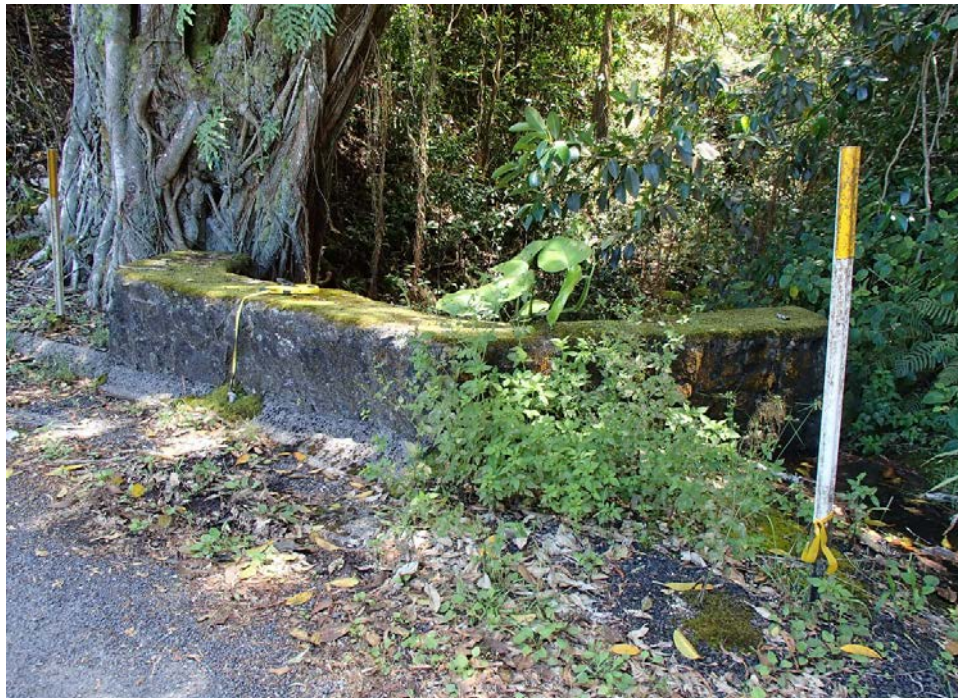
View of upstream CRM parapet.

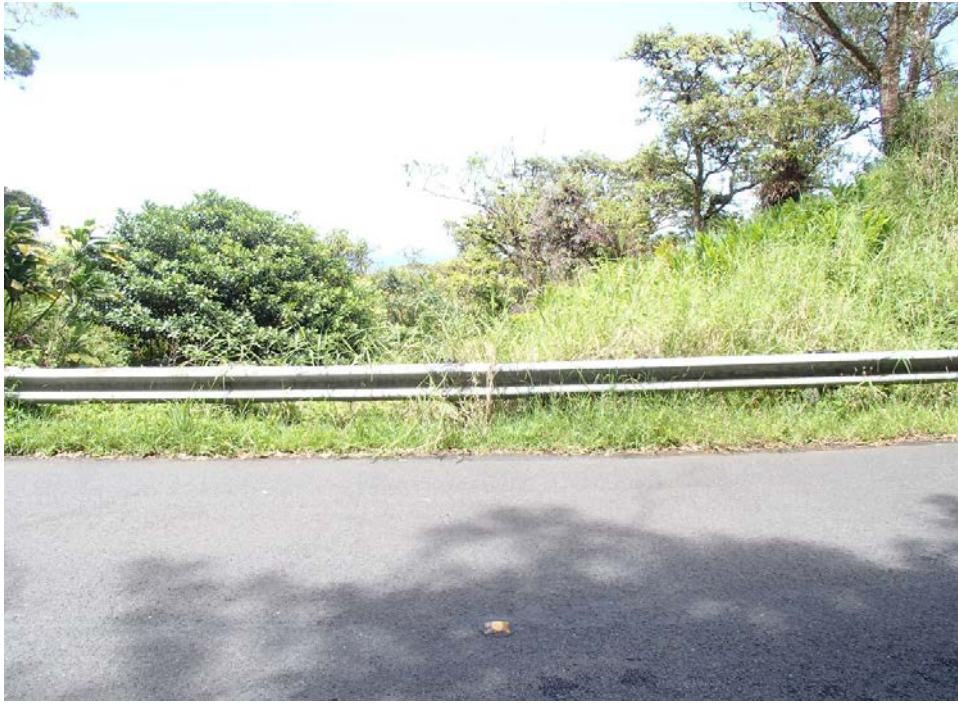
View of downstream metal guardrail.

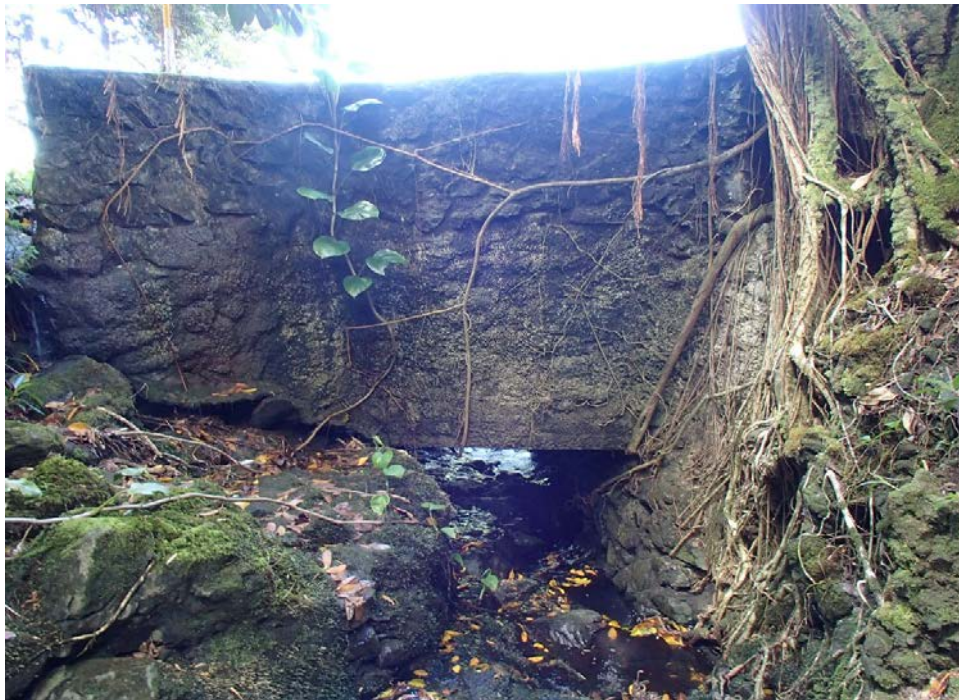
View of upstream CRM headwall / parapet and wingwalls.
