# **SECTION C**

CULVERTS

## HAER CULVERTS OVERVIEW

## Hana Highway, Route 360

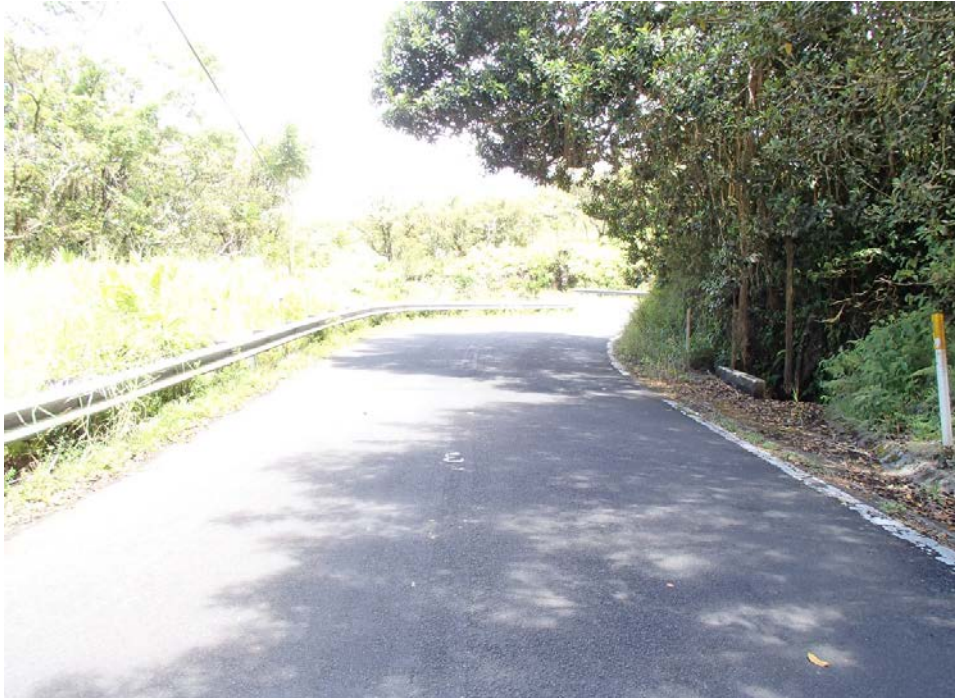
Kahului approach looking toward Hana.

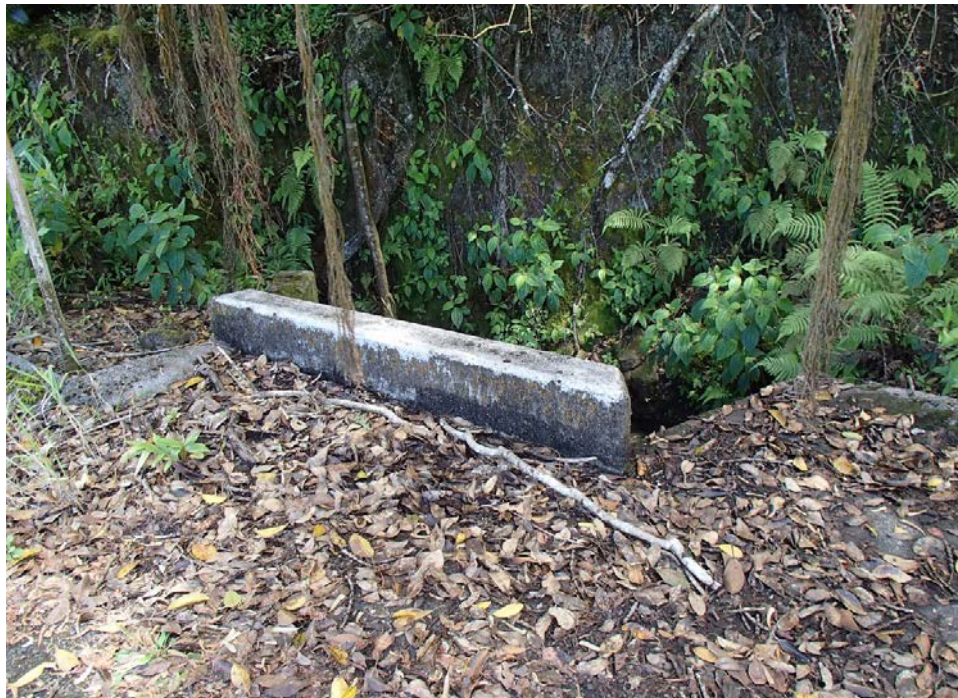
View of upstream concrete parapet.

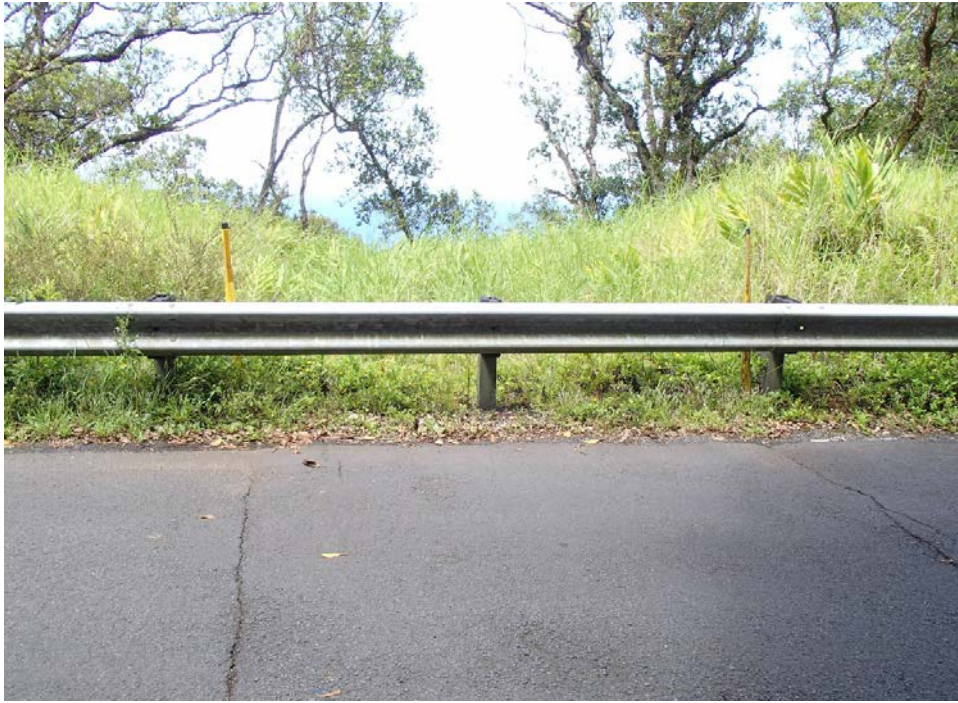
View of downstream metal guardrail.

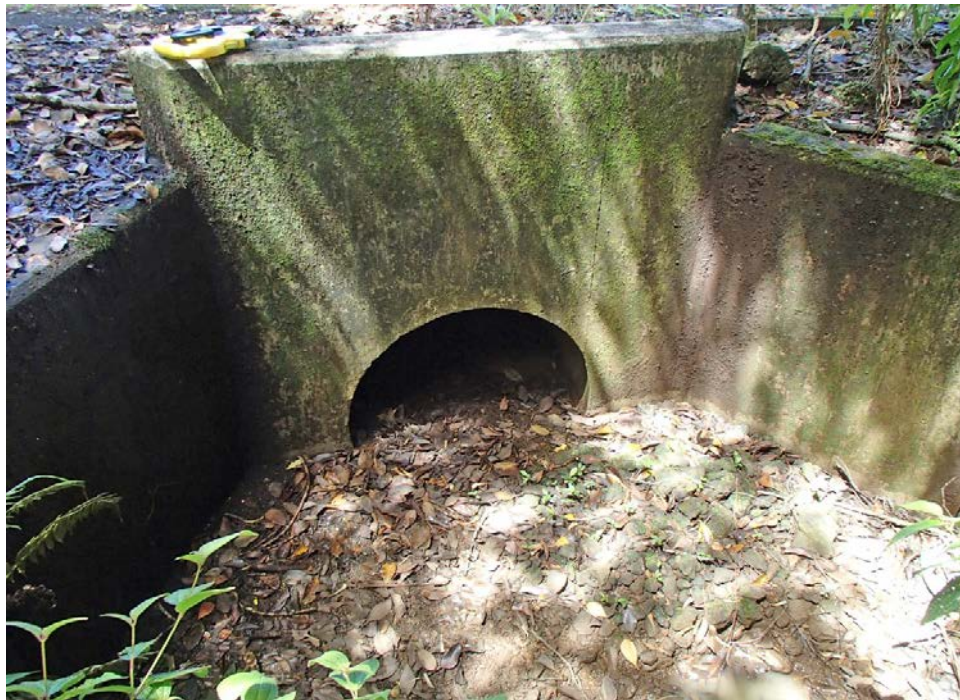
36" diameter RCP inlet at upstream side.

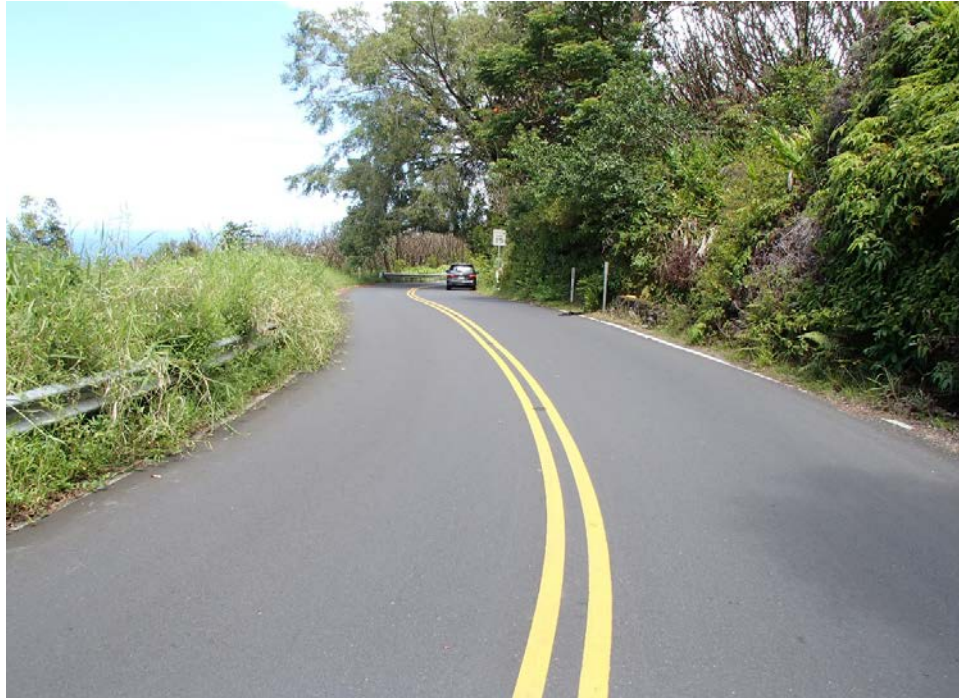
Kahului approach looking toward Hana on upstream side.

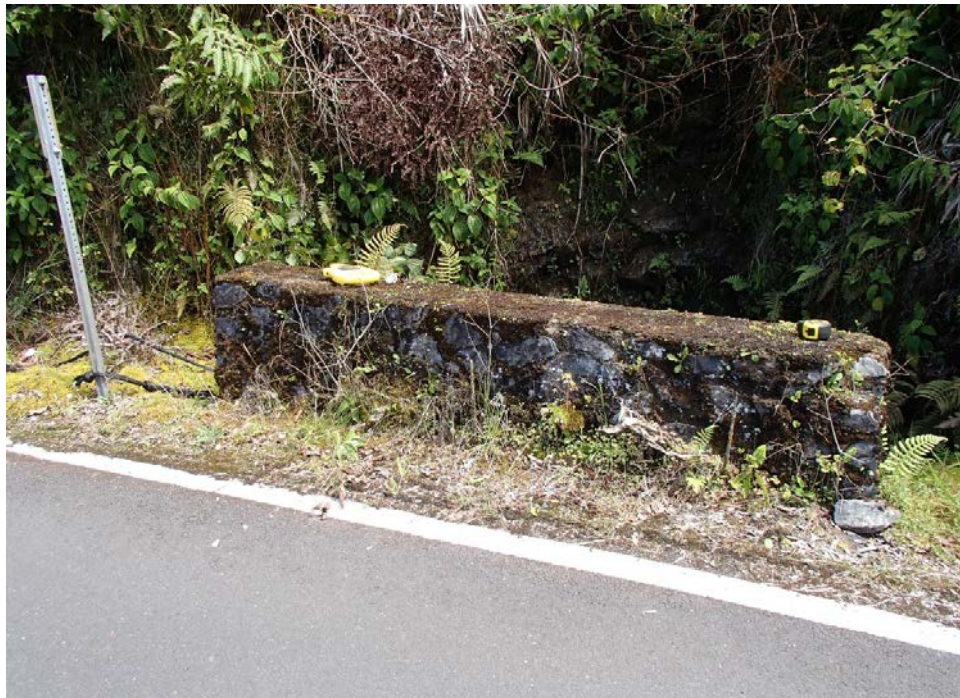
View of upstream CRM parapet.

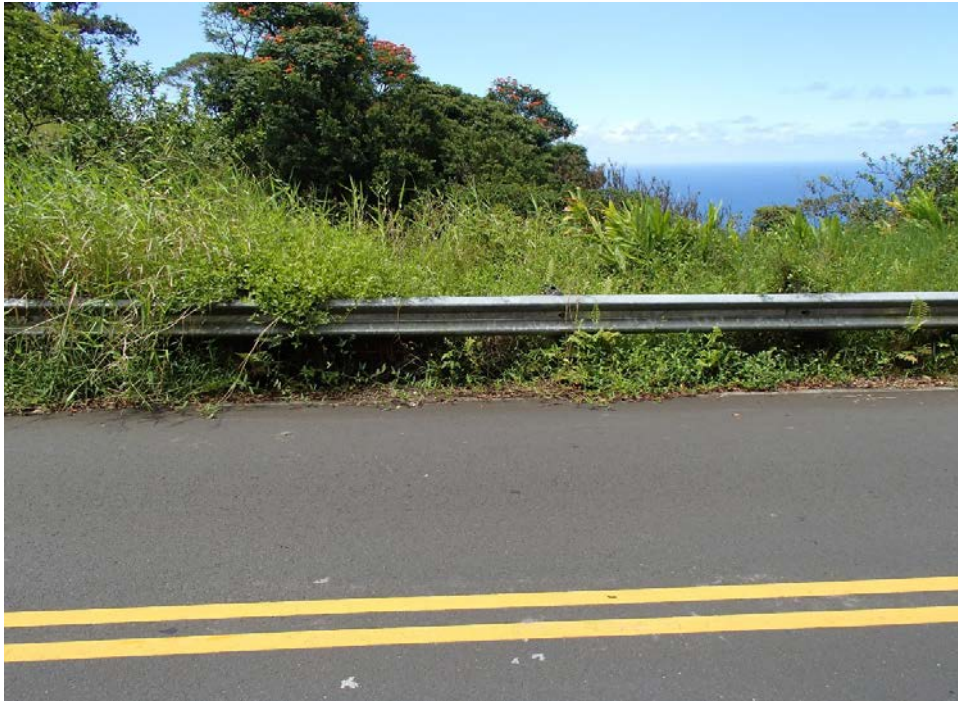
View of downstream metal guardrail.

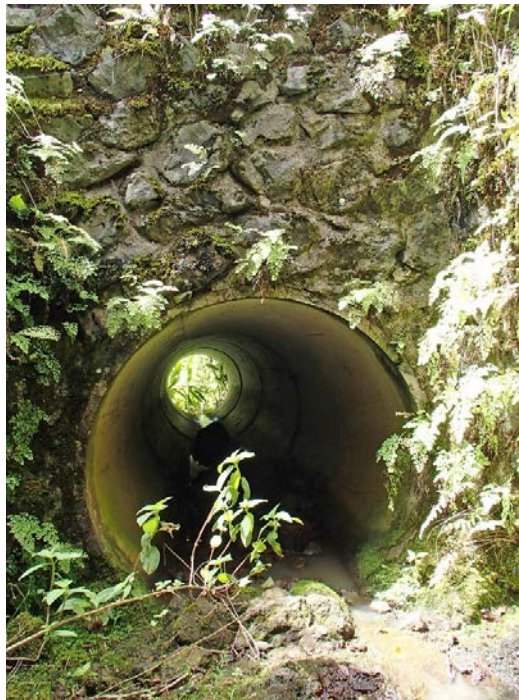
48" diameter RCP inlet at upstream side.

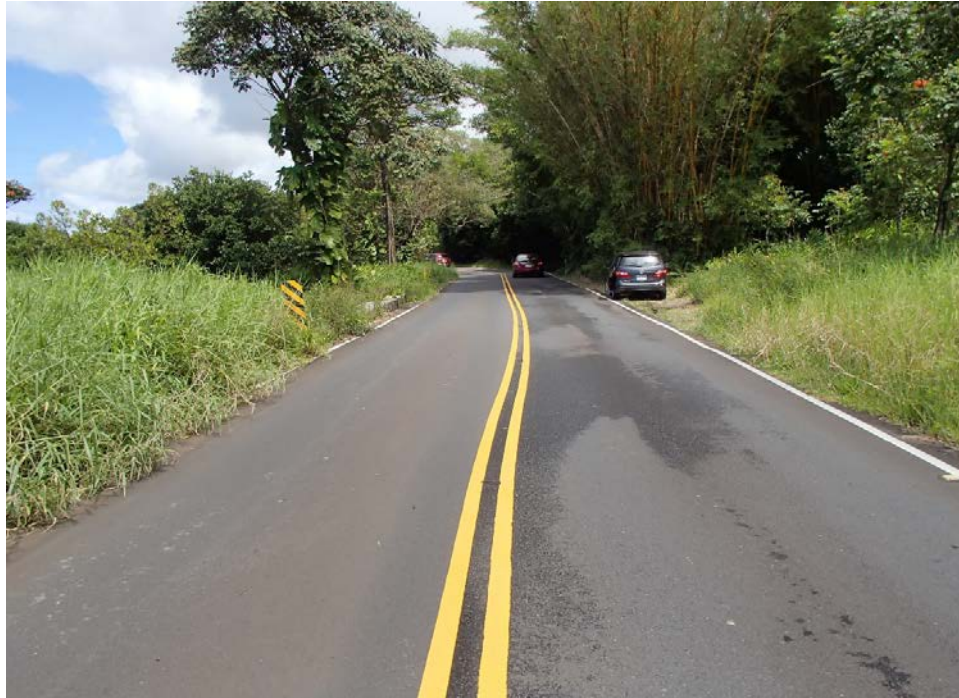
Kahului approach looking toward Hana on upstream side.

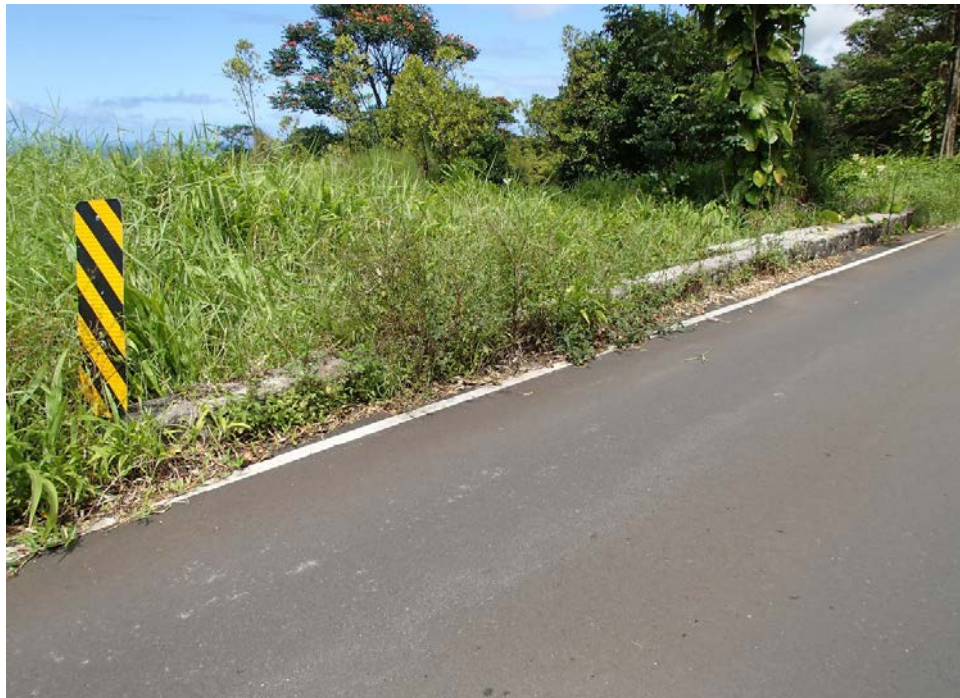
View of downstream CRM parapet.

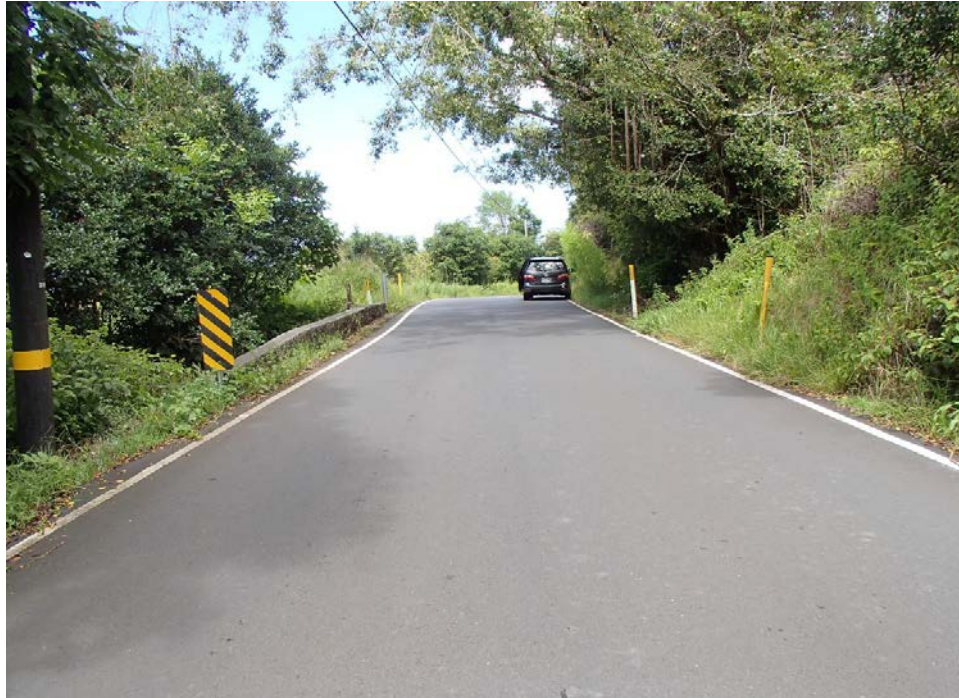
Kahului approach looking toward Hana on upstream side.

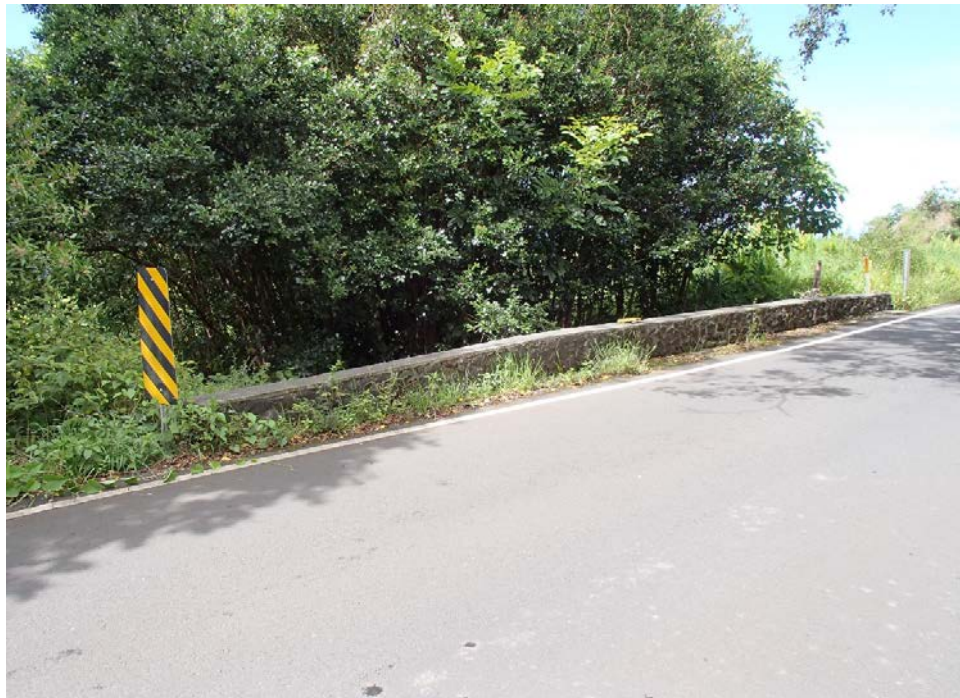
View of downstream CRM parapet.

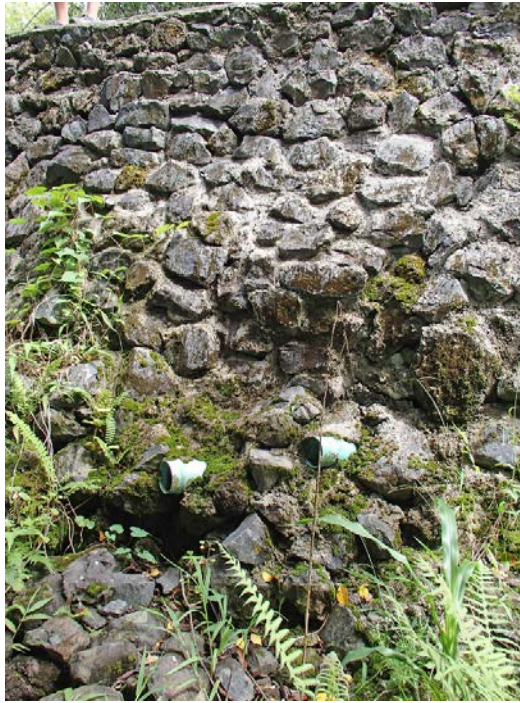
2 - 4" diameter pipe outlets at downstream side.

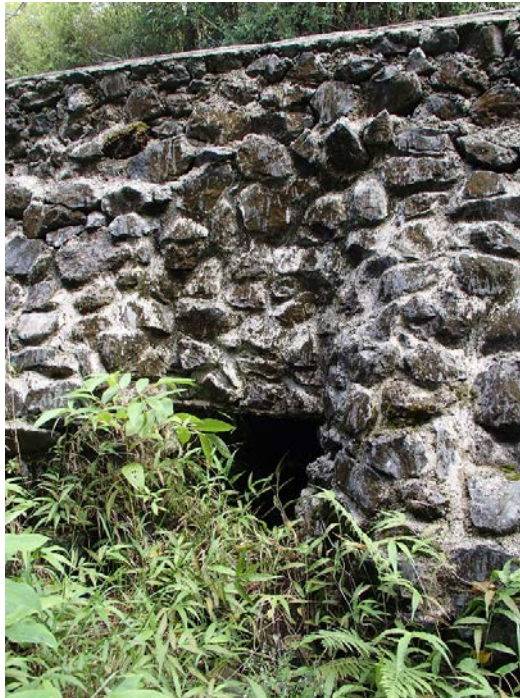
View of CRM headwall / parapet at downstream side.

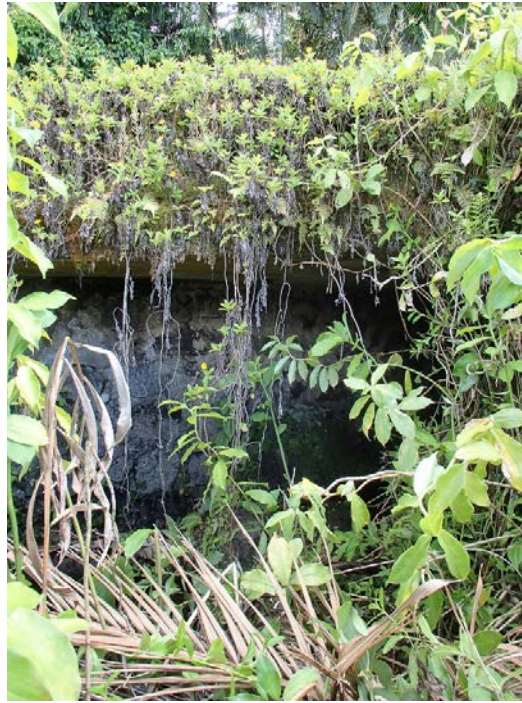
View of downstream CRM headwall / parapet covered with vegetation.

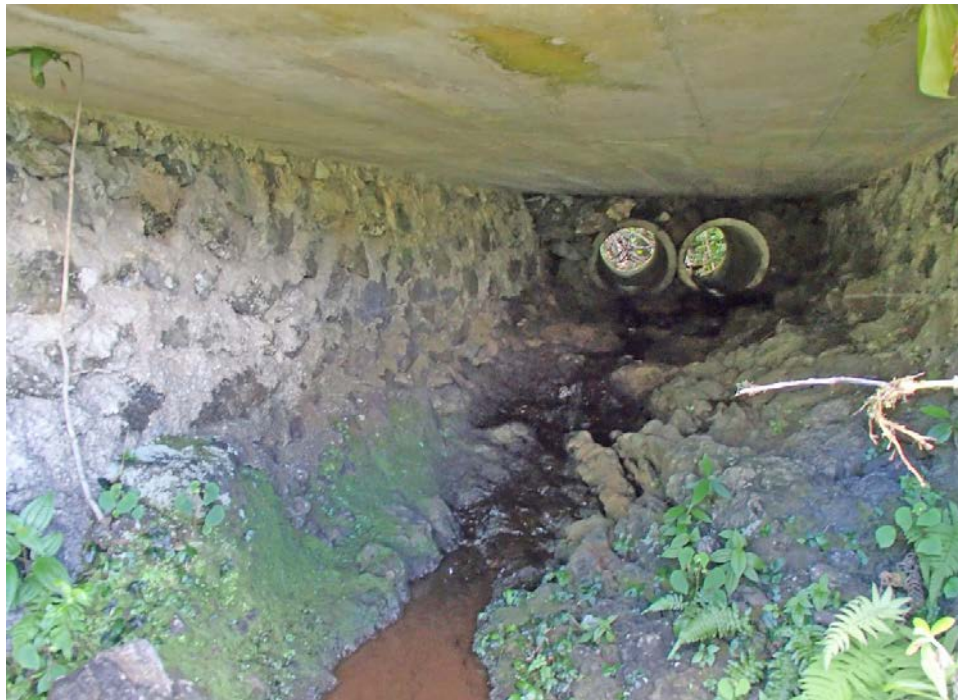
View of upstream through culvert.

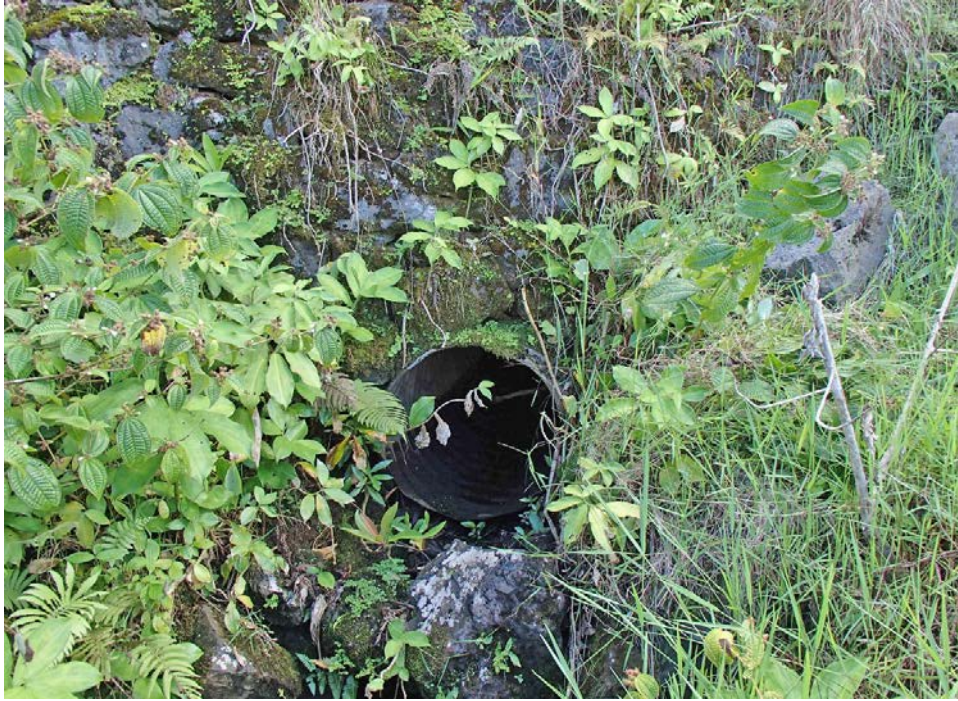
24" diameter CMP outlet at downstream side.
